## **Post-Tensioning Assessment and Rehabilitation of the I-526 Wando River Bridge**

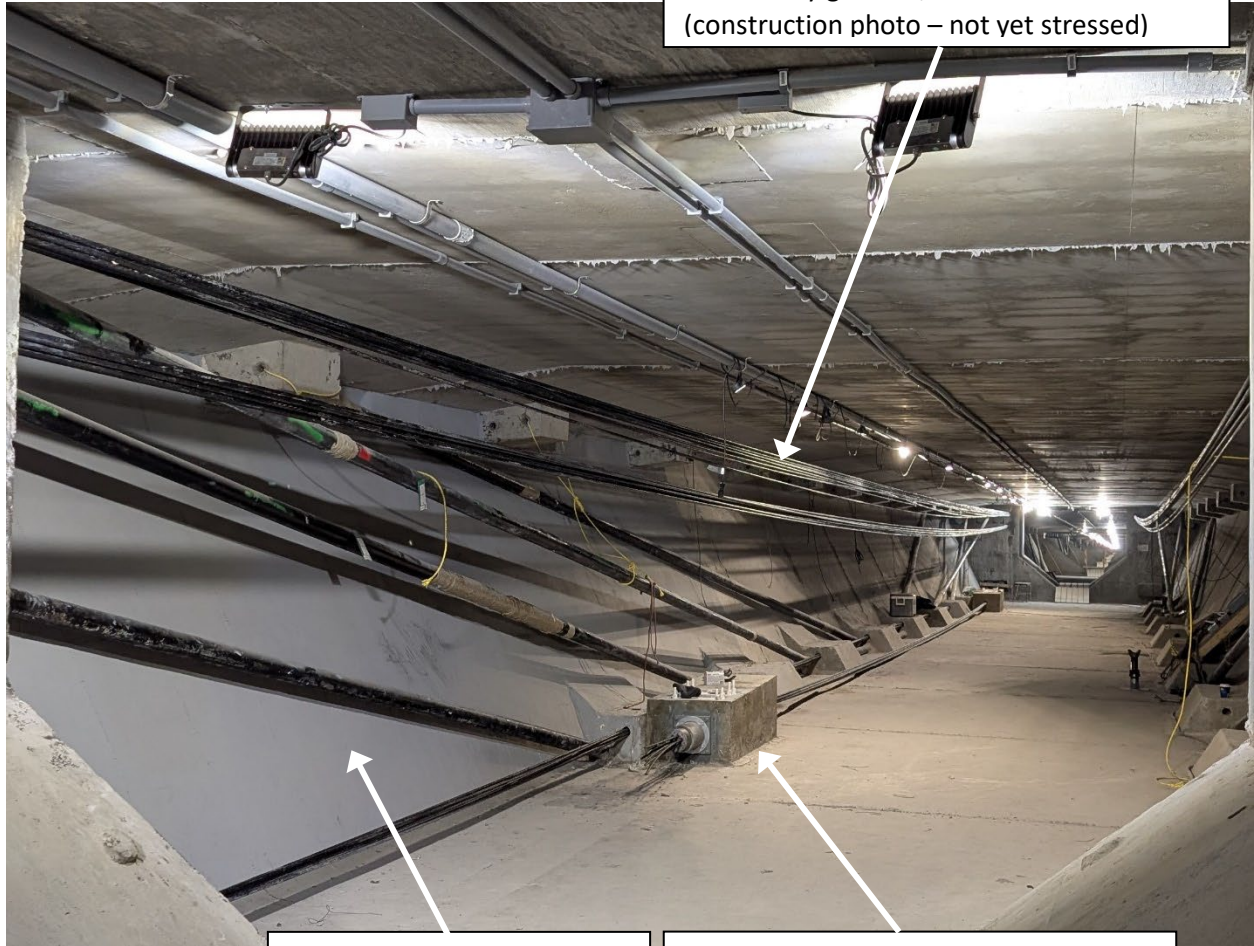
New multi-strand PT tendons comprised of individually greased/sheathed strands (construction photo – not yet stressed)

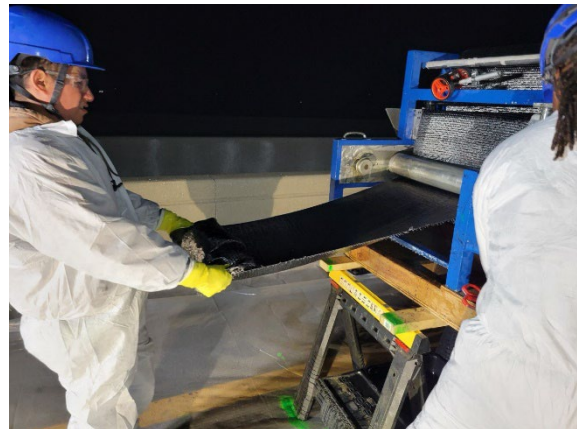
Installation of CFRP on exterior face of webs from snoopers (photos from Structural Technologies)

In this phase HDR also designed a strengthening plan to replace the effect of a partially detensioned draped tendon. The design included carbon fiber reinforced polymer (CFRP) sheets on the webs of the affected span to add shear capacity. Additionally, the design utilized an asymmetric configuration of five new straight tendons. As the first unducted post-tensioning system in a bridge superstructure in the United States, this innovative solution used individually greased-and-sheathed strands and custom anchor assemblies to simplify installation and avoid the need for grouting ducts while still providing a comprehensive tendon protection system.

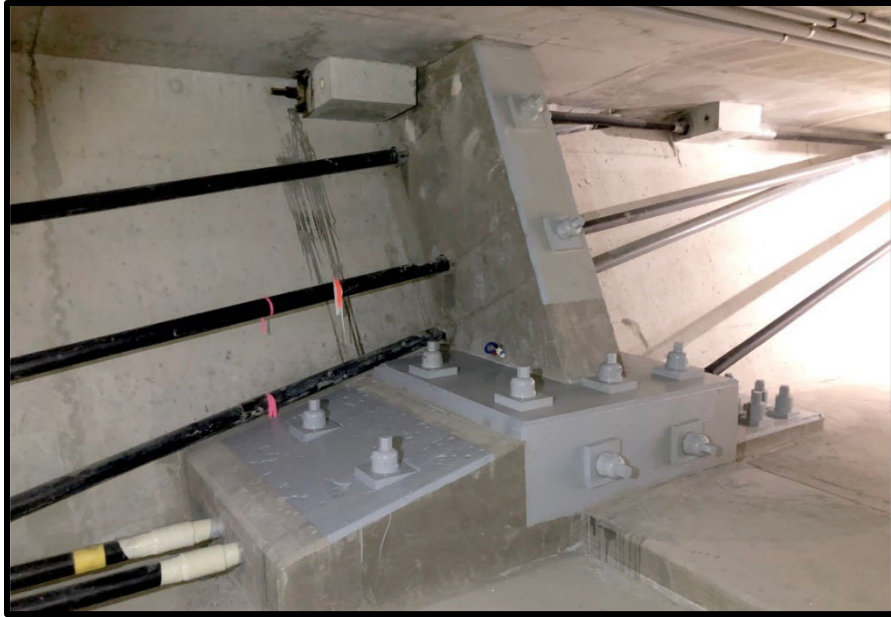
*Diaphragm coring for new tendons. Note CFRP sheet used on the right face of the diaphragm to resist anchorage general zone bursting forces. (Photo from Structural Technologies)*

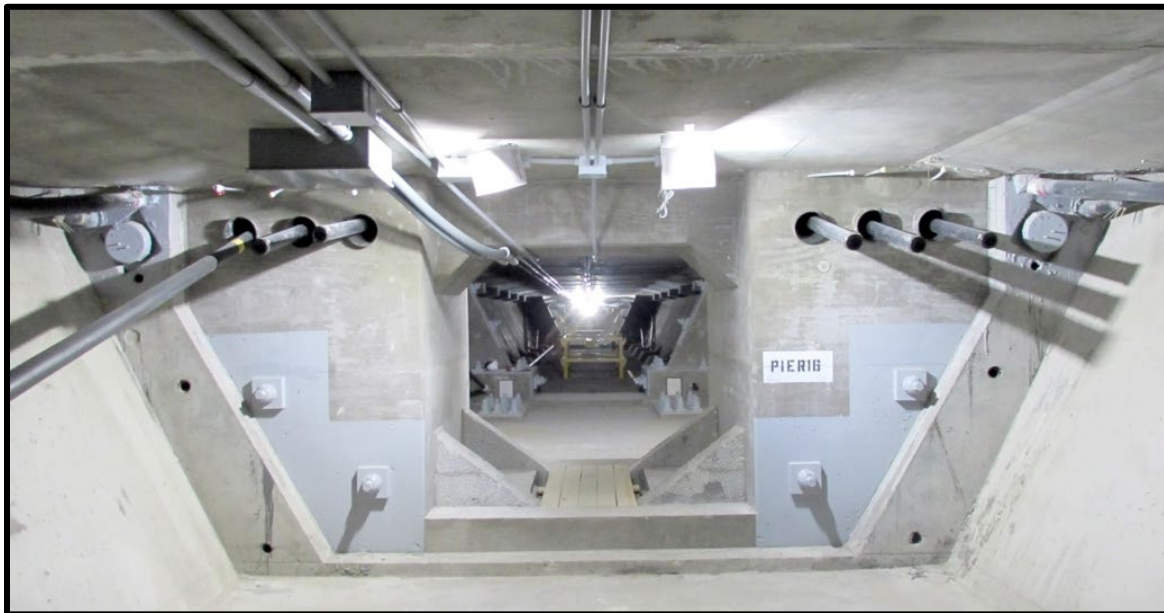
*New anchor/deviator designed to anchor and deviate new draped tendons*
