# Post-Tensioning Inspection and Rehabilitation of the I-526 Wando River Bridge

Nick Amico, PE

Senior Bridge Engineer

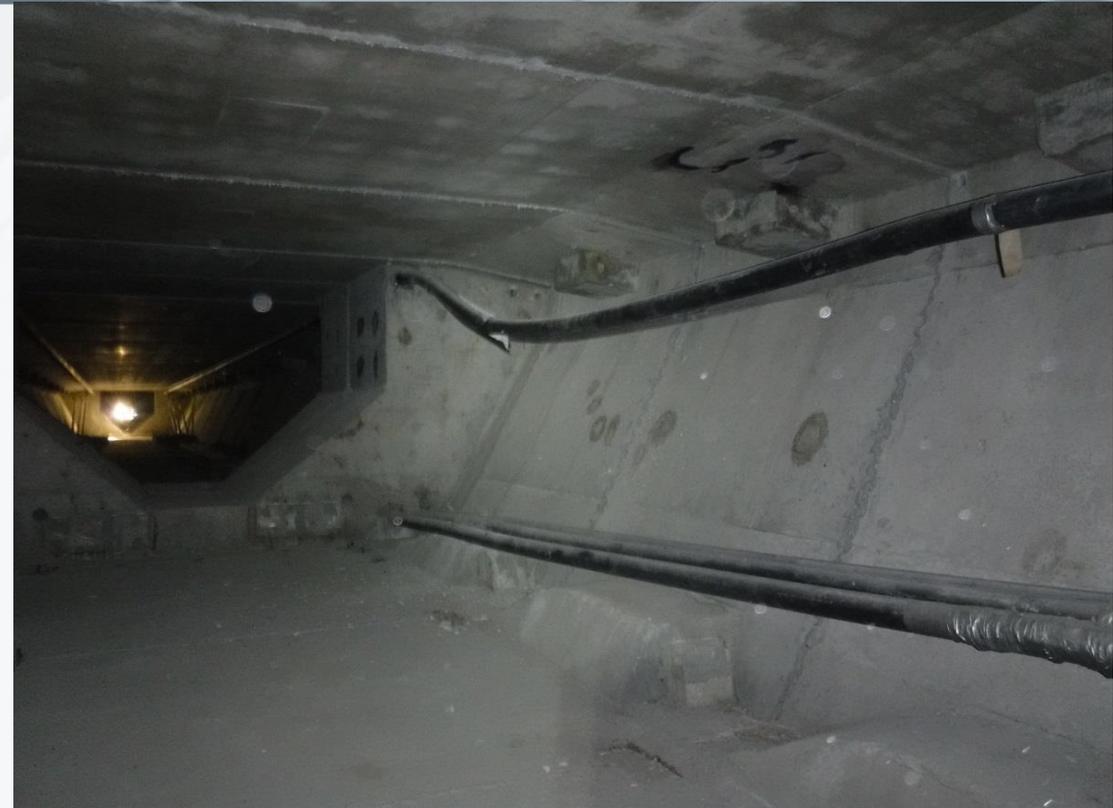
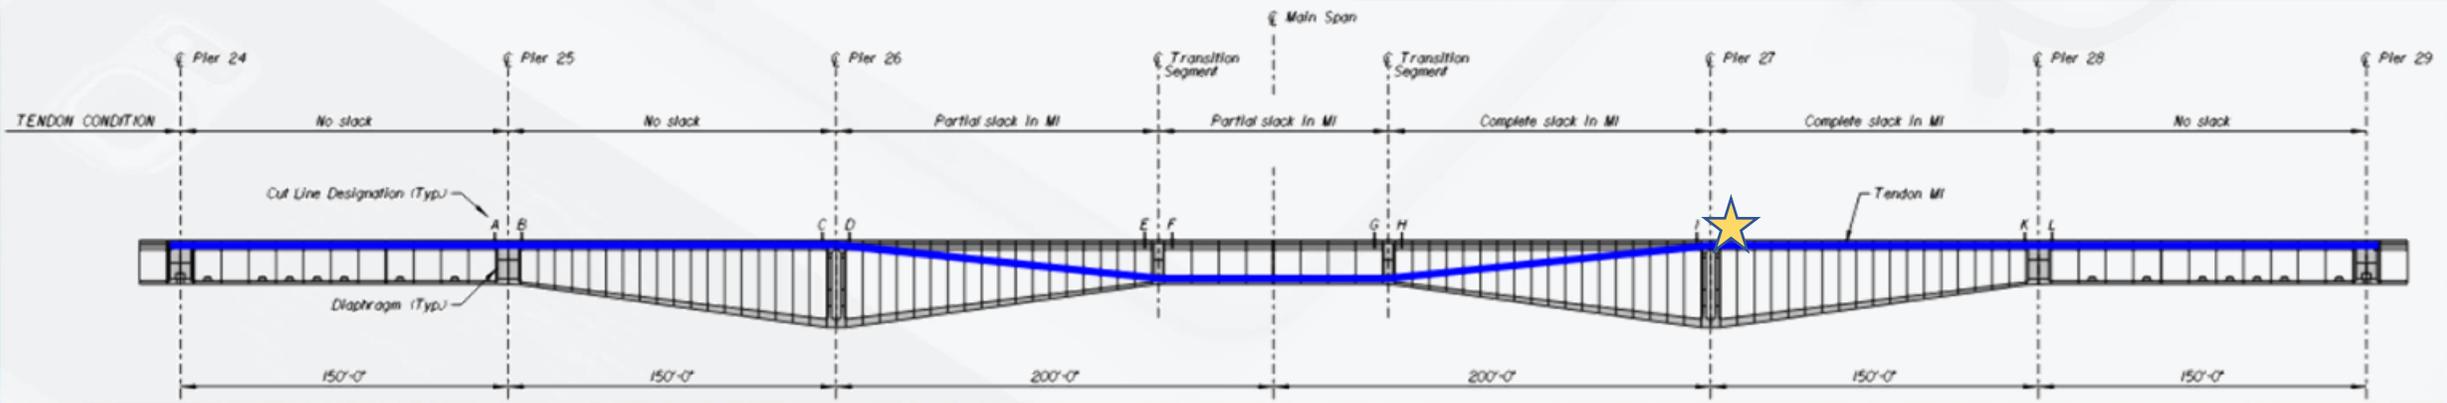
- M1 Tendon Failure
  - 19 Strand Tendon
  - 1,010 ft long
  - External Tendon
  - Continuous between Piers 24-29
  - Passing 8 Diaphragms

- Response:
  - No other distress evident
  - Installed crack monitors at key locations
  - Closed one traffic lane to reduce load and provide a work zone on the deck
  - Modeled and analyzed main span unit
  - Installed one supplemental tendon
  - Detensioned and replaced M1 tendon

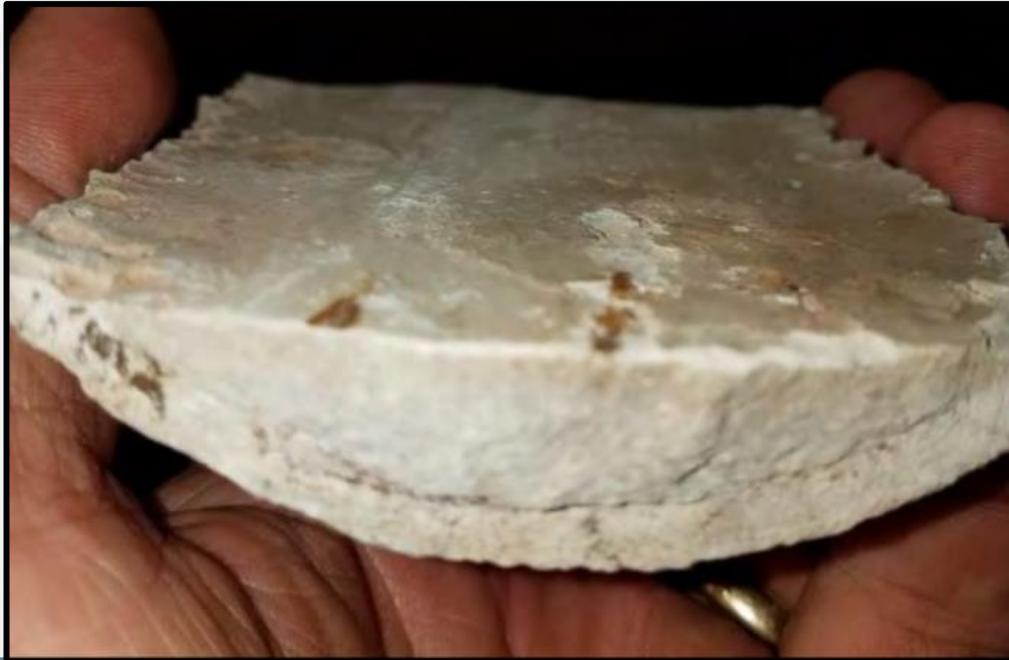
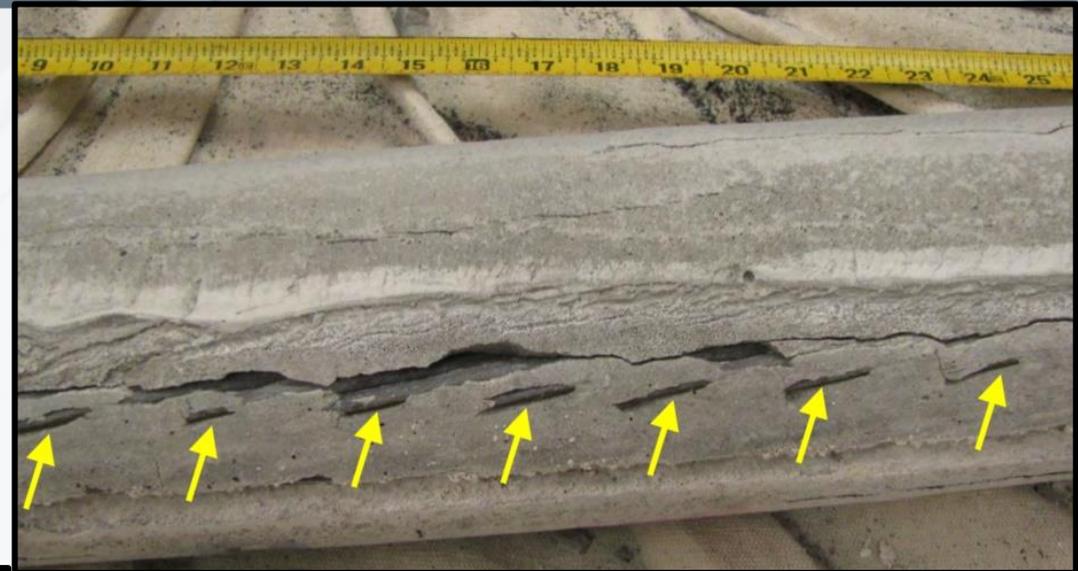
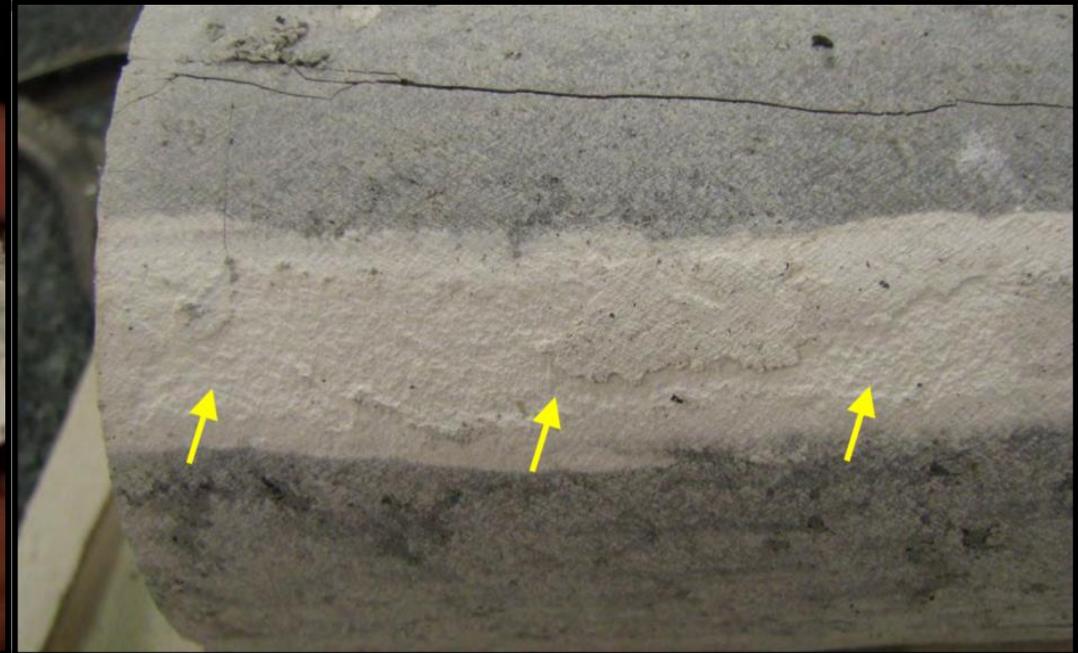
- Tendon and Grout condition observations

- Severe corrosion of the strand
- Duct was approximately 80% empty
- pH was very low
- Water infiltration
- In short: large void at the high point of the tendon left the strand unprotected

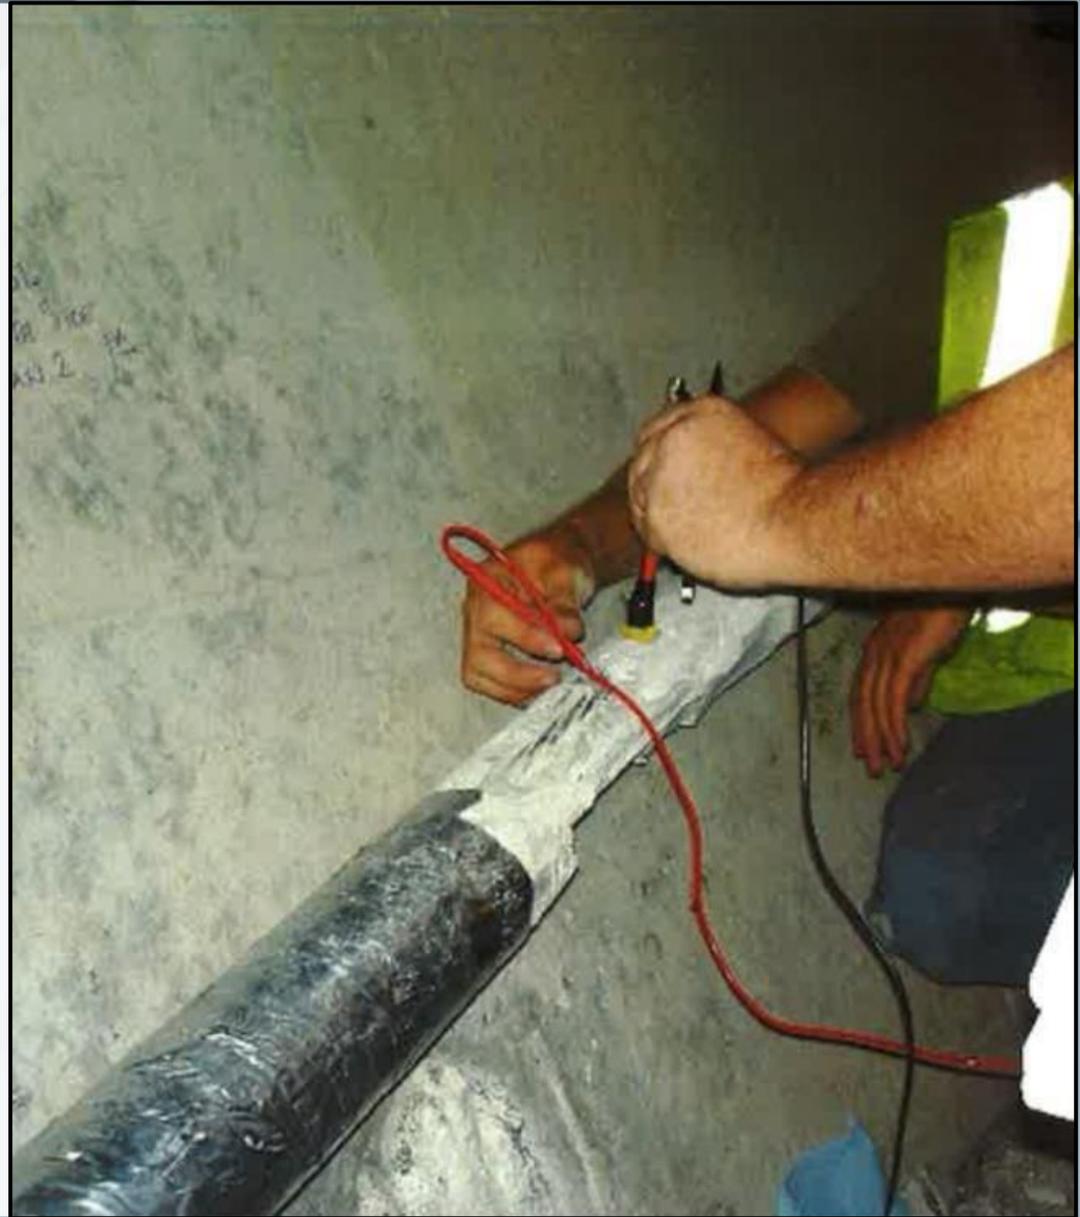
- Grout condition observations
- Corrosion potential (ASTM C876)
  - Indicated no active corrosion for all tendon samples

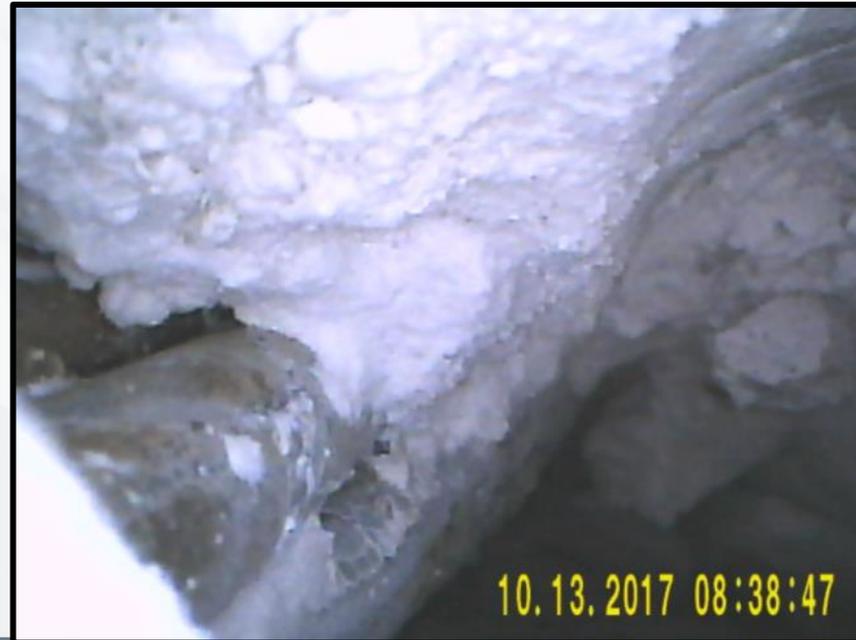
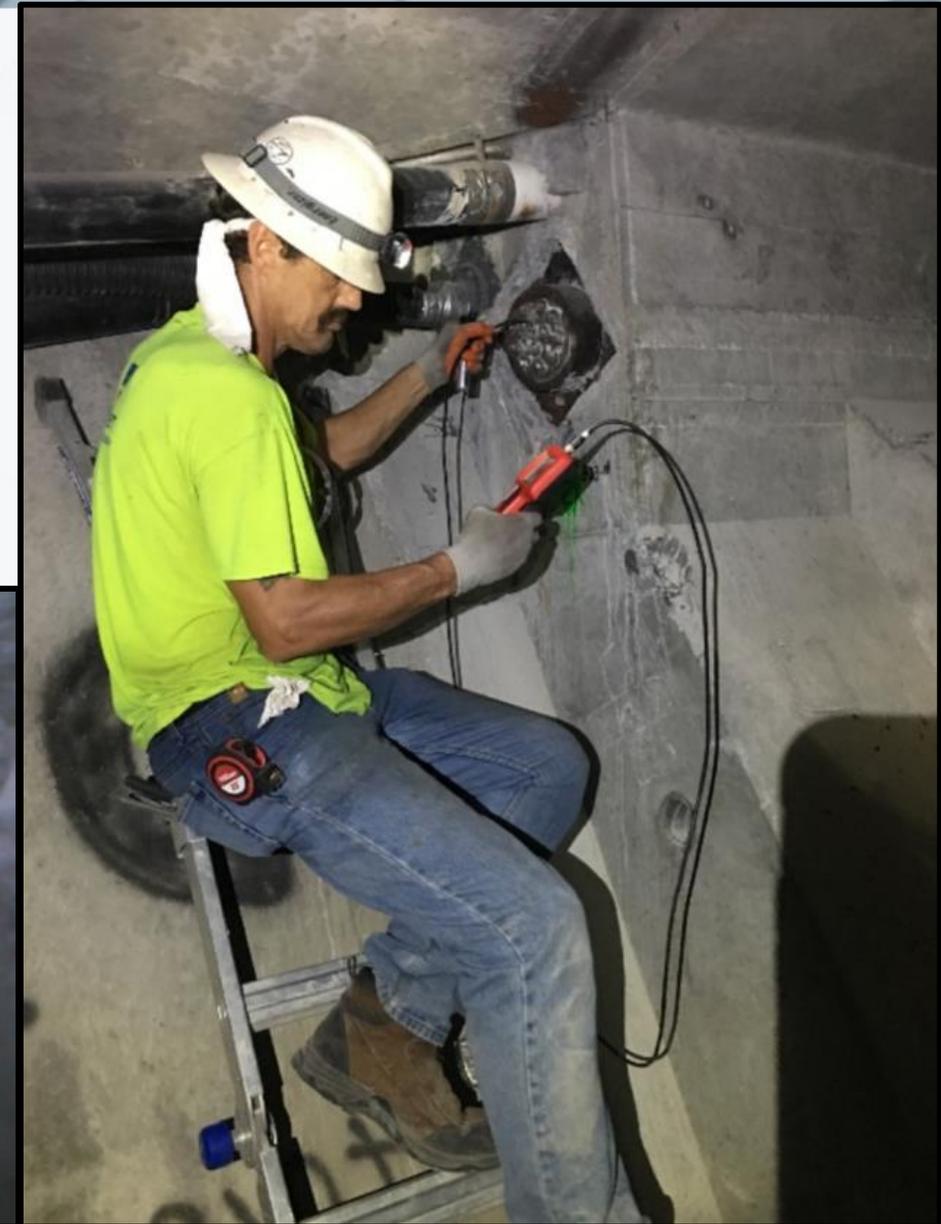
- Total of 300 borescope inspections performed
  - 270 Accessible external tendon anchors investigated
  - 30 External tendon high points investigated
- Various deficiencies included
  - Grout voids
  - Exposed strand
  - Corrosion
  - Soft grout
  - Water leaking

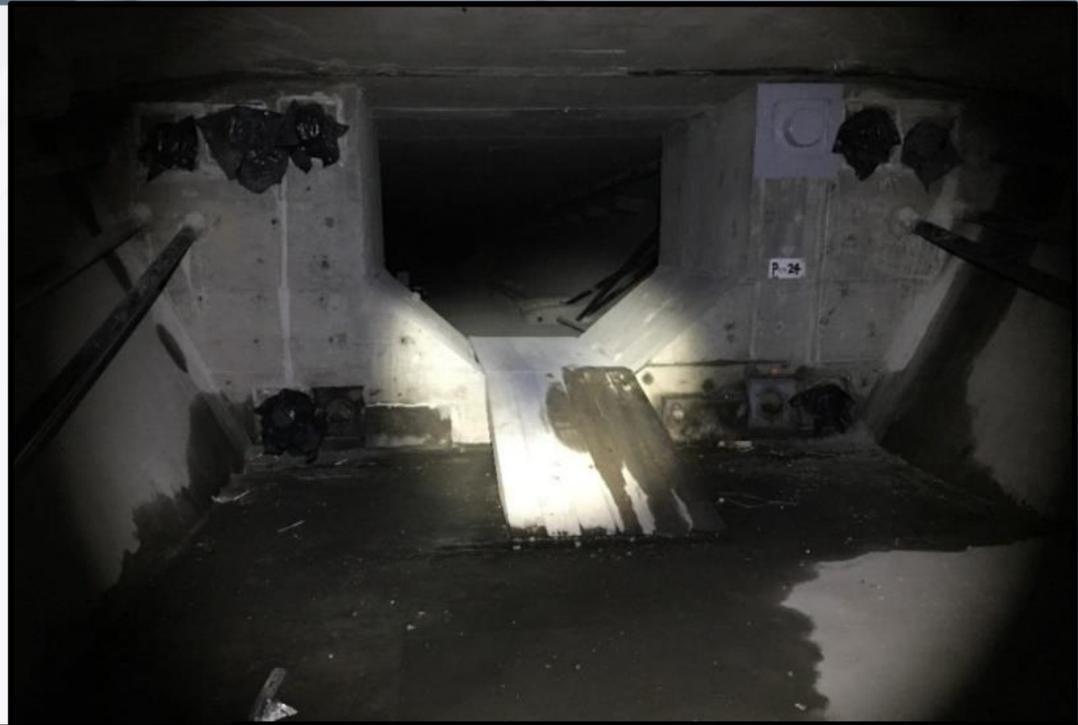
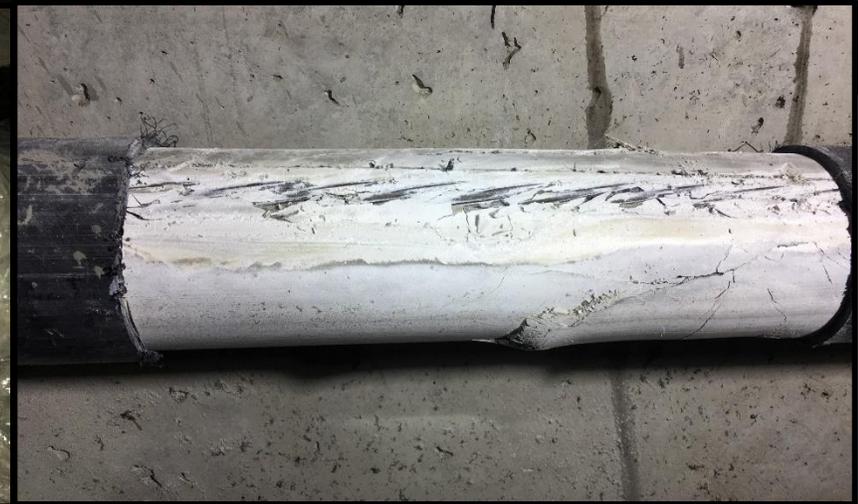
- Leaking segment joints
- Slack tendon (Span 16)
  - No evidence of water infiltration, corrosion, or poor grout
- Slack strands
  - Fully grouted in place, indicating occurrence during construction

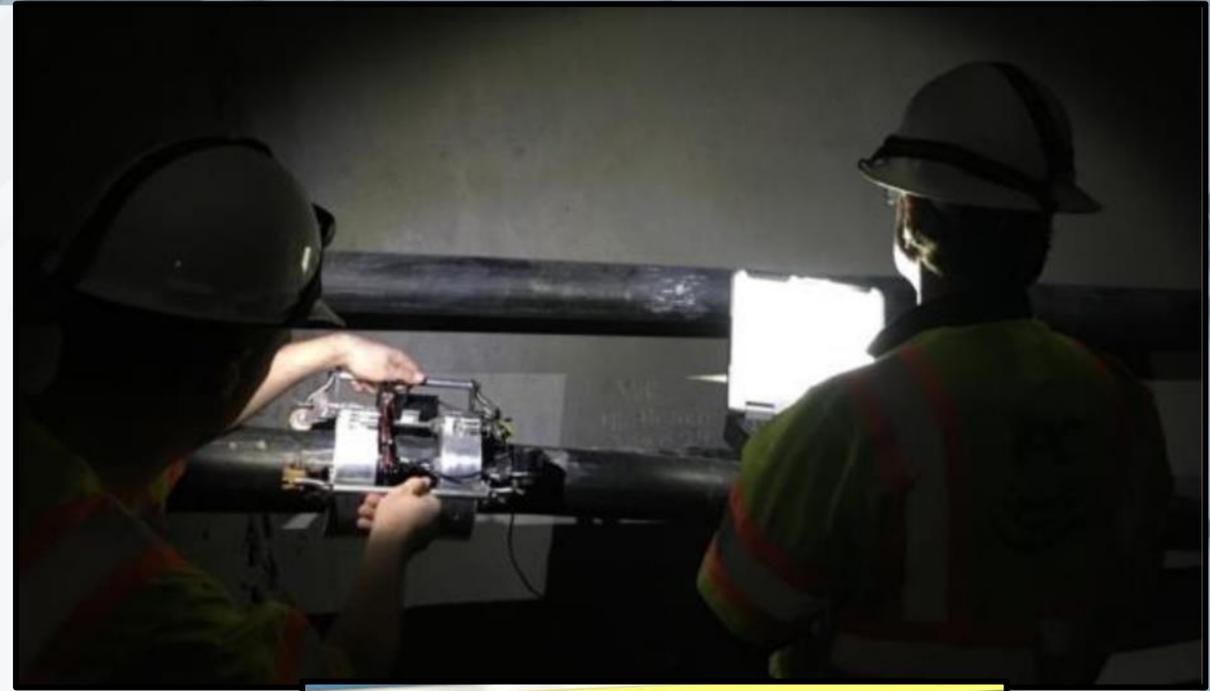
- Total of 24,525 lf of external tendons were investigated
- Locations of indicated section loss were flagged for monitoring or opening for investigation
- Openings at the five tendons in the highest category revealed minor corrosion that did not warrant further testing or replacement

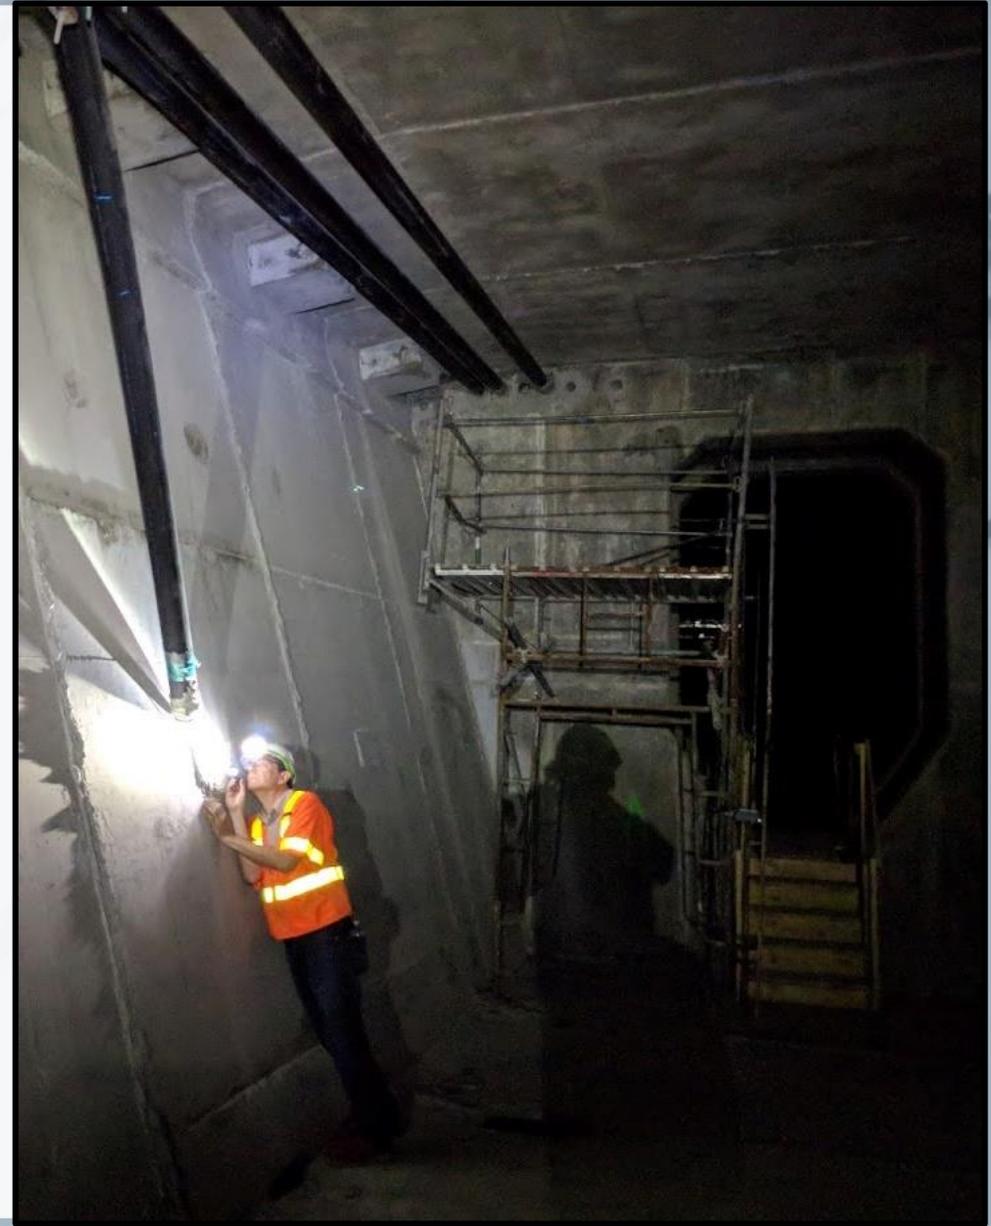
- Second WB tendon rupture, May 2018
- Rupture at same location as M1 tendon
- Closed WB structure; crossovers used to shift WB lanes to EB structure

- Two supplemental tendons permanently installed in both structures
- Deck repairs performed
- Metallurgical testing
- Bridge reopened after 19 days

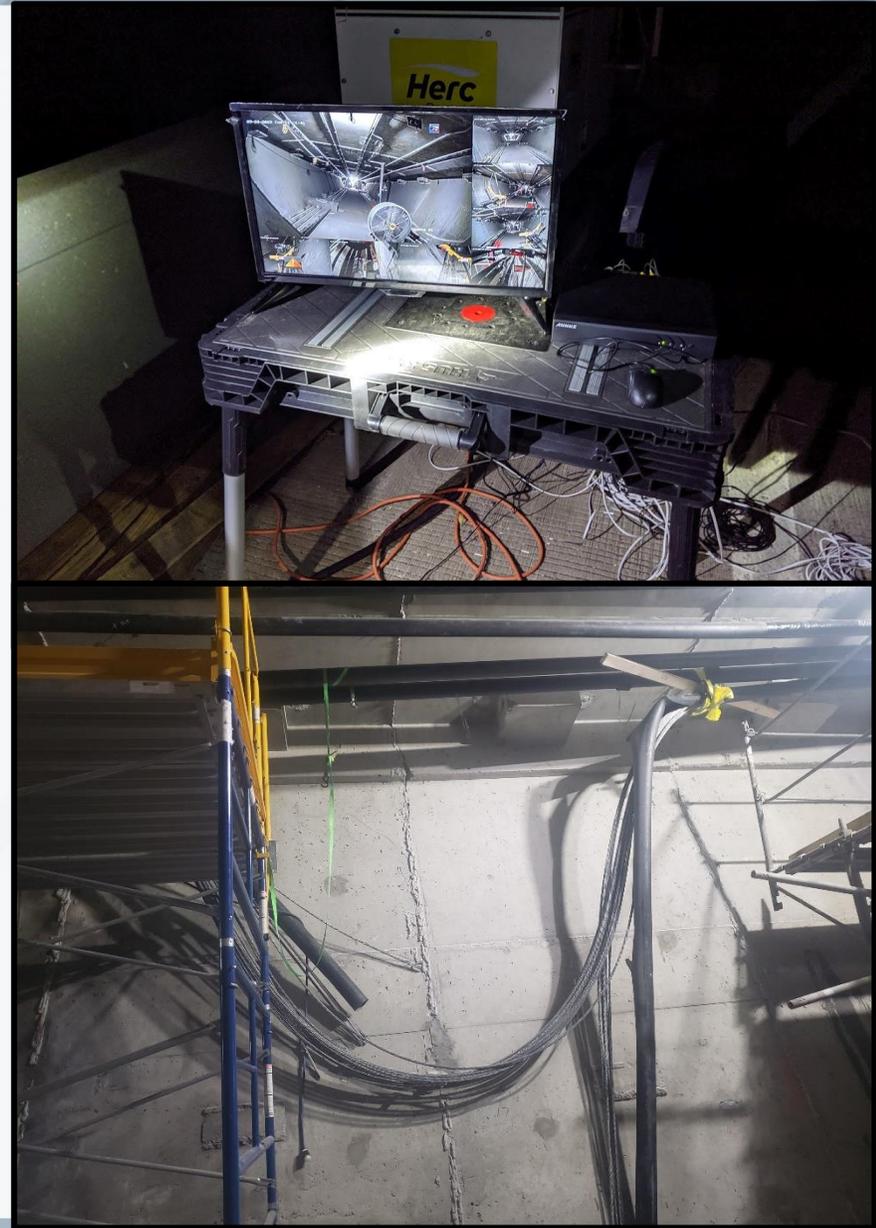
- M2-L and M2-R tendons were replaced one at a time
- Inspection of the tendons revealed corrosion, but was not as extensive as anticipated

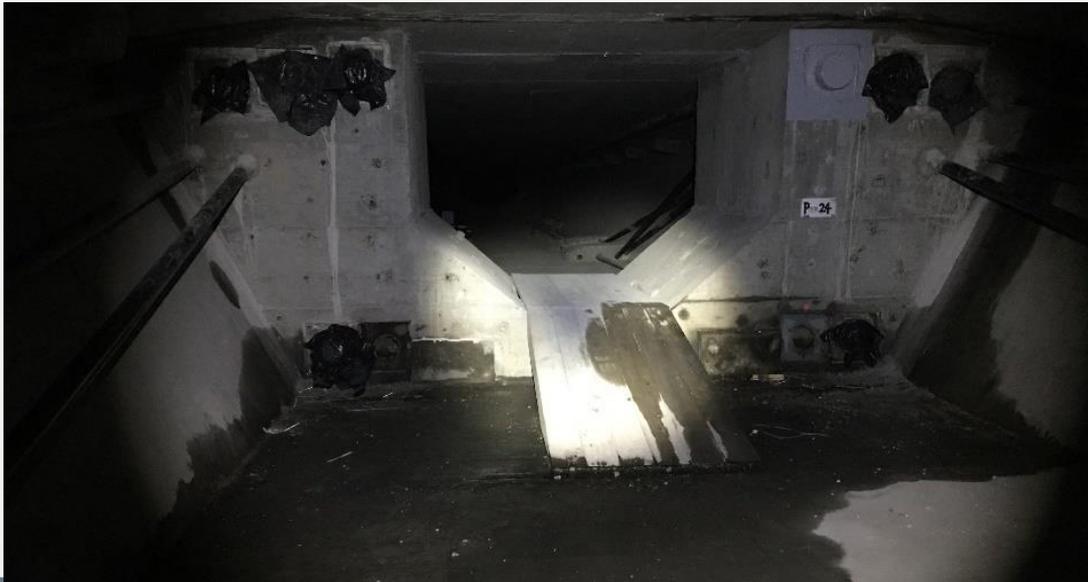
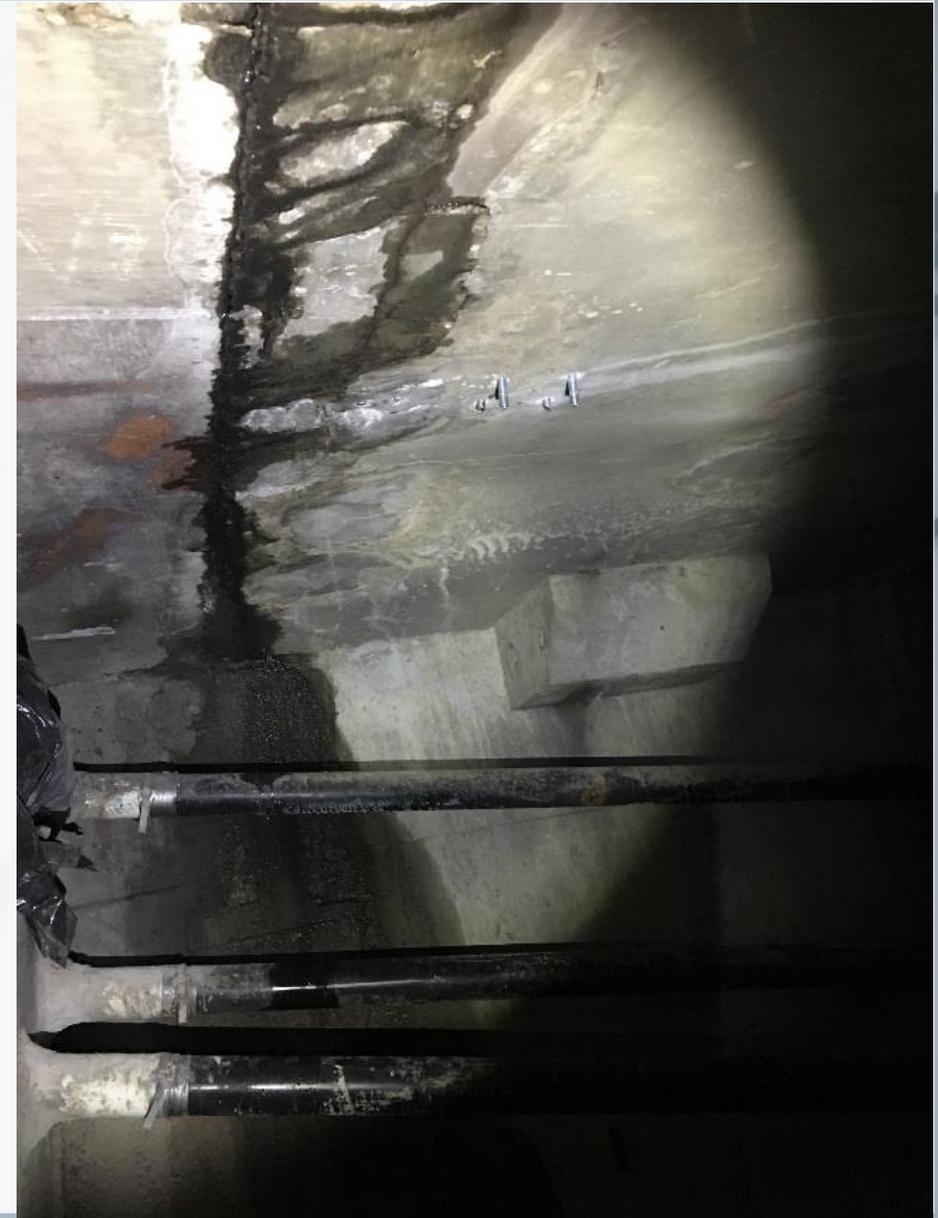
- Leaking and damaged joint at P24 diaphragm, both structures
- Joint further damaged in prior efforts to seal it
- Visible differential displacement under truck loads

- Joint is between a pier segment and a typical segment
- Differential deck displacement at joint causing additional spalling and deterioration
- Needed to control the differential displacements, repair the deck, and seal the joint
- Deck is 8" thick (before milling) and very lightly reinforced, so limited shear capacity if a frame was added

- Two-part solution:
  - Steel frame to limit the displacement of the deck
  - Precast drop slab to additional shear capacity to the deck
- Steel frame designed to be removeable to provide anchor access
- Drop slab is connected to the top slab with epoxy and a grid of post-tensioned rods for composite action

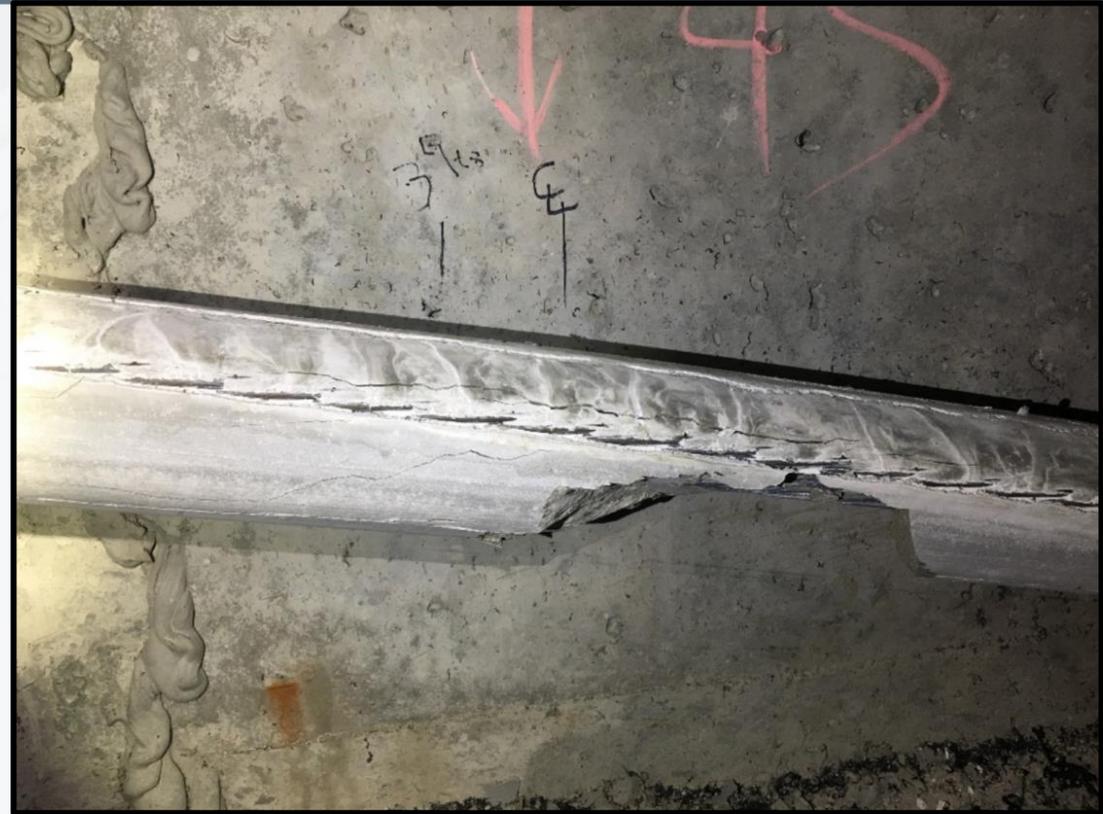
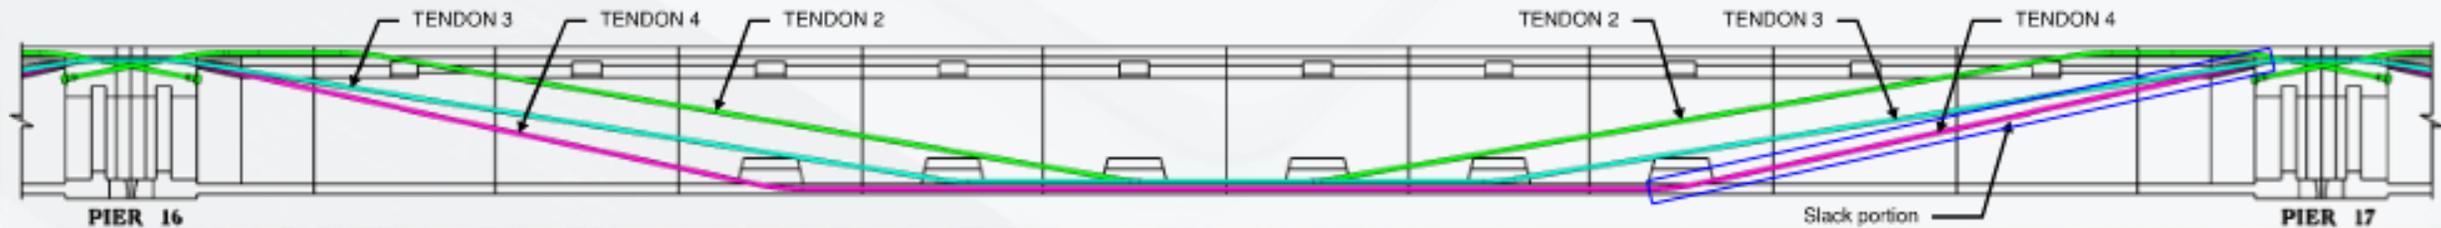
- Draped portion of Tendon 4S found to be during assessment phase
- Several bulges in the HDPE duct
- Opened in two locations to reveal fractured grout
- Downstation end of tendon still had tension
- No evidence of corrosion or water infiltration of the tendon or at the diaphragm

- Two new tendons, crossing at the midspan of Span 16
- Places all anchor blocks on the bottom slab → no impact to traffic
- Matches the  $V_p$  provided by the original tendon
- Doubles the number of strands crossing the midspan
- Provides redundancy for existing coupled tendon in adjacent span
