#### WALTER P MOORE

## THE USE OF NDE AND ANALYTICAL TOOLS IN POST-TENSIONING REPAIRS

April 27, 2015

## CASE STUDY #1

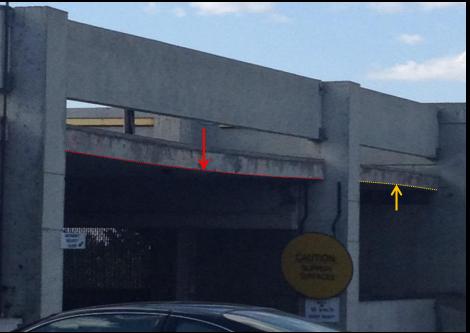
• A slab deflection of approximately 54 mm at the turning bay and a camber of approximately 22 mm in the adjacent end bay span were observed in the northwest quadrant of the roof level ramp.

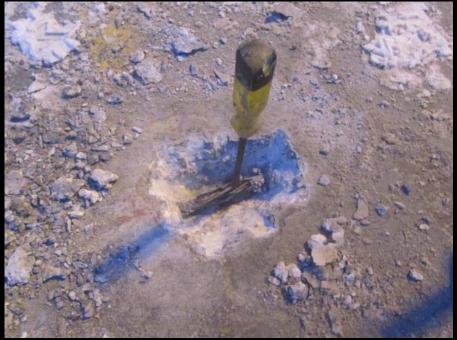
Exploratory openings of tendons in areas of observed distress (slab cracking, deflections) revealed detensioned and loose post-tensioned tendons in addition to the failed tendon observed at the roof level slab soffit.

Screw drive penetration test indicating a de-tensioned PT tendon on the ramp at the Roof Level

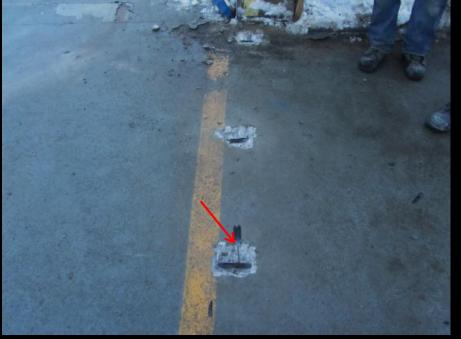
Screw drive penetration test indicating a de-tensioned PT tendon on the flat portion of the Roof Level

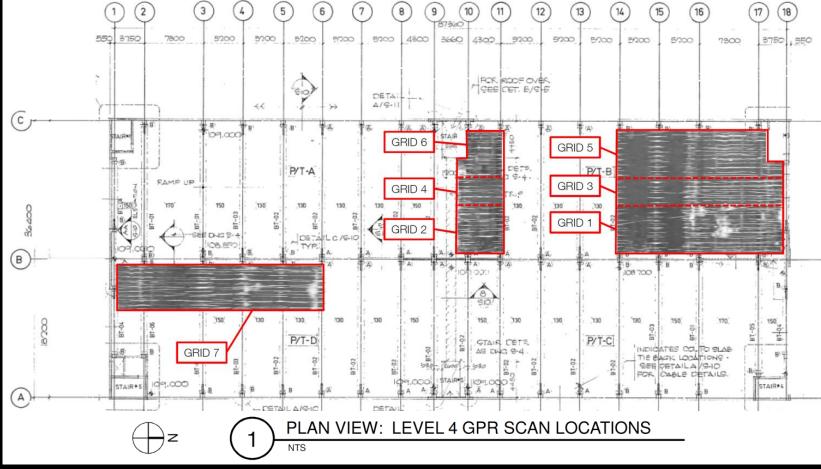
A Ground Penetrating Radar (GPR) survey was performed at selected areas of the roof level floor slab to determine the as-built post-tensioning tendon profiles.

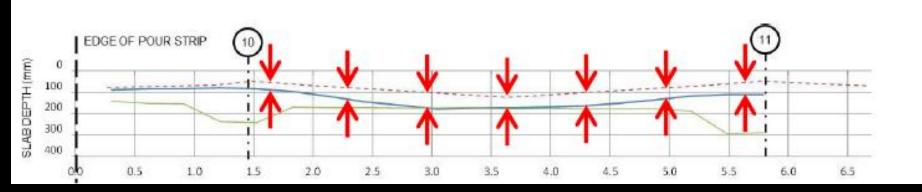
Individual vertical tendon profiles were determined for each tendon in the scan areas and were plotted against the design tendon profiles specified in the record drawings.

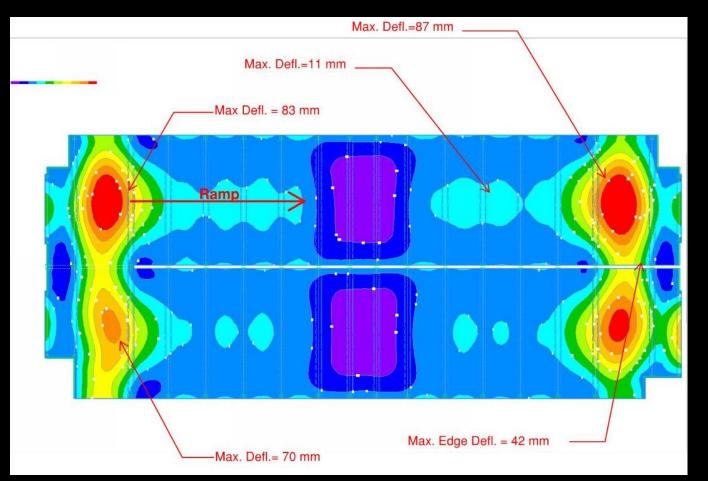
- → A structural analysis was performed based upon three structural configurations and the loading requirements of applicable code
  - Case I Analysis of the original design

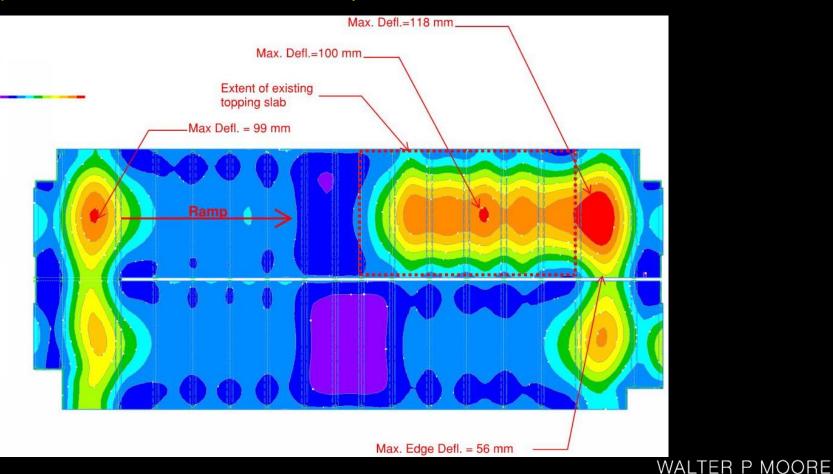
- → A structural analysis was performed based upon three structural configurations and the loading requirements of NBC 2005.
  - Case II Analysis of the as-built structure based upon information for tendon profiles obtained from the GPR survey.

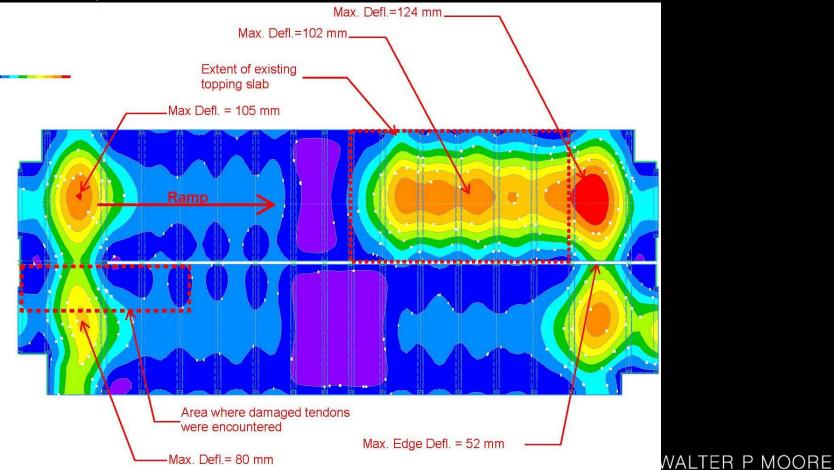
- → A structural analysis was performed based upon three structural configurations and the loading requirements of NBC 2005.
  - Case III Analysis of the as-built structure with consideration of the effects of the observed post-tensioned tendon distress.

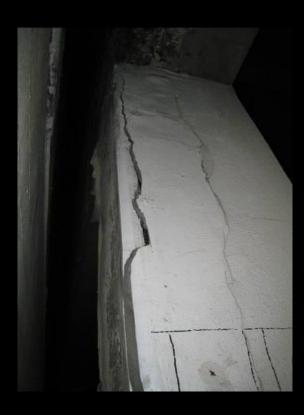
Cracking and Spalling in Overhead Concrete Pan on Roof Level

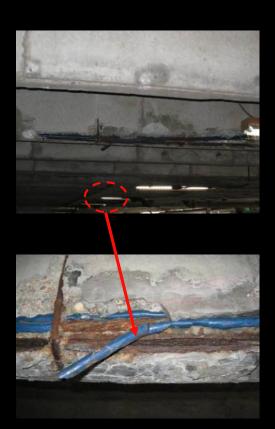
Column Distress on Level 1 Concrete Distress and Post-Tensioning Tendon Corrosion at Roof Joist

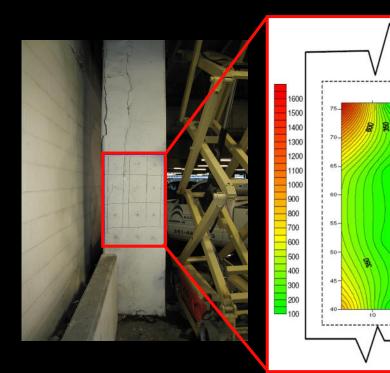
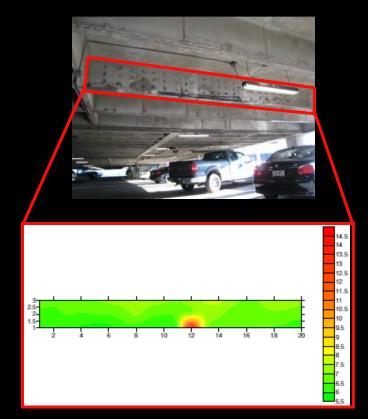
UPV Testing of Roof Level Joist
