# **NON-DESTRUCTIVE TESTING OF UNBONDED POST-TENSIONED TENDONS**

J. MILLER AND A. SCOTT

Authorized reprint from: December 2006 issue of the PTI Journal

## ABSTRACT

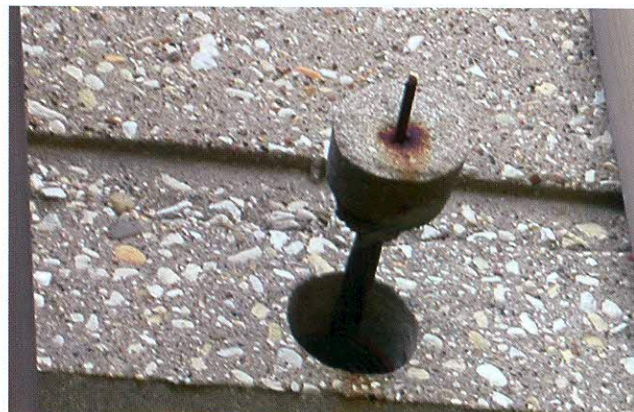
Fig. 1 – Visual Indication of a Broken Tendon

As a benchmark, two additional tests on a tendon known to be broken were performed. The two tests were conducted on the same tendon from Fig. 1 in two different locations along the length of the tendon. This particular tendon was a slab temperature tendon and extended the full 170-foot width of the structure. One test was conducted approximately 10 ft from the end and the other test was conducted at approximately the midpoint of the tendon. In both cases the pulling force never exceeded 200 lb and the tendon was drawn out of the sheathing until the hydraulic ram bottomed out. This verified that a broken tendon would have been easily identified during the testing. This also confirmed that an unbonded condition exists.

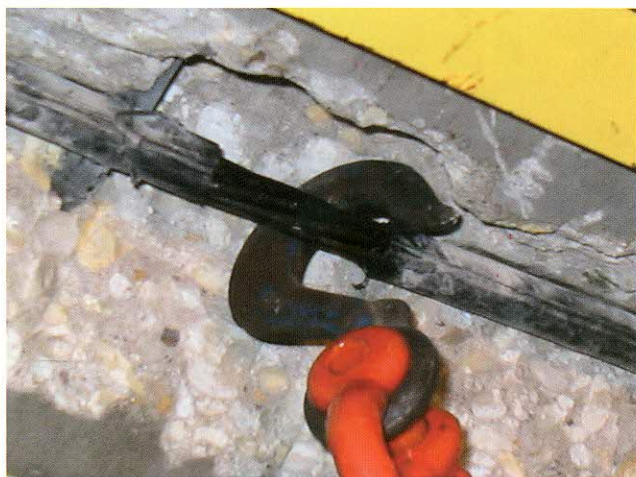
Fig. 6 – Close Up of Test Hook on Exposed Tendon

the test hook. See Fig. 6. The tendons were regreased and rewrapped and the test areas were easily patched at the conclusion of the test.

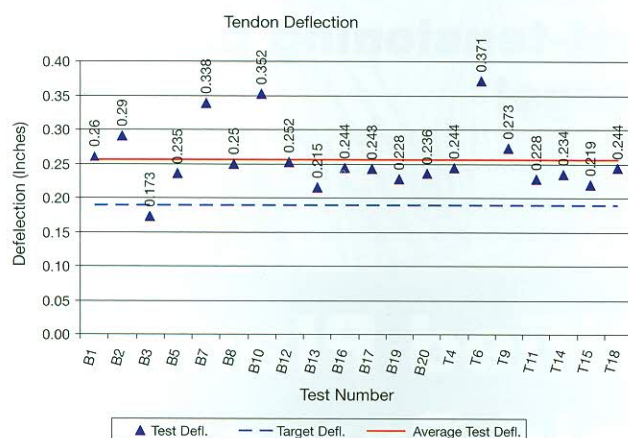
The pull tests were performed and the procedure went smoothly, with no problems or disruption. The expected deflection was theoretically established as 0.19 in. at the load increment of 1500 lb. The actual measurements and range of data are shown in Fig. 8. Most measured deflections were slightly higher than the expected results. The average deflection of all tested tendons was 0.25 in. There were three tests where the measured deflection exceeded 0.30 in., with a maximum test deflection of 0.37 in.

Fig. 8 – Tendon Deflection Test Results

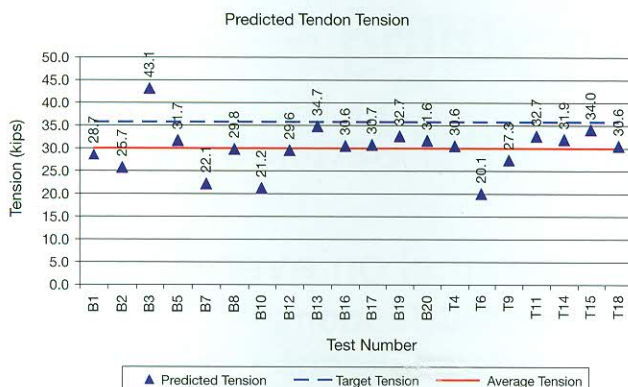
Fig. 9 shows the calculated tendon tension compared to the expected tension (final design tension specified on the structural drawings). The expected tension is 35.7 kips, while the average of all 20 tests was 30.0 kips. The lowest tendon tension measured was 20.1 kips and the highest was 43.1 kips.

Fig. 9 – Tendon Tension Test Results

The test results indicate that a significant amount of prestressing force exists in the tendons. No broken tendons were identified from the selected sample. Only 3 out of the 20 tendons tested showed a moderately low amount of prestress force as compared to the expected force. In the worst case, test T6 showed a tension of 20.1 kips of the expected tension of 35.7 kips, or approximately 56%. While this is a

significantly low force, randomly located tendons with such a loss of prestress—even complete loss—normally do not significantly affect the serviceability of the parking garage. On average, the amount of prestress force on the 20 tendons tested was approximately 84 percent of the expected force. Based on the test results, it was judged that the parking structure would be serviceable during the 3 year period while a replacement garage was designed and constructed. The Owner was advised to monitor the structure for any changes over the following three year period.
