REPAIR OF PARTIALLY GREASE-FILLED ENCAPSULATED MONOSTRAND POST-TENSIONING TENDONS

Authorized reprint from: July 2007 issue of the PTI Journal

REPAIR OF PARTIALLY GREASED-FILLED ENCAPSULATED MONOSTRAND POST-TENSIONING TENDONS

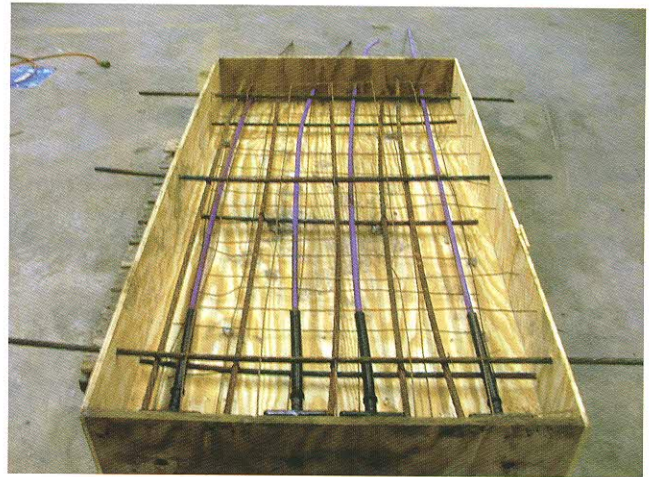
Since the project conditions and tendon profiles varied on the project, it was necessary to test the method with mock-ups, prior to mobilization to the site. The mock represented actual field conditions to ensure the reliability of the method. (See Figs. 1 and 2).

Fig. 1 - Mock-up test set-up

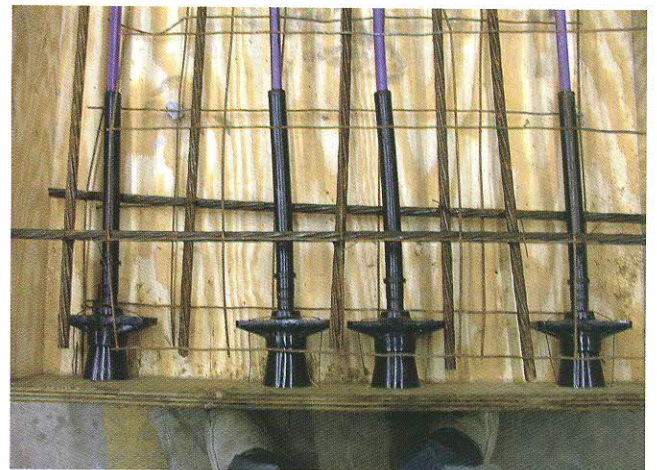
Fig. 2 - Close up of mock-up test set-up anchorages

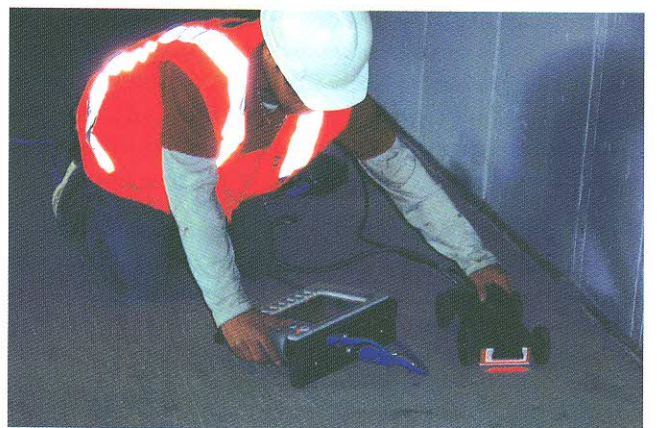
Fig. 3 - GPR scanning for tendon location

vidual tendons, the technique works reasonably well. Fig. 3 shows a GPR scanning from the top of the slab. When the deck is exposed to an aggressive environment it is recommended that GPR scanning be performed from under-

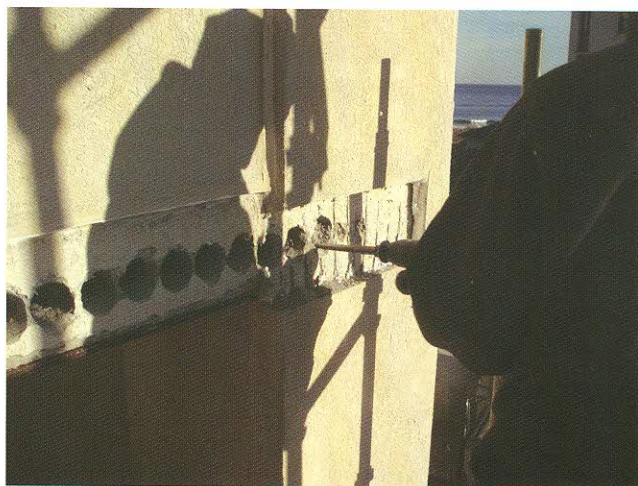
This includes the removal of existing grease caps; cleaning and inspection of anchorage condition (Figs. 6 and 7 show the grout removal and Fig. 8 shows the condition of the anchorages as they are exposed). The anchorages and concrete pocket surfaces are wire brushed for cleaning. The cleaned open pocket serves two purposes: The flow of grease through the wedges is used to confirm that all void spaces have been filled. It can also be used as an injection port when practical; in this situation the hole drilled through the sheathing serves as a vent hole.

Fig. 6 - Removal of grout from stressing pockets

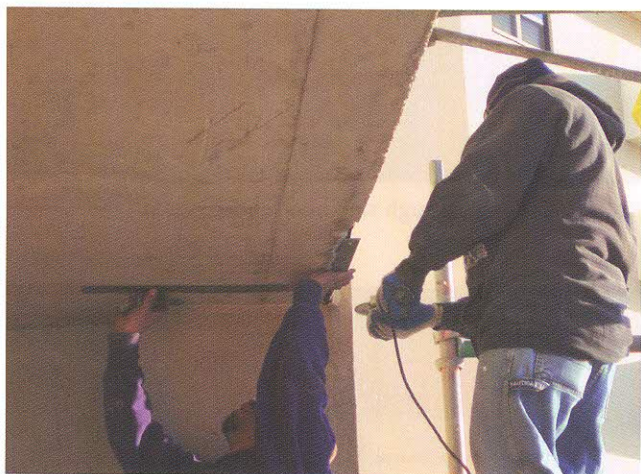
neath the slab. Once the tendons are located drilling can also be performed from underneath the slab, reducing possibility of future water intrusion through the drilled holes or patches, after the work is completed. As the tendons are located, the drill locations are marked on the structure. (See Figs. 4 and 5).

Fig. 4 - Marking of tendons

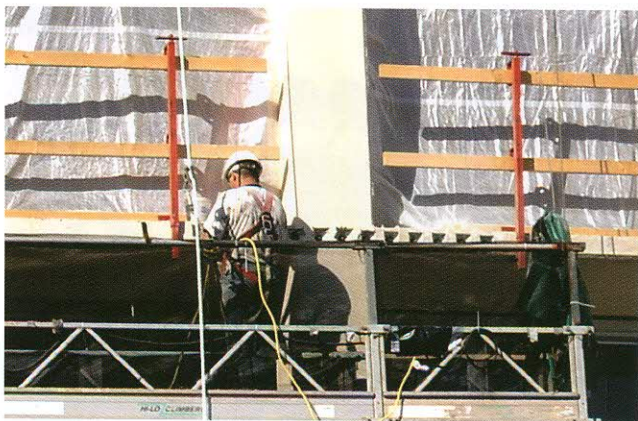
Fig. 7 - Exposed stressing pockets

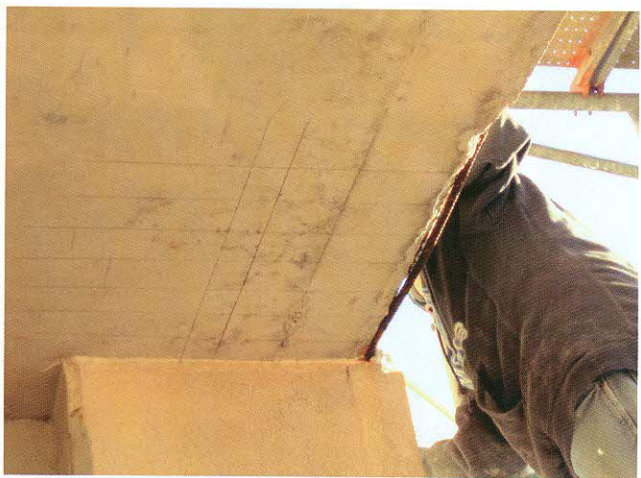
Fig. 5 - Marked tendons at the soffit of slab

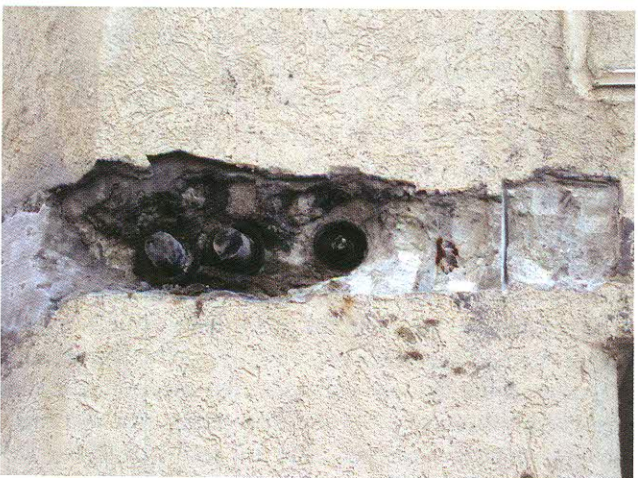
Fig. 8 - Deteriorated anchorages due to improper end-cap installation

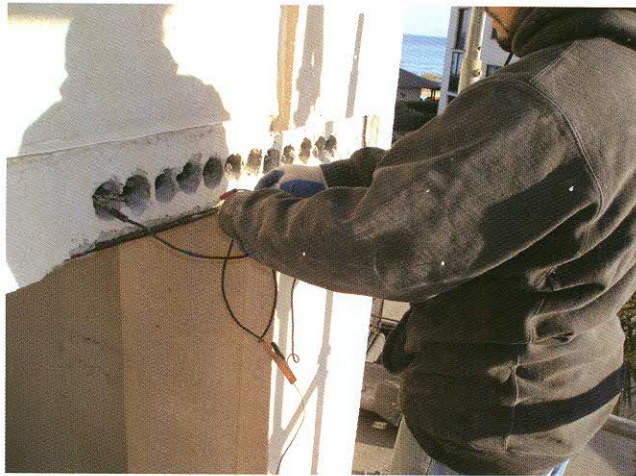
Fig. 9 - Establishing electrical continuity with the strand tails

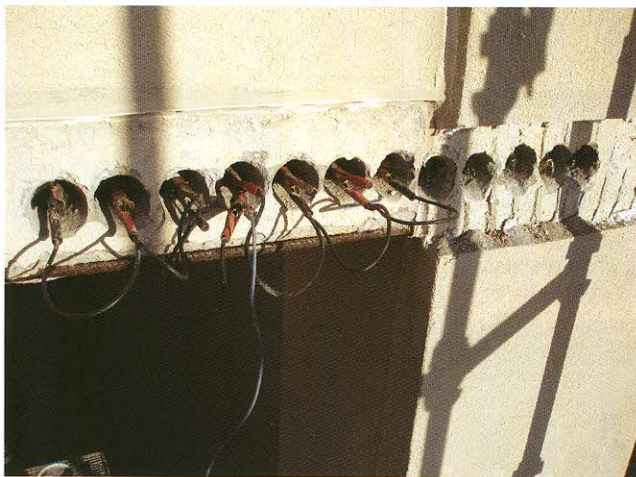
Fig. 10 - Connection to strand tails

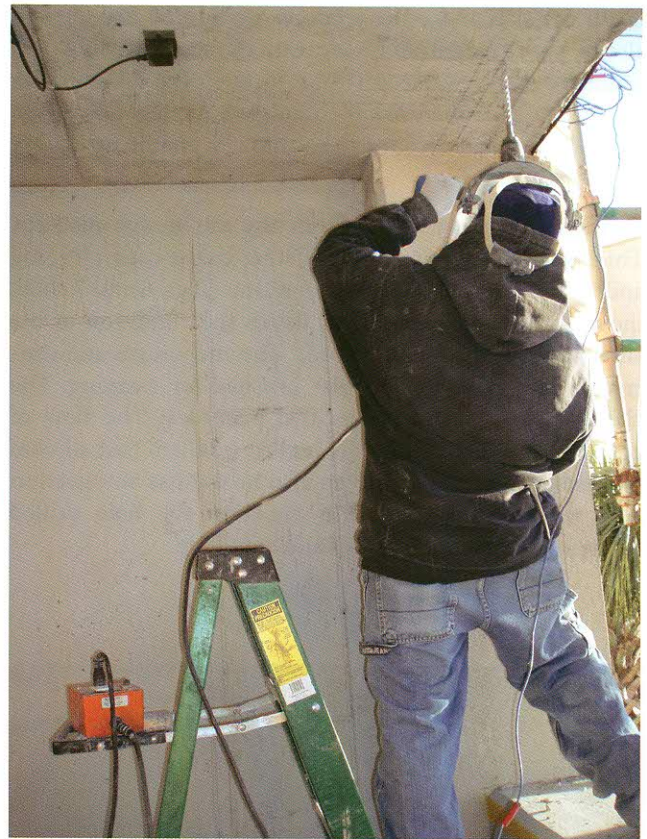
Drilling of injection ports and installation of fittings for grease injection: Prior to the beginning of the drilling operation, it is important to implement a drilling system that will automatically shut-off when the tip of the drill bit touches metal. This is a critical step necessary to protect the prestressing steel during the drilling operation through the tendon sheathing (Figs. 9 and 10 illustrate the connection to strand tails.) Despite the fact that automatic shut-off equipment is used, careful attention is needed during the drilling operation to avoid errors. Errors could be costly and may result in a damaged strand. The drilling is done through the concrete slab and tendon sheathing at a location where the need for grease starts; it could be one to three feet from the anchorage or more, depending on each situation. In this case, from the preliminary sample inspection performed by the Owner, it was found that the absence of grease in the tendons started at the connection of the greased sheathing with the seal tube (about one foot from the anchorage). However, due to access reasons, the drilling into the sheathing was performed at about three feet from the anchorage in those cases where the tendons went through the columns. Figs. 11 and 12 illustrate

Fig. 11 - Drilling through slab and tendon sheathing

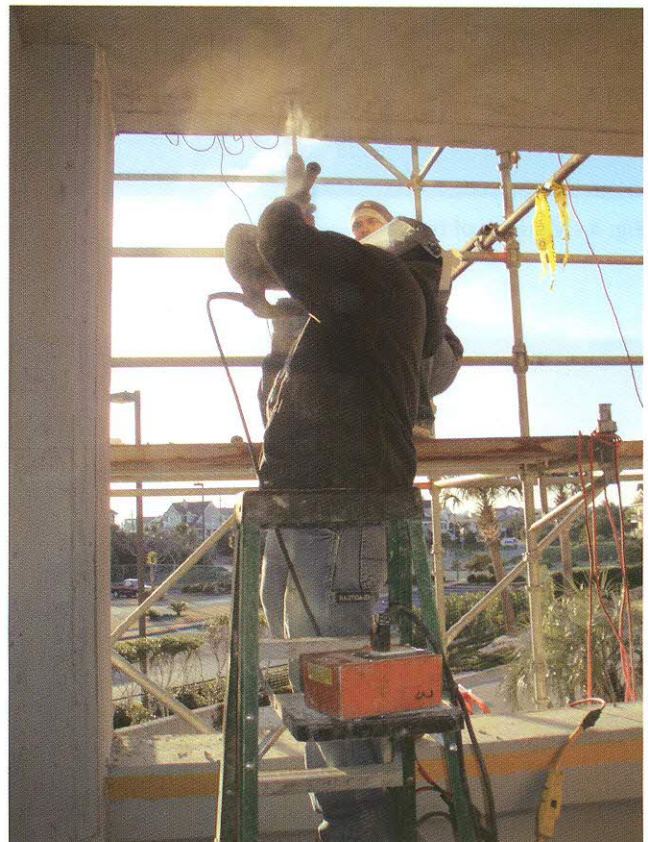
Fig. 12 - Drilling through slab and tendon sheathing

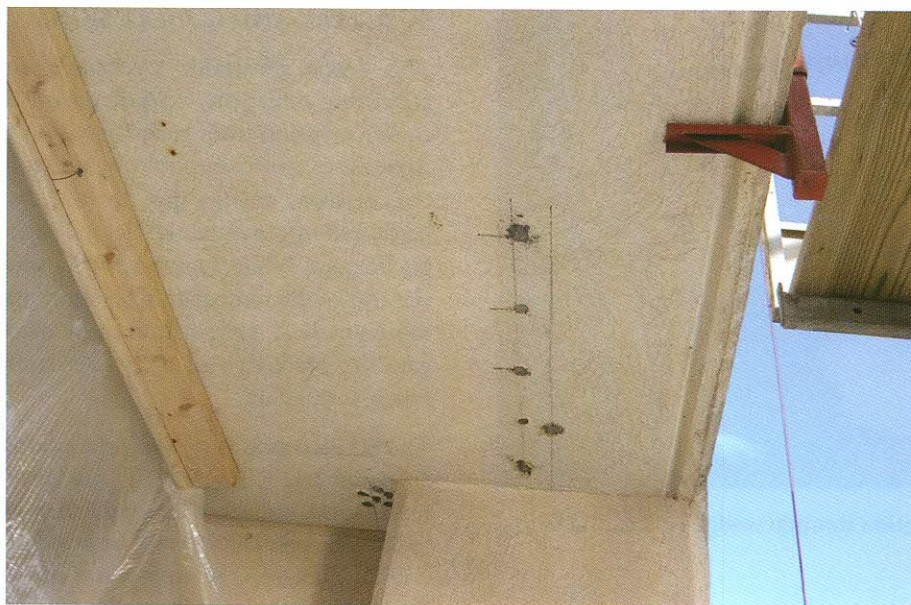
Fig. 13 - Drilled holes into tendon sheathing at balcony

drilling from underneath the slab at a distance of about two feet from the anchorage. Fig. 13 shows the drilled holes; note that the holes may need to be staggered to accommodate all of the tendons in a group for banded tendons. (see the staggered holes behind the column in Fig. 13).

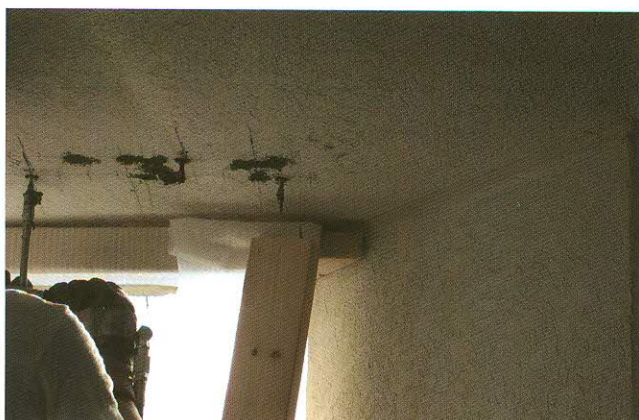
Grease Injection: In slab decks or balconies exposed to aggressive environments, the injection of the annulus between the sheathing and strand takes place from injection ports underneath the slab (see Fig. 14); the space between the strand and wedges at the anchorage serves as a vent. However, there are some cases where it is more practical to perform the injection from the anchorage (Fig. 15). An example is in case of banded tendons crossing at columns, where the points of access into the tendons falls behind the column face. The tendons are very close to each other; this makes it difficult for the GPR to individually locate the tendons and also to use the same location as an injection port (see Fig. 13, behind the column). Despite this difficulty, vent holes should be drilled whenever possible, at the sheathing; otherwise, air can get trapped inside.

Fig 14 - Injecting grease from ports located underneath the slab

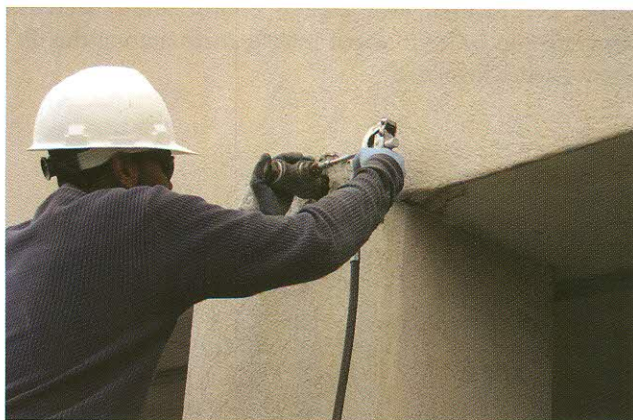
Fig 15 - Grease injection at anchorages

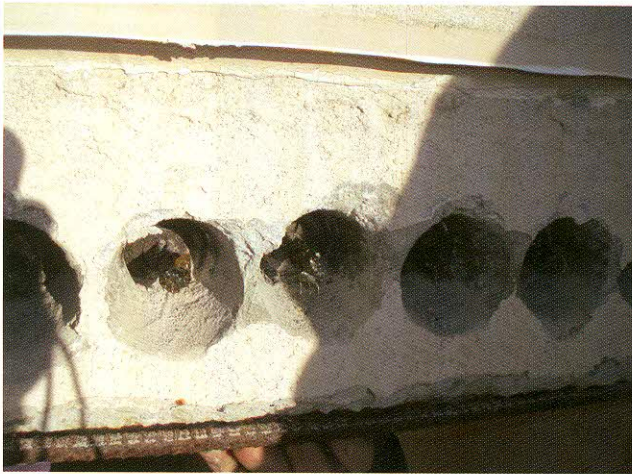
The grease injection from the fittings installed at the drilled ports should continue until the grease comes out through the wedges at the anchorages (see Fig.16). At the balconies, all injection ports are located underneath the slab in order to eliminate any subsequent water intrusion through those ports. The GPR scanning and grease injection can be performed from the top and bottom respectively to expedite the production rate of the repair.

Fig. 16 - Grease excretion through wedges indicating filling of sleeves
