**PROGRESSIVE DETERIORATION CAUSED BY
POOR QUALITY CONTROL AND INADEQUATE
MAINTENANCE: THE SAD TALE OF A
DOOMED PARKING STRUCTURE**

by Gregory P. Chacos

This is a case study of a 2200-car, municipally-owned, cast-in-place, post-tensioned parking structure, opened in 1975 and demolished in 1994 because of severe deterioration. A review is made of significant features of the design, construction, and maintenance as they relate to the deterioration. The number and timing of broken strands (tendons) is given, as are descriptions of the incremental shoring that was installed and the demolition.

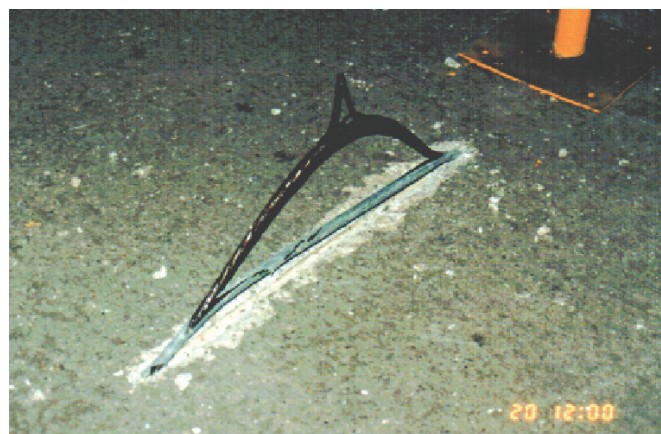
In 1985, the author was retained to investigate the cause of a broken strand that was an impediment to traffic in a municipally-owned, 10-year-old public parking facility (Fig. 1). An initial inspection revealed the presence of six broken strands, but there was no record of when the first five occurred.

Fig. 1—Broken strand popout.

Broken strands were identified by popouts that occurred when the strand recoiled within its sheathing and broke through the concrete cover. Most of the time, the entire strand was visible but sometimes only a single wire identified the break. Most of the

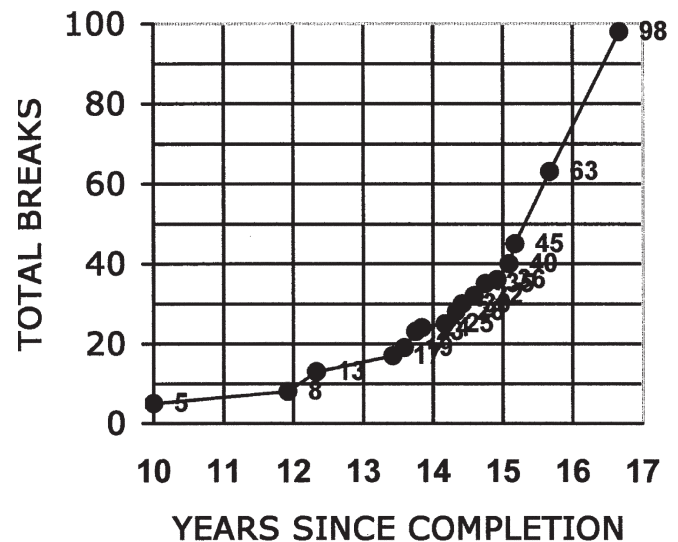
Broken strands were found with increasing frequency as time passed (Fig. 4). (It was not feasible to determine how many broken strands did not popout and were therefore not found.)

The rate of breaks found varied from two per year initially to 36 per year less than 7 years later. The records that survive are not complete enough to separate the breaks to each level, but approximately half the total number of breaks were found in Level L1. (The few broken strands in the top level were in beams along the expansion joints and were ignored for this study.)

Fig. 4—Total strand breaks found from 1984 to 1991.

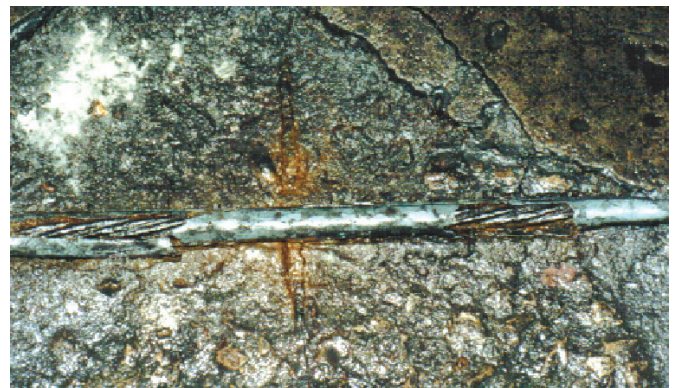
Figure 5 shows the author's favorite strand. It was monitored in this condition, with pitted and dented wires, for nearly 2 years before it broke. (The strand was checked for tension with a large screwdriver during each inspection.) It was midway between columns in a turning lane, was nearly always wet, and was exposed to abrasion by automobile tires 5 days a week. The cover over this strand was less than 0.5 in. (13 mm).

Fig. 5—Exposed unbroken strand in traffic lane.
