VDOT EXPERIENCE WITH GROUTS AND GROUTED POST-TENSIONED TENDONS

MICHAEL M. SPRINKEL

Authorized reprint from: August 2015 issue of the PTI Journal

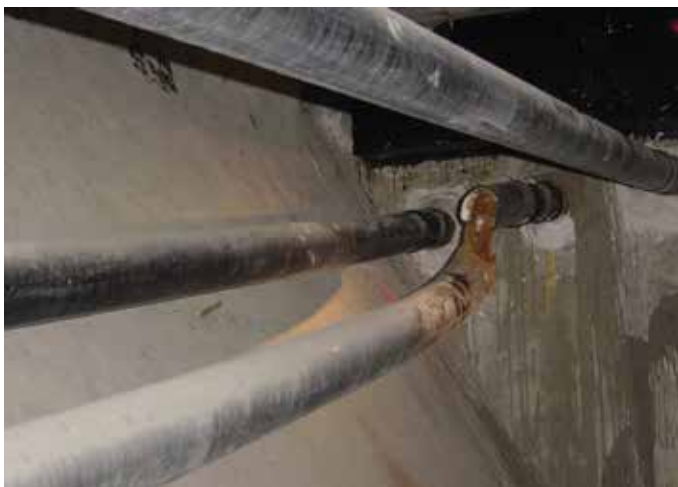
On May 22, 2007, Tendon SP12T15 was found in a state of failure (Fig. 2) during a biannual inspection. The failed tendon raised concerns about the condition of other tendons in the structures and the FHWA authorized emergency funding to replace the failed tendon, determine the condition of other tendons, and make needed repairs. During the repairs, short sections (approximately 18 in. [460 mm] long) were removed from ducts at 20 locations. Eight sites were selected for monitoring. The sites represented various conditions ranging from corroding and broken wires to exposed wires with no grout but no corrosion.

Fig. 2—Failed draped tendon found during inspection on May 22, 2007.

Tendon replacement is an expensive and time-consuming activity. In 2007, emergency funding was used to replace two tendons (one that had failed, and one with three broken wires), to evaluate the condition of all tendons using magnetic flux testing (approximately 80% of the length of each tendon), and to do other inspections and repairs deemed appropriate. In addition to the failed tendon, a second tendon was replaced that was found to have three failed wires caused by exposure to water laden with pigeon droppings that had ponded around the tendon in the vicinity of a drain that was plugged with grout that had leaked from the tendons. The failed tendon had already been detensioned and was easier to replace than the second tendon that still had to be detensioned. The second tendon had an anchor plate at a joint between continuous spans. Access to the anchor plate was not adequate to allow easy removal of the anchor plate. Exposure to deicing chemicals

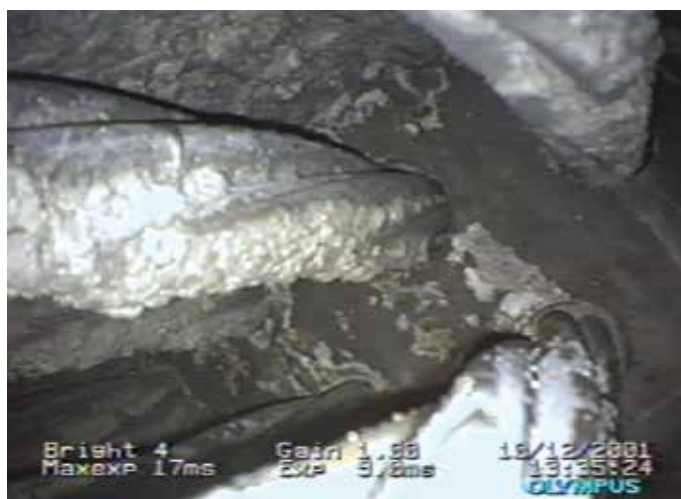
Varina-Enon Bridge—The tendons in the Varina-Enon Bridge were first inspected in 2001 after failures were noted in similar bridges in Florida. A number of 1 in. (25 mm) diameter inspection holes were found in the plastic ducts. The strands were corroded slightly in the vicinity of the holes and small voids were found in the tops of the ducts. Another problem was a floor drain that was plugged with grout that leaked out while a tendon was being grouted, allowing water from a nearby leaking joint to surround a tendon. The water was acidic from pigeon droppings. The acidic water accelerated corrosion of the strands. A third problem was vent tubes in most draped tendons were found to be open. Borescope inspections made through the open vent tubes revealed voids in the tendons adjacent to the anchor plates (Fig. 3) and traces of grout on the strands and walls of the vent tubes. The traces of grout indicated that the tendon and vent tube had been filled with grout but the grout had bled and segregated, leaving water on the topmost surface of the grout that later evaporated, leaving a void of approximately 4% of the length of the tendon. Longer sections of voids that were found provided an indication that grout had leaked from the tendons prior to setting.

Fig. 3—Typical voids adjacent to anchor plates in draped tendons.

Contracts to vacuum grout from known voids in the tendons and seal vent tubes in the Varina Enon bridge were awarded in 2003 and 2004.

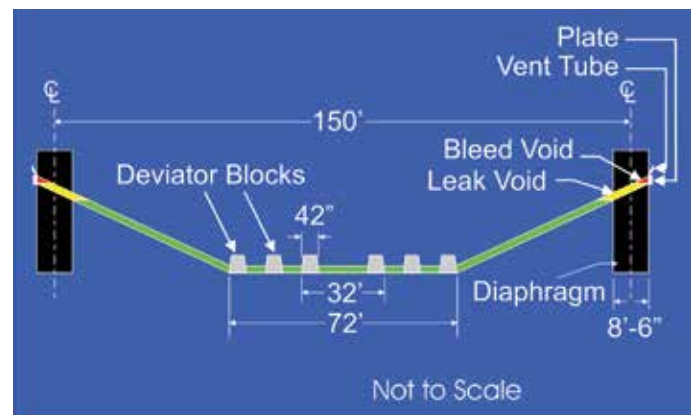
A grout material problem that may contribute to a reduction in the service life of a tendon is bleeding and segregation. For corrosion protection, the strands are supposed to be surrounded by a high-quality portland cement grout. Prior to 2001, grouts were typically cement, water, and an expansive admixture. These grouts would bleed and segregate after being pumped into a tendon. A wick-induced bleed test indicates that bleeding in grouts used prior to 2001 was approximately 4%. In a typical 150 ft (45.7 m) long tendon in the Varina Enon Bridge (Fig. 4), 4% bleeding can cause 6 ft (1.8 m) of void at the

Fig. 4—Typical Varina Enon span with draped tendon and bleed and leak voids. (Note: 1 ft = 0.305 m; 1 in. = 25.4 mm.)

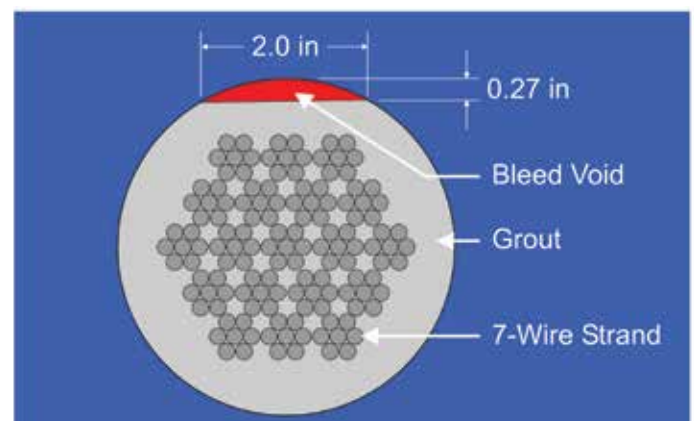
Fig. 5—Typical Varina Enon horizontal tendon section with bleed void. (Note: 1 in. = 25.4 mm.)

high points in the draped tendons and a void along the top of a horizontal tendon (Fig. 5). Six of the eight tendons in a typical span of the Varina Enon bridge are draped. While strands that were not surrounded by grout were found to be not corroded after 11 years (Fig. 3 and 6), strands that were found to be corroded and having broken wires were either not surrounded by grout or were surrounded by low-quality grout that segregated around the strands following the bleeding of the grout. No corrosion was found in strands that were surrounded by grout of the quality specified for the construction that was not diluted by bled water. The strands in the failed tendon failed at a location where the strands were surrounded by the low-quality grout that forms at the highest level in the tendon as a result of bleeding and segregation of the grout. Typically, the poorest-quality grout surrounds the strands near the anchor plates in draped tendons because the anchor plates are located at the highest point. High-performance grouts specified for use beginning in 2001 do not bleed and segregate and consequently the material problem of corrosion caused by bleeding and segregation of the grout has been eliminated for new structures grouted with HPG.

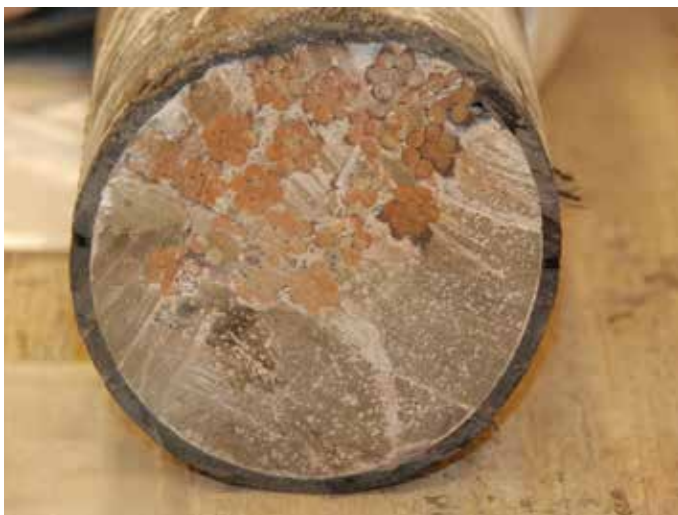
A design problem is that the strands in a draped tendon are not centered in the plastic duct but rather pressed against the top side of the duct, and the topmost strands are not completely surrounded by grout (Fig. 6). The problem of corrosion caused by strands bearing against the top of the duct cannot be solved, but has not caused failures as long as the duct is intact and the strands are not exposed to moisture, oxygen, and chlorides.

Fig. 6—Typical grouted draped tendon, indicating it is not possible to surround strands with grout.

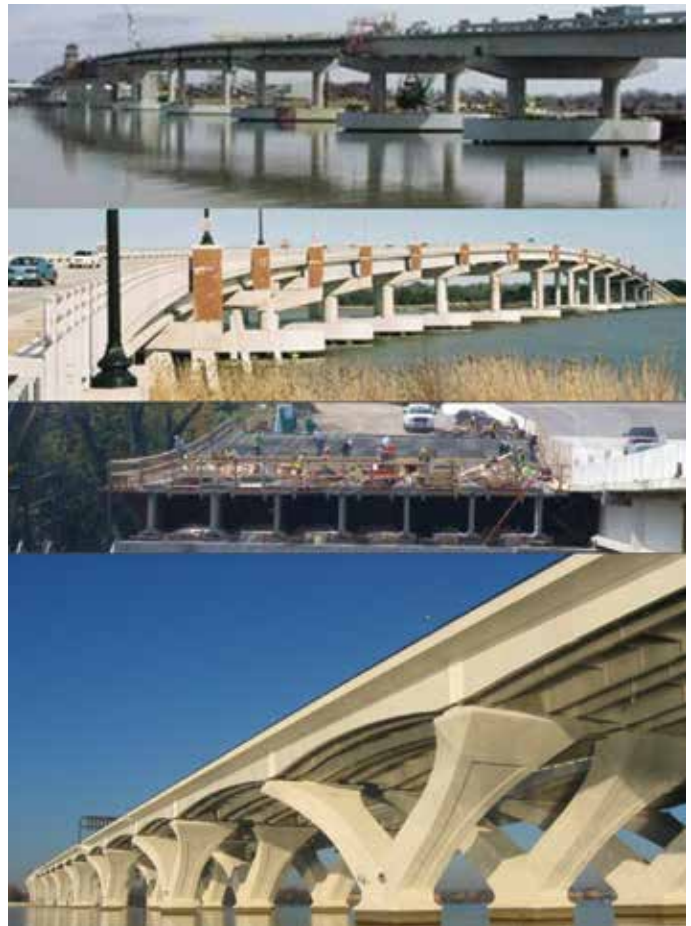
Fig. 9—Internal tendons in bridges on US-33, US-123, and I-95 were grouted with Grout 2, containing chlorides.

The implementation of HPG seemed to be going well until, in 2011, the supplier of Grout 2, the most-used HPG, announced that the grout contained chlorides that were in the cement in the prepackaged grout. Despite test reports indicating acceptable levels of chlorides, the problem had gone undetected for approximately 10 years. The grout had

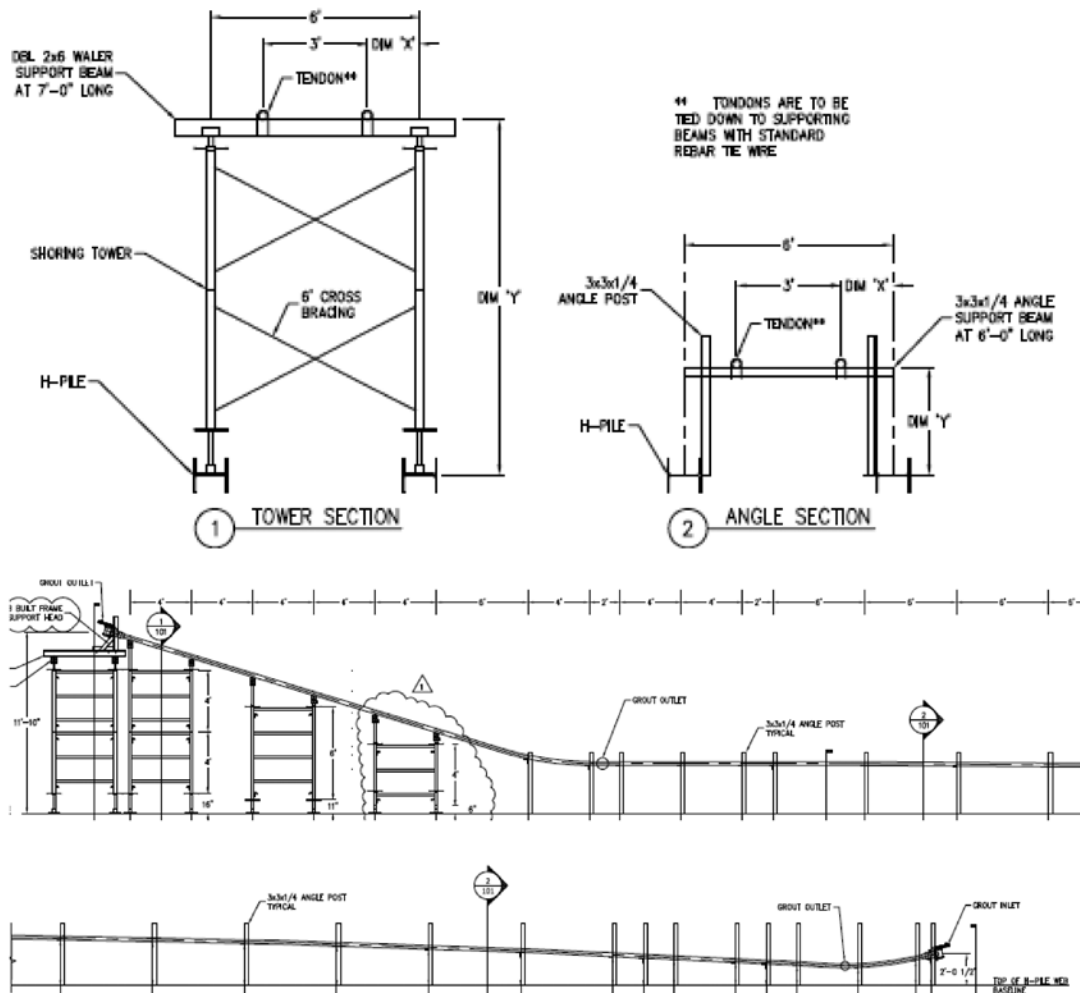
Fig. 10—US-460 mockup.

vertical rise of the tendon. Figure 10 shows the mockup section. Nine seven-wire strands were placed in the ducts but were not stressed.

Until there are lab tests that can identify acceptable grouts, perform a mockup test of the most critical tendon situation (greatest height change and length) using grouts, equipment, and staff proposed for the project.

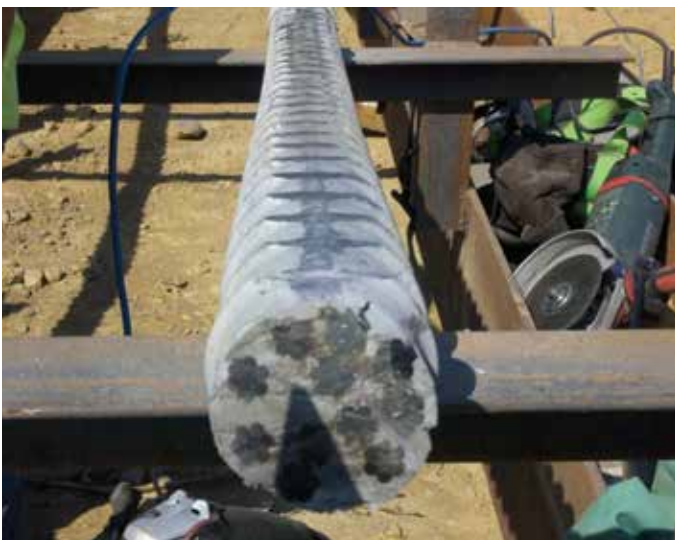
Fig. 11—Grouted tendons.

The mockup revealed that Grout 2 was not acceptable for use. Grout 2 produced voids along the top of the tendon and at the end caps and left soft grout that never set at the end caps (Fig. 11 and 12). The soft grout had a high sulfate content and is very corrosive. Grout 3 performed exceptionally well and fully grouted the tendon. Grout 3 was used to grout the bridge.

Grout 2 tendon has void along top.

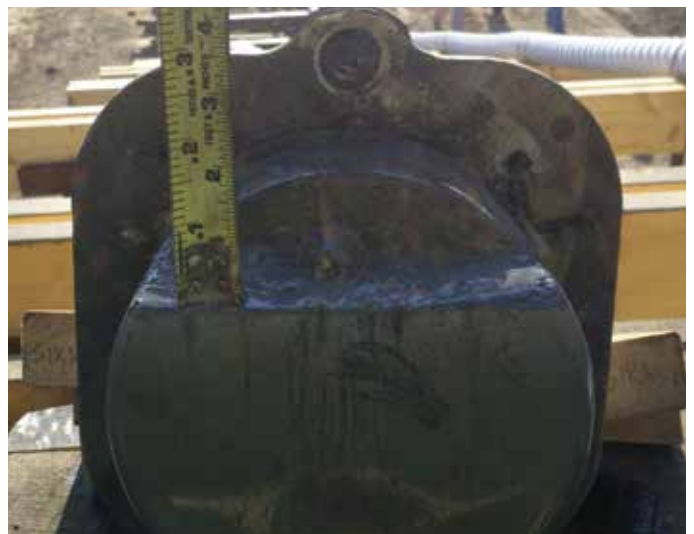
Fig. 12—Grouted end caps.

Grout 2 outlet end cap has void and soft grout.

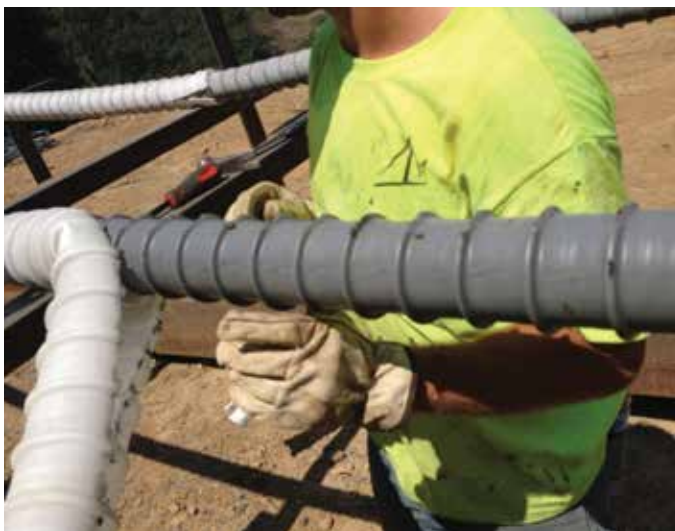
Grout 3 tendon is fully grouted.

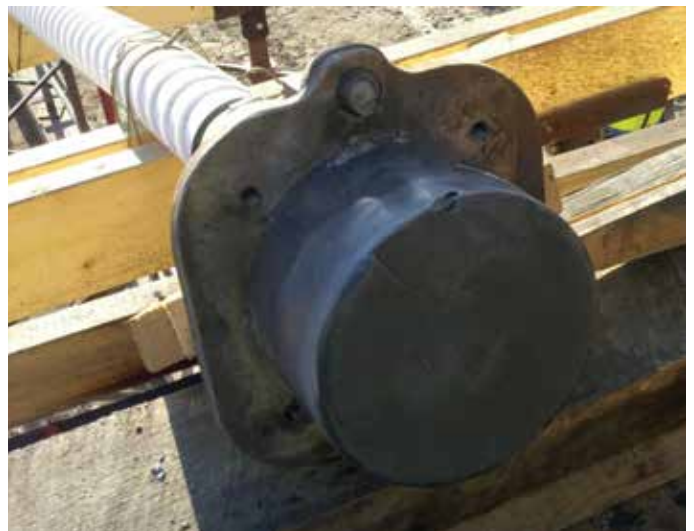
Grout 3 outlet end cap fully grouted.

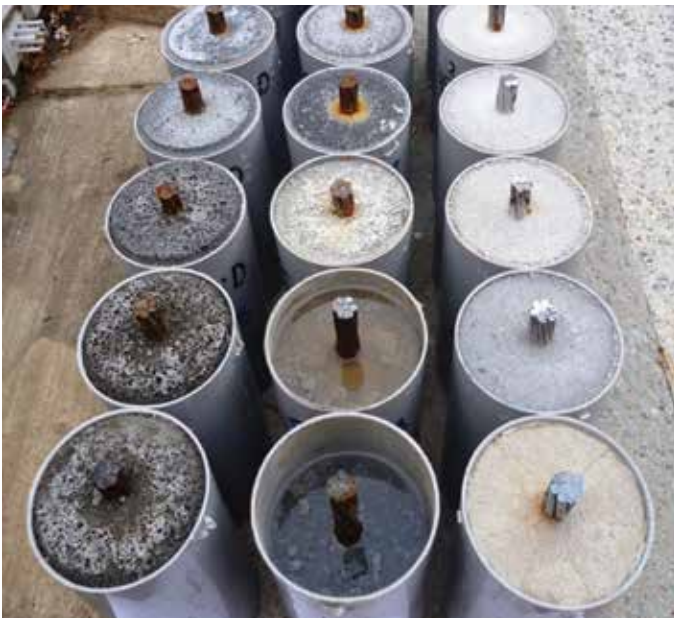
lems with the HPG. Given that Grout 3 performed well in the mockup when batched at the correct water-bag ratio (w/b), grout specimens were cast when batched with extra water to see the effect of increasing the water content. Grouts 1, 2, and 3 were batched at w/b of that specified by the manufacturer as well as 0.45, 0.5, 0.55, 0.6, and 0.65. Results were quite interesting. As the w/b increased, Grout 1 exhibited diminished properties; Grout 2 bled, segregated, and produced soft grout in increasing amounts; and Grout 3 produced a lower-strength foam in increasing amounts. Results are pictured in Fig. 13 and 14. Figure 15 shows that the compressive strength decreases as the w/b

Fig. 14—Specimens cast with Grouts 1, 2, and 3 (right to left) and specified to 0.65 w/b (top to bottom).

While grouting, the water in each batch must to be carefully measured and the bags of grout weighed to provide the required w/b .
