REPAIR AND REPLACEMENT OF PARTIALLY GROUTED EMBEDDED EXTERNAL TENDONS

Authorized reprint from: August 2015 issue of the PTI Journal

This paper discusses the removal and replacement of two partially grouted embedded external tendons in a two-span 220 ft (67 m) long viaduct. Embedded external tendons were used for cast-in-place viaducts for the Terminal Area Roadways Project (TAR) at Boston Logan Airport in Massachusetts. The project comprised more than 200,000 ft² (18,580 m²) of viaduct. More than 70% of the viaducts were designed using external tendons partially embedded in the bottom slab of the box girder near midspan. The remaining viaducts had internal tendons inside the webs due to their tight curvature. The quality and integrity of grout is of prime importance for the structural integrity and long-term durability of post-tensioned concrete structures. Grout is one of several layers of protection against corrosion. It prevents corrosion of the strands by completely encasing them, it prevents water from collecting and freezing in the ducts by eliminating all voids, and it provides effective bond between prestressing steel and concrete. Improperly grouted tendons do not meet s

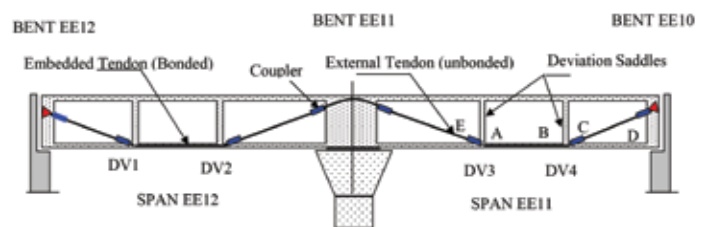
Spans EE11 and EE12 are two equal spans each 119 ft (36.3 m) long simply supported at Bents EE12 and EE10 and continuous over Bent EE11, as shown in Fig. 1. The two-span structure is a three-cell box girder 6.5 ft (2.0 m) deep and 56 ft (17.1 m) wide. The box girder is post-tensioned with 12 tendons (T1 through T12), each having twenty-seven 0.5 in. (13 mm) diameter strands whose profile is shown in the elevation in Fig. 1. Each span has two deviation saddles (Fig. 2) and the tendons are partially embedded in the bottom slab. The anchorage locations at each end were 4.5 ft (1.4 m) from the soffit of the 6.5 ft (2.0 m) two-cell box girder. At midspan, the tendons were located 6 in. (152 mm) from the soffit of the box and the intermediate support (Bent EE11); the high point was

Fig. 1—External tendon layout for Tendons T1 and T2 in Spans EE11 and EE12.

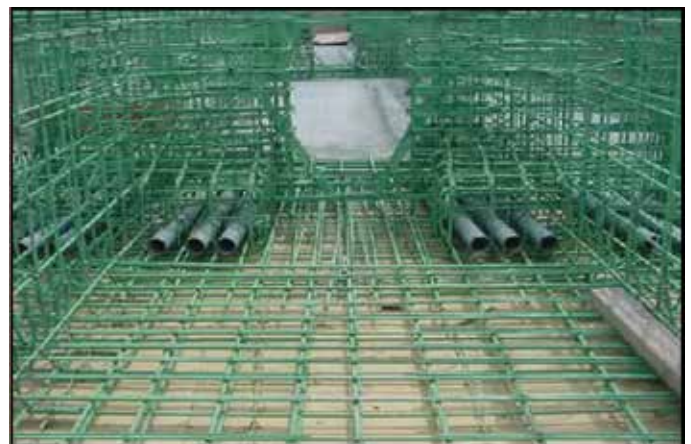
Fig. 2—Deviation saddle and bottom slab reinforcement.

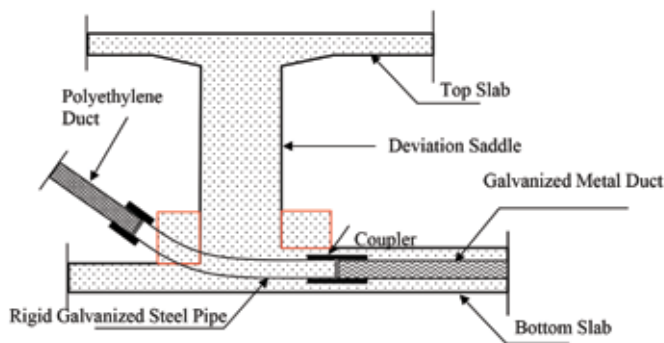
located 5.75 ft (1.8 m) from the soffit. The connection details for the ducts at the deviation saddle locations are shown in Fig. 3. Strands were installed in Tendons T1 and T2 and the two tendons were stressed following the installation and stressing procedures specified on the contract drawings and in the project specifications. While grouting tendon T1, the Tendon developed multiple leaks. Leaks were identified at the rubber coupling connection between the galvanized deviation pipes and the high-density polyethylene (HDPE) exposed ducts. Leaks also occurred at a spalled location in the bottom slab. Once the leaks became evident, the grouting operations stopped and grouting remediation was attempted.

Fig. 3—Duct details at deviation saddles.

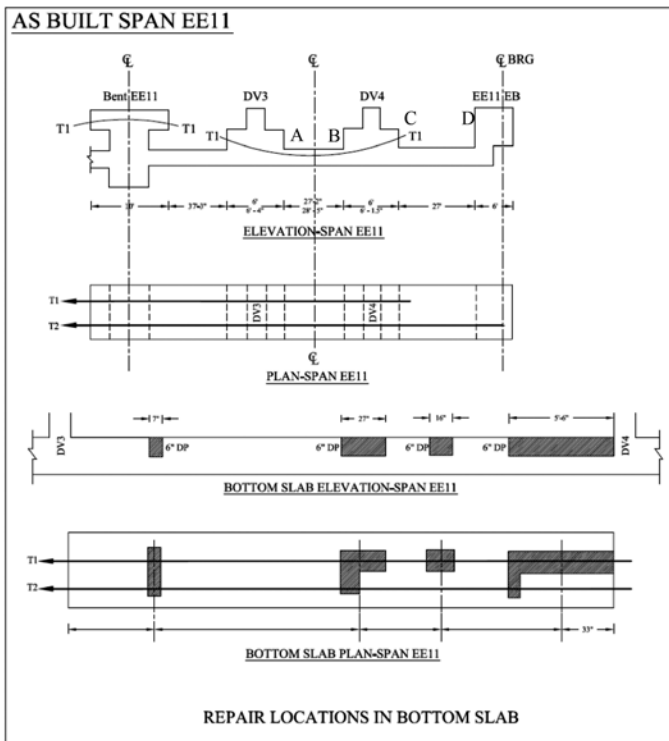
Fig. 4—Repair locations in elevation and plan in thickened slab in Span EE11.

Removal of partially grouted Tendons T1 and T2 in Spans EE11 and EE12 by slackening the strand alternatively on each side of the deviation saddle was recommended. This procedure is similar to the one used for the removal of corroded external tendons of the Mid-Bay Bridge in Florida in 2001.¹⁵ The difference between the tendons in the Mid-Bay Bridge and those in Spans EE11 and EE12 of this project was the embedded portion of the tendons in the bottom slab near midspan. This portion was approximately 45 ft (13.7 m) long in each span between deviation saddles and it was difficult to remove it.¹⁴ The removal and replacement of this portion was time consuming. Portions of the slab had to be chipped away at various locations to allow for the tendon removal and the contractor was able to do that without removing any portions of the deviation saddles or causing damage in the saddle. In Span EE11, approximately 30% of the of the bottom slab had to be chipped away to allow for the removal of Tendon T1 and 8% for the removal of Tendon T2, as shown in Fig. 4. In

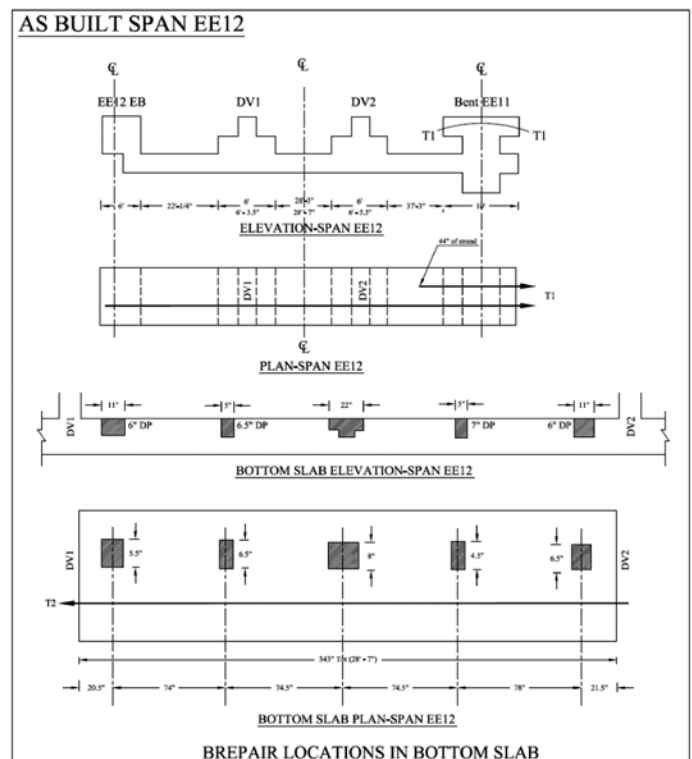
Fig. 5—Repair locations in elevation and plan in thickened slab in Span EE12.

Span EE12, approximately 16% of the of the bottom slab had to be chipped away to allow for the removal of Tendon T1 and only minor chipping was needed for the removal of T2, as shown in Fig. 5. The procedure used for the removal and replacement of Tendons T1 and T2 is described in the following sections.

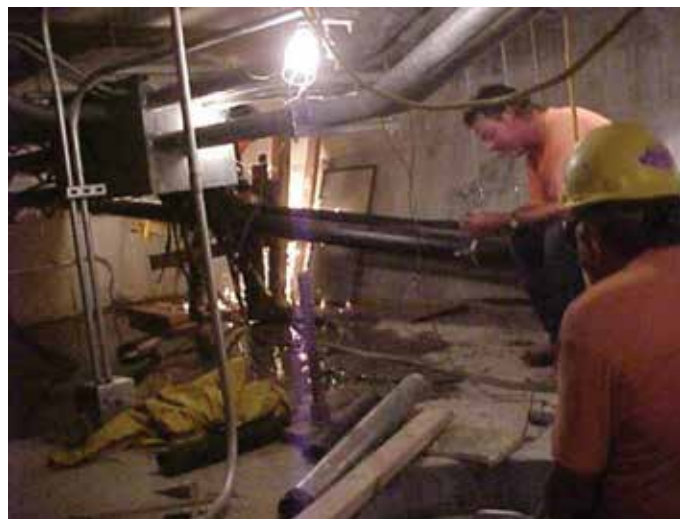
Fig. 6—Removing HDPE duct around strands and installing clamps.

The HDPE duct was removed from the entire length of the tendon between anchorages and deviation saddles, as shown in Fig. 6. The grout was then removed from acces-

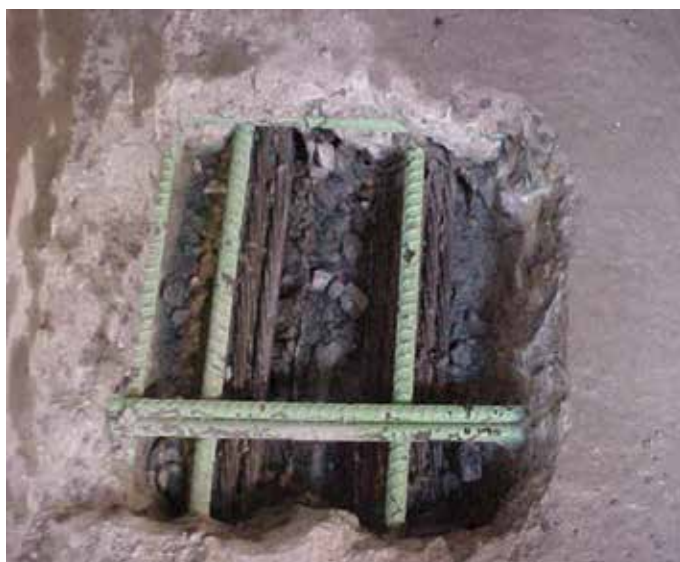
Fig. 7—Exposing strands in portion of tendon embedded in bottom slab.

sible locations throughout the entire length of the tendon. Portions of the bottom slab were chipped way around the tendons, as shown in Fig. 7 and 8. Heavy-duty U-shaped clamps were used and were placed approximately every 4 to 6 ft (1.2 to 1.8 m) to control strands' sudden release of force and energy when the strand was cut, as shown in Fig. 6. A power saw was used to cut strands. The process started by chipping concrete in the bottom slab portion between the deviation saddles to expose strands, as shown in Fig. 7 and 8. One strand was then cut at Location C (refer to Fig. 1 and 4), leaving a sufficient length of strand so that it can be gripped by a monostrand jack to remove it later after all strands were cut. The force from the cut strand was transferred to the remaining strands due to bond transfer over the length of the tendon on both sides of the cut. The stress in the remaining strands slightly increased due to force transfer over the bond length. The cut strand resulted in overall reduced tendon force over bond length of the tendon. One strand was then cut at Location B on the other side of the deviation saddle, as shown in Fig. 1 and 4. Cut strands were then checked to make sure they shortened to release force. If not, the clamps were allowed to release some force to allow cut strands to shorten. Strands in the tendon were then cut in an alternating pattern at Locations C, B, A, and E. Strands were not allowed to be out-of-balance at the deviation saddles by more than one strand at any time during the cutting process. Figure 9 shows all strands cut in Tendon T1. Once all strands were cut at locations C, B, A, and E, high-pressure hydroblasting was used

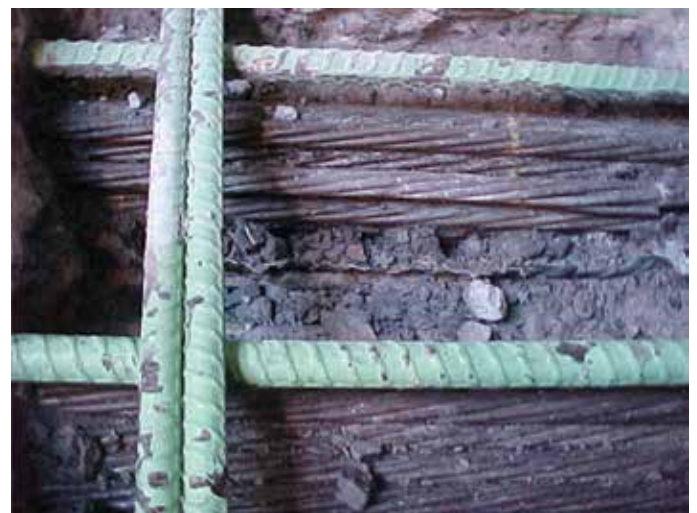
Fig. 8—Close-up of exposed strands in portion of tendon embedded in bottom slab.

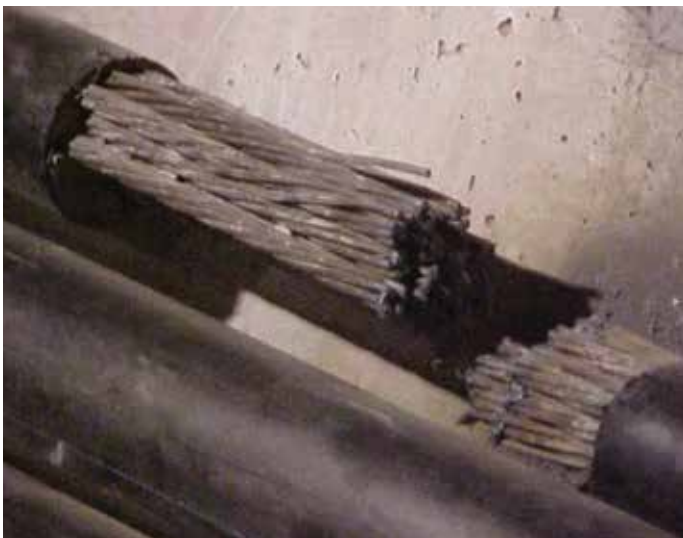
Fig. 9—Tendon T1 with completely cut strands.

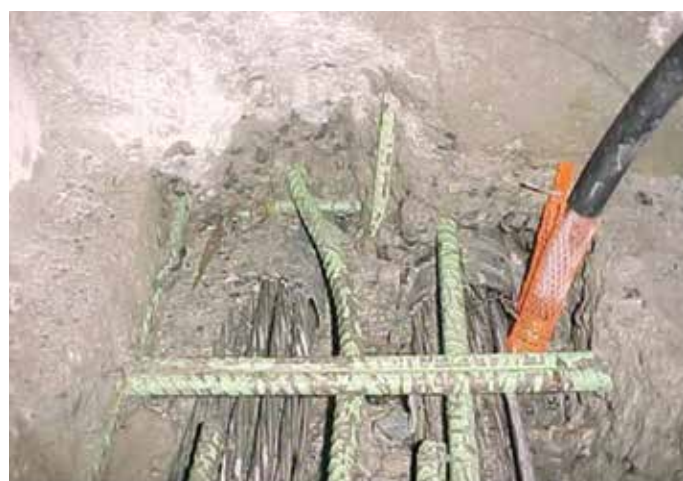
Fig. 10—Hydroblasting grout from around strands in bottom slab.

to remove as much grout as possible in the bottom slab and near the deviation saddles, as shown in Fig. 10. The strands between the deviation saddles and at Bent Cap EE11 were then pulled out using a monostrand jack. Hydroblasting was then used to remove the remaining grout in the bottom slab and at Bent EE11 and near anchorages.

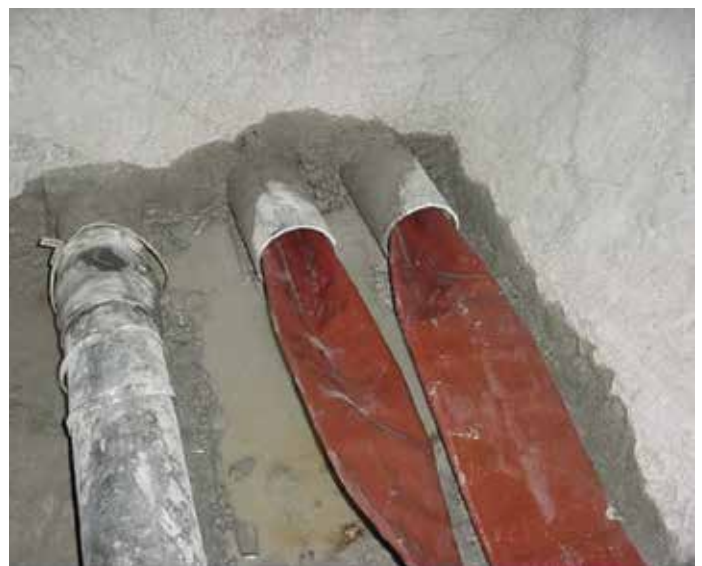
Fig. 11—Inserting inflatable tubes (mandrels) into bent steel pipes.

After all strands were removed and all concrete was chipped away, unsound concrete and debris were removed. The bottom half of the corrugated duct that remained embedded in the bottom slab was trimmed and removed. The full length of the duct was then cleared from debris and loose grout. An inflatable tube (mandrel) was installed through the steel pipes at the deviation saddle through the duct path in the bottom slab to maintain the same size and geometry of the ducts, as shown in Fig. 11

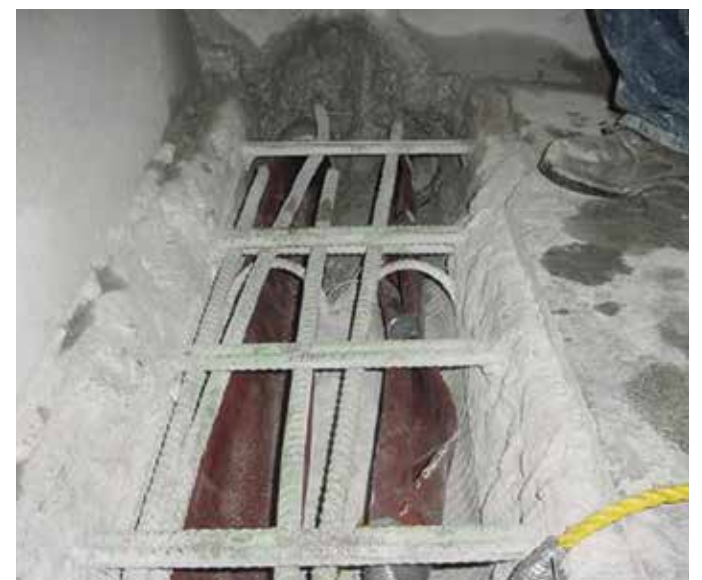
Fig. 12—Inserting inflatable mandrels in cleaned ducts path in bottom slab.

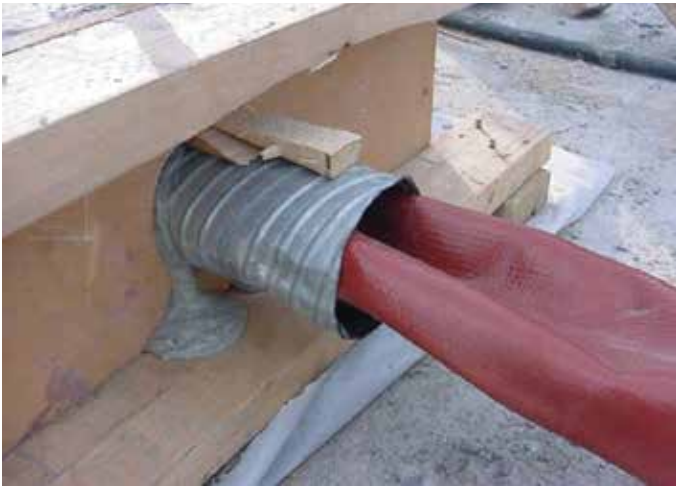
Fig. 13—Mockup tests for mandrels.

and 12. Mockup specimens were built to check the effectiveness of the inflatable bladder in maintaining the duct path and geometry, as shown in Fig. 13 and 14. The ducts were cleaned and checked for any obstructions after the mandrels were removed. The bottom slab was repaired in those areas where concrete had spalled or cracked, and epoxy grout was injected at some locations in the bottom slab and at deviation saddles. Ducts were flushed along the full length, water blown out with oil-free air before strands were installed. The strands were then anchored and the tendons stressed. Grout vents were capped and tendon tails cut within a few hours of stressing. Grout was mixed and injected under pressure into the ducts within 7 days, according to project specifications.

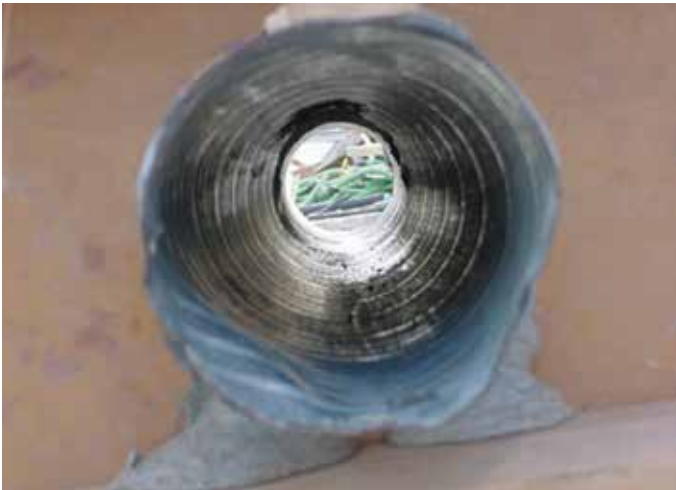
Fig. 14—Interior of PT corrugated duct after using mandrels.
