GROUTED POST-TENSIONING TENDON EVALUATION

BY LIAO HAIXUE

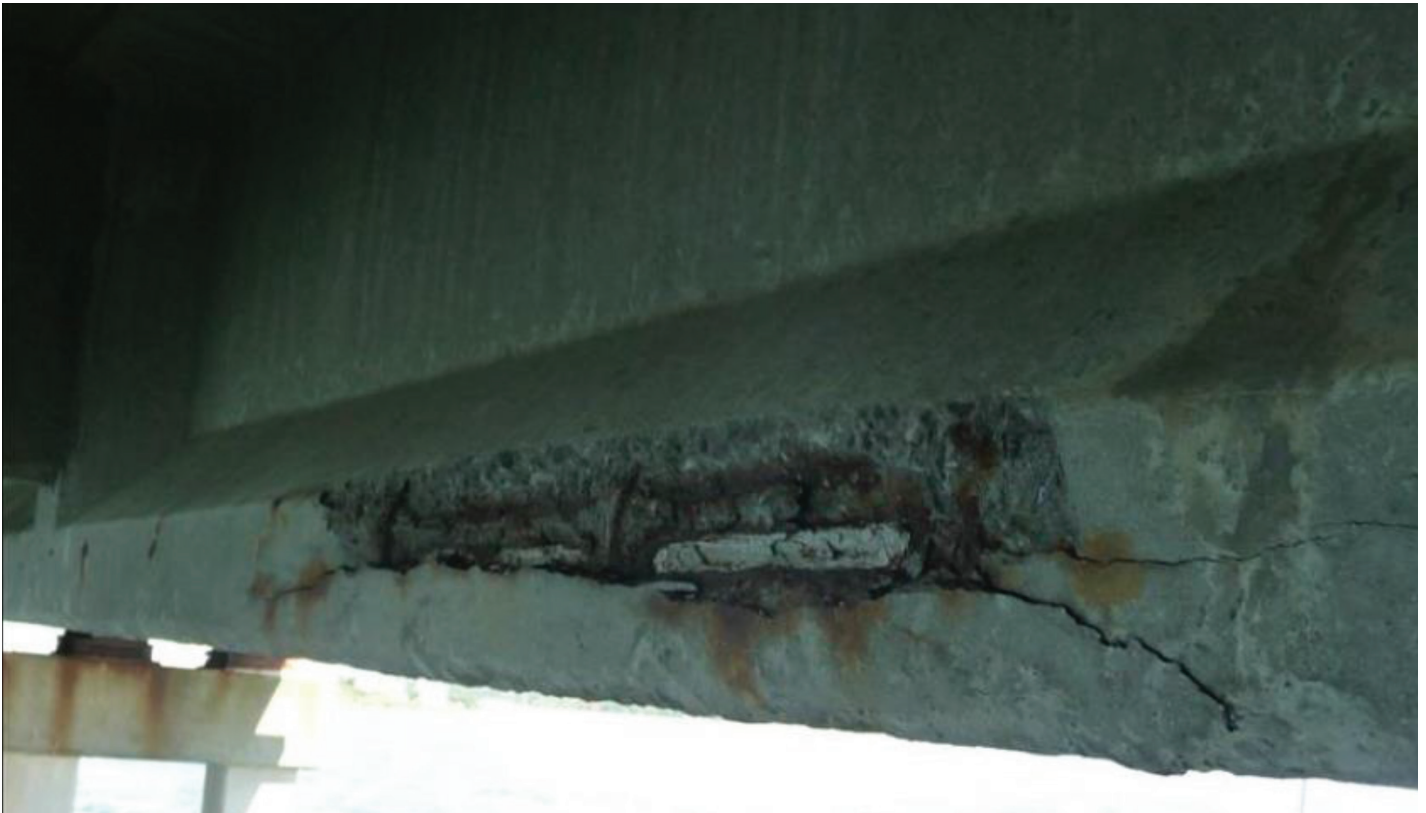
The visual inspection focuses on identifying cracking, rust staining, spalling, and efflorescence (Fig. 1 and 2). These factors are strong visual indicators of corrosion activity and other forms of concrete deterioration. Cracking along the tendons can be a result of PT corrosion, as well as freezing and expanding of the water in the grout void.

Fig. 1—Deteriorated beam exhibiting cracking, rust staining, spalling, and efflorescence.

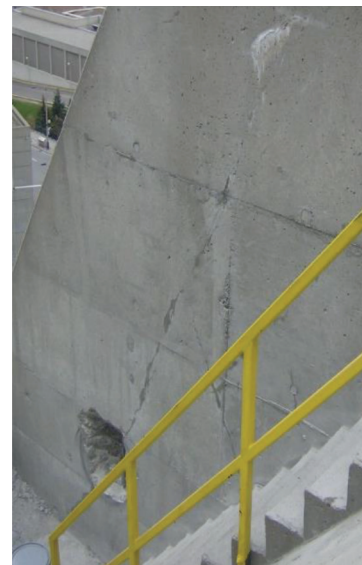
Fig. 2—Concrete showing efflorescence and cracking.

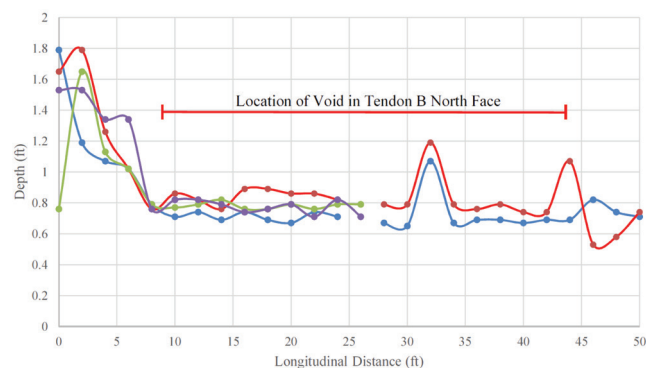
GPR was used to locate the tendons (Fig. 4), and then sonic/ultrasonic impact echo testing was performed to

Fig. 4—Sonic/ultrasonic impact echo testing identified potential voids and soft grout areas.

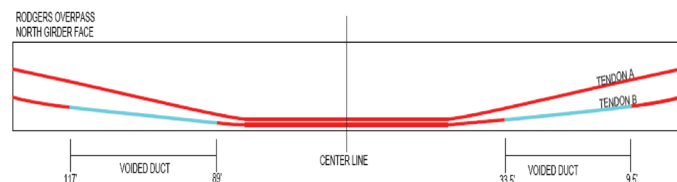
Fig. 5—Potential voids and soft grout areas.

identify potential voids and soft grout areas. Two substantial possible voids of approximately 25 to 30 ft (7.6 to 9.1 m) were identified in one duct (Fig. 5). Small 3/4 in. (19 mm) holes were drilled to verify the presence of the voids, which found the voids were 28 and 33 ft (8.5 and 10 m), respectively.

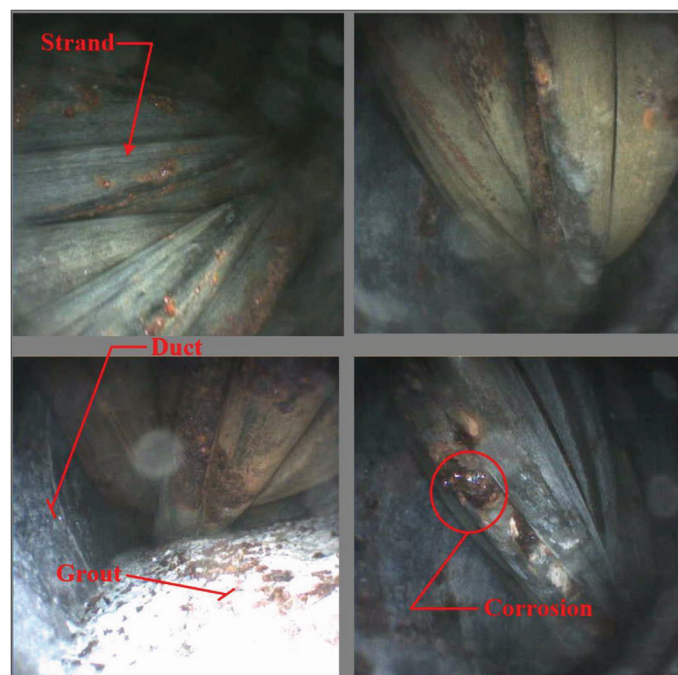
A borescope was then inserted into the holes to evaluate the conditions of the tendon and grout (Fig. 6). Throughout the voids, corrosion product was observed along the strands. There were no observed broken tendons. It appeared that the wires near the grout had more severe corrosion than those further away from the grout. At each end of the voids, the grout was white, which is typically due to a high w/c at the grout surface because bleeding water from the grout traveled along the interstitial spaces between wires to the high point and created a layer of grout with high w/c at high points. The grout can be seen filling the duct and encasing the strands gradually. This transition typically occurred over only a couple of feet.

Fig. 6—Borescope images confirming voids and corroded PT strands.

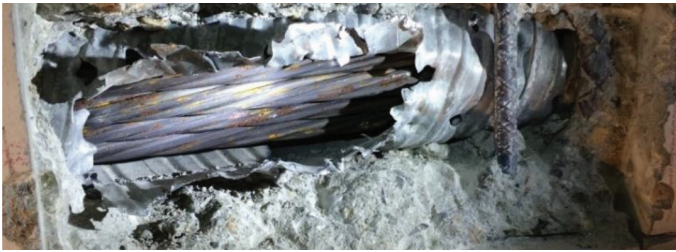
Once void detection and borescope testing were completed, locations were selected to create large openings so that grout samples from inside the duct could be collected for laboratory testing (Fig. 7). The cover concrete was removed using a concrete grinder wheel and chipping hammer. Then the galvanized ducts were opened using a chisel. Once the duct was opened, a chisel was used to collect grout samples for petrographic and chloride testing. After sampling and photo documentation of the

Fig. 7—Inspection opening in voided area.

Finally, lab tests were performed to determine the grout quality, which found the chloride content was low and had no carbonation. Petrographic analysis revealed that the w/c was approximately 0.33, calcium hydroxide was abundant, and the air content of the grout was in the range of 1 to 3%.

opening, the metal duct was closed and the cover concrete was replaced with a fast-setting vertical patch material.
