**STRESSING THE QUALITY OF UNBONDED POST-  
TENSIONED SINGLE-STRAND SYSTEM INSTALLATIONS**

RALF LEISTIKOW

Authorized reprint from: December 2017 issue of the PTI Journal

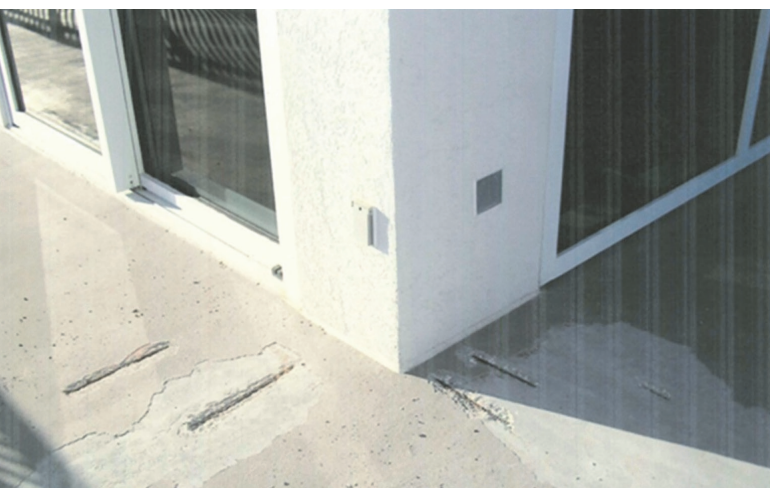
Fig. 1—Exposed reinforcing at balcony and corner column.

was specified by the engineer-of-record. At this location, the concrete cover over the embedded conventional and PT reinforcement was measured to be as shallow as 1/4 in. (6 mm) (Fig. 1). The structural and architectural drawings specified a minimum 1 in. (25 mm) concrete cover on all embedded reinforcement at the balconies and a sloped concrete top surface down toward the balcony edge. In addition, the PT design and shop drawings specified the tendon high points at the perimeter columns. Combining all the specified information and neglecting construction tolerances, it was determined that all of these requirements could not have been met, and only a maximum concrete cover of 1/2 in. (13 mm) could have been achieved given the specified tendon placement (Fig. 2).

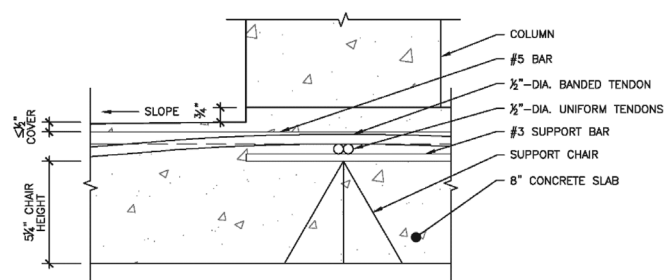
Fig. 2—As-specified reinforcing layout at balcony slab turndown.

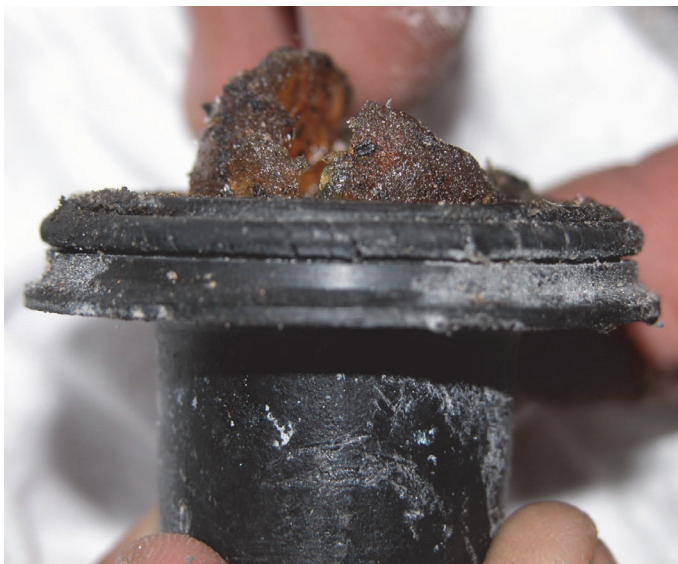
between the anchor body and cap. Another encapsulation cap contained an O-ring that exhibited extensive cracking, which would have prohibited a watertight seal (Fig. 3). At the last location, the encapsulation cap was placed sideways in the stressing pocket, and a void was found behind the encapsulation cap (Fig. 4). Based on these conditions, additional stressing anchorages were exposed at random locations on the elevated floor slabs, and similar conditions were observed. In addition, moisture and minor surface corrosion on the strand tails and anchors were observed at some of the exposed stressing anchorages. These installation defects essentially changed the originally specified encapsulated PT system required in a corrosive environment to a standard system typically used in a protected environment.

Fig. 3—Close-up of end cap O-ring with cracks.

Various repair alternatives were proposed to the association and the developer, including the removal of all the grout from the stressing anchorages, replacing and properly installing the encapsulation caps, and removing the surface corrosion. In addition, repairs to the plaza waterproofing and expansion joints were recommended. However, as part of the settlement negotiations, the developer only repaired the waterproofing and expansion joints, and applied an elastomeric coating on the exterior of the building. In addition to continued maintenance of these elements and coating, the condominium association was ultimately left with a non-encapsulated and less-protected PT system.

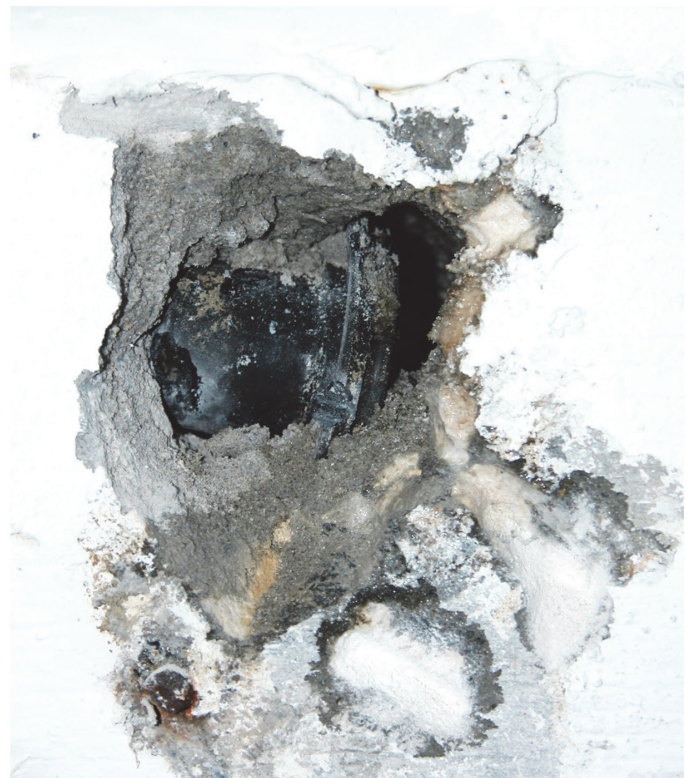
Fig. 4—Deficient encapsulation cap installation with void visible behind encapsulation cap.

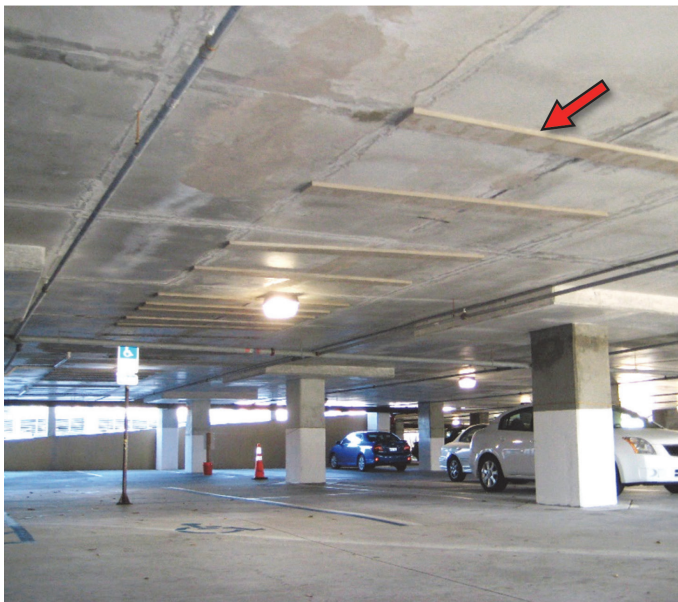
slabs with an encapsulated PT system contained exposed concrete patches on the undersides of the elevated slabs and exhibited strand blowouts (Fig. 5 and 6). Based on these conditions, the association became concerned about potential future strand and concrete failures, the as-built versus as-designed load capacity of the elevated slabs of the parking structure, and whether the long-term service life of the parking structure had been impacted by the as-built conditions. The available third-party inspector's field reports listed some issues with the PT strand drapes and vertical alignment, cut sheathing, and other minor placement issues, but stated that these were all corrected during the original construction.

Fig. 5—Typical overhead patches aligned with uniform strands in parking structure.

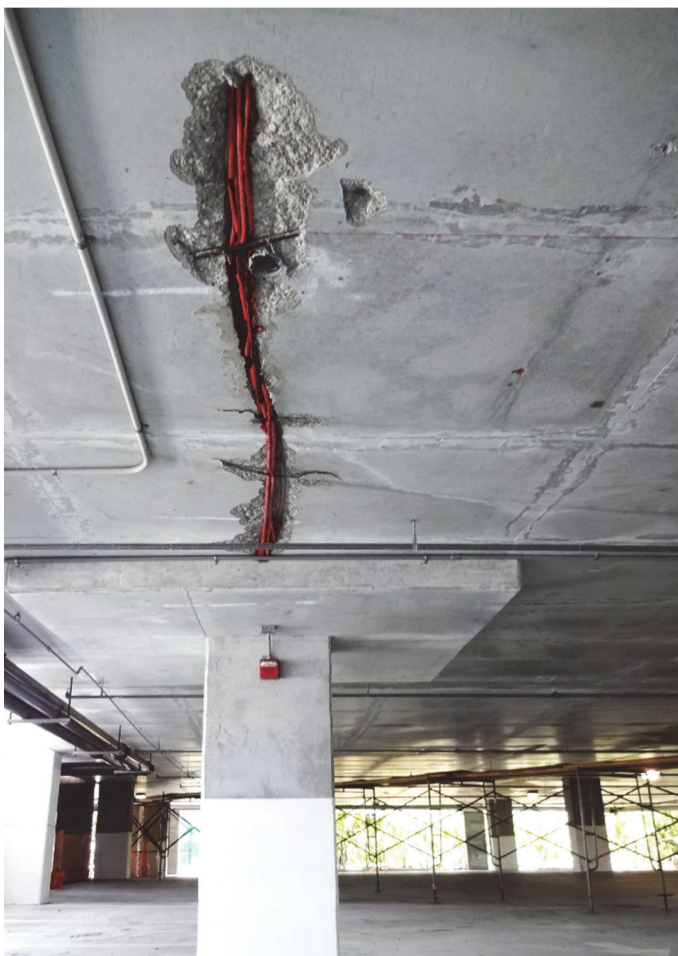
However, a recent PT strand blowout showed deficient original vertical and horizontal strand alignment (Fig. 6). Similar conditions were also observed at the overhead concrete patches. After completing a ground-penetrating radar (GPR) survey of the elevated slabs and verifying these readings with exploratory openings, significant deviations from allowable construction tolerances were noted. Throughout the elevated PT slab, the uniformly distributed strands were observed to follow the drape of the banded strands along the column strips instead of the specified parabolic drape (Fig. 7). Furthermore, the hori-

Fig. 6—Strand blowout with deficient horizontal and vertical PT strand alignment.

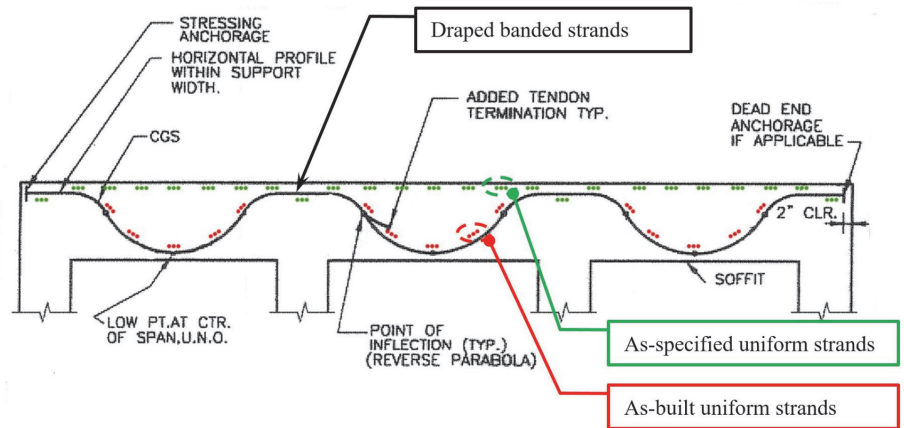
Fig. 7—Uniform tendon vertical alignment (red dots) following banded tendon profile. Green dots indicate specified uniform tendon placement.

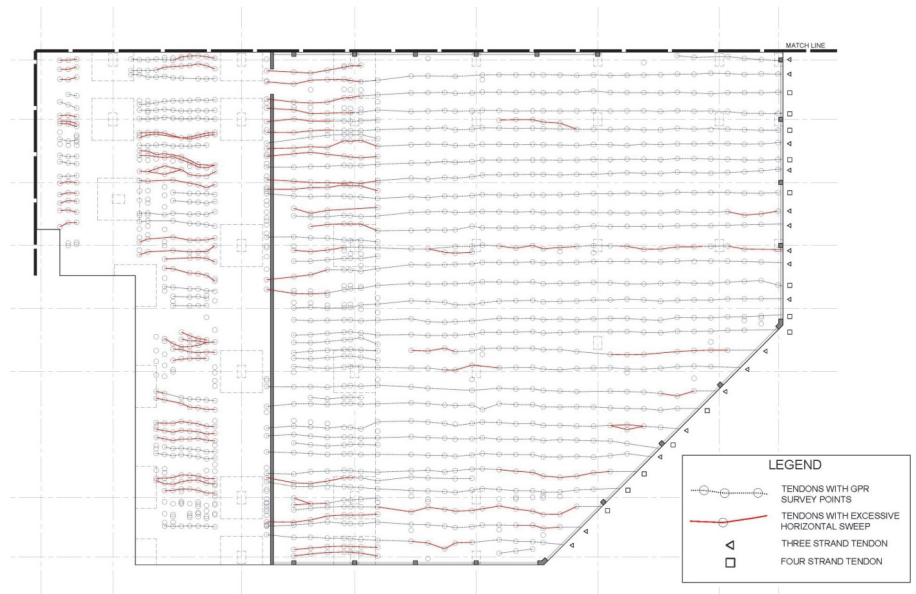
horizontal sweep in the uniform strands exceeded industry standard tolerances (Fig. 8). At locations with overhead concrete repairs, existing strand sheathing repairs were exposed for visual inspection and were observed with incomplete sheathing repairs.

Based on the field investigation and structural analyses completed using the as-built conditions, the elevated slabs were determined to have sufficient load capacity to carry the code-specified demands. However, the widespread excessive horizontal sweep of the uniform strands was not within industry standards and presented a potential safety concern in the form of potential future concrete blowouts. The strands with deficient horizontal sweep were recommended to be realigned to reduce the potential for such blowouts. However, based on bids from repair contractors and the magnitude of the necessary demolition required to realign the existing PT strands, it was determined that the removal and replacement of the elevated slab would be more economical.

Fig. 8—Plan view of uniform PT strand horizontal misalignment based on GPR scans and exploratory openings. Red lines indicate tendons with excessive horizontal sweep.

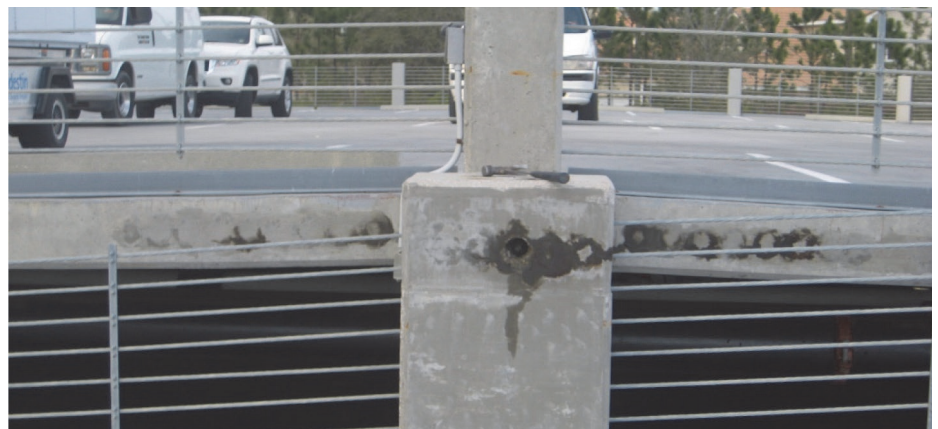
Along the slab edges, some of the stressing pockets exhibited moisture leakage and staining (Fig. 9). After removing the grout, the encapsulation caps were observed to not be properly seated within the anchor barrel. The exposed strand tails were measured to be too long to allow for these encapsulation caps to be seated. In addition to moisture in the stressing anchor barrel, emulsified PT coating was found in the encapsulation caps (Fig. 10).

Fig. 9—Moisture emanating from grout pockets along elevated slab edge.

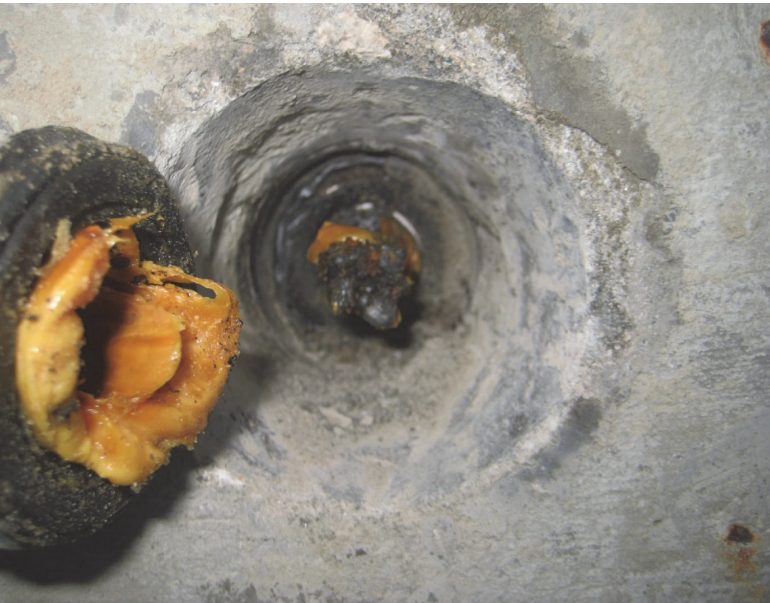
Fig. 10—Strand tail too long, encapsulation cap not seated, and emulsified PT coating.

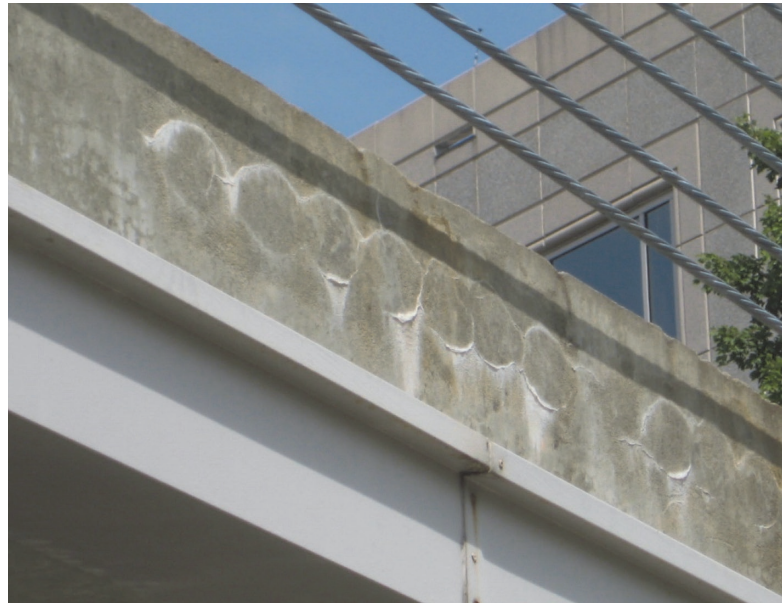
Fig. 13—Grout shrinkage at grout pockets with efflorescence emanating from grout pocket.

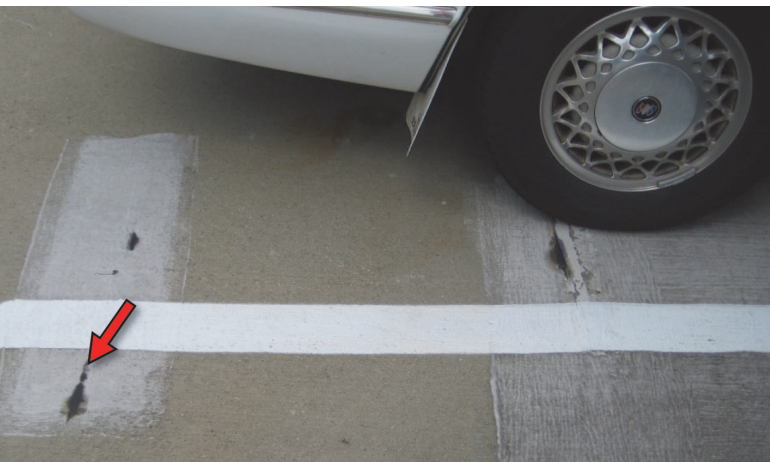
Fig. 11—Exposed PT sheathing and PT coating stains at top of slab.

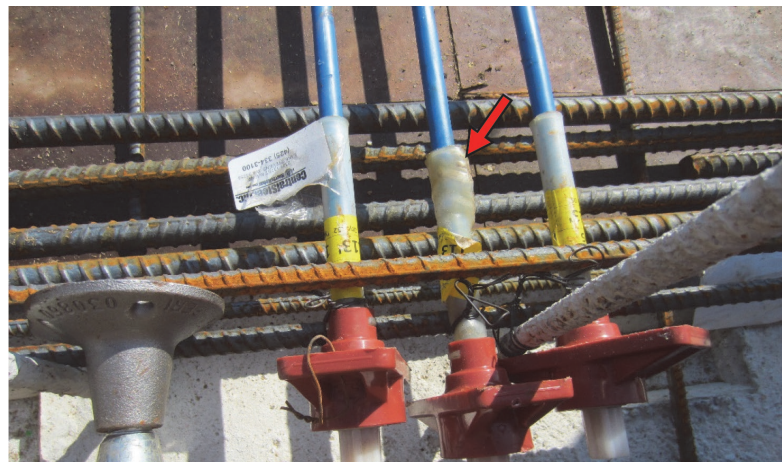
Fig. 14—Damaged PT sleeve prior to concrete placement.

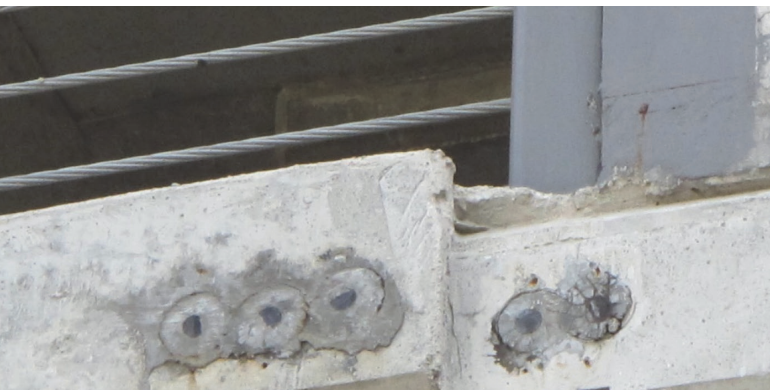
Fig. 12—Exposed encapsulation caps and voids in grout at stressing pocket.

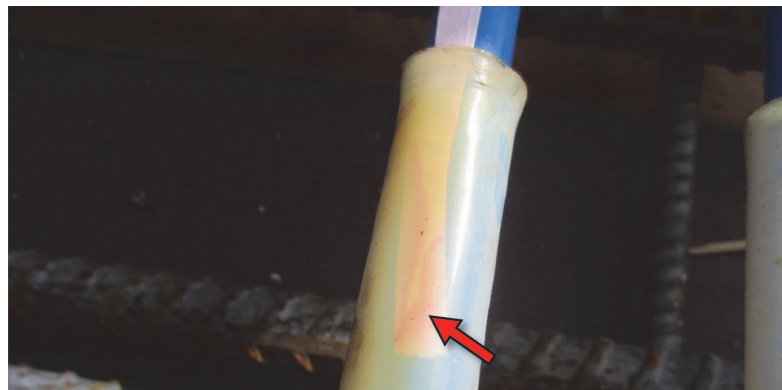
Fig. 15—Discolored moisture-sensitive paper indicating moisture in sleeve and poor seal between sleeve and sheathing.

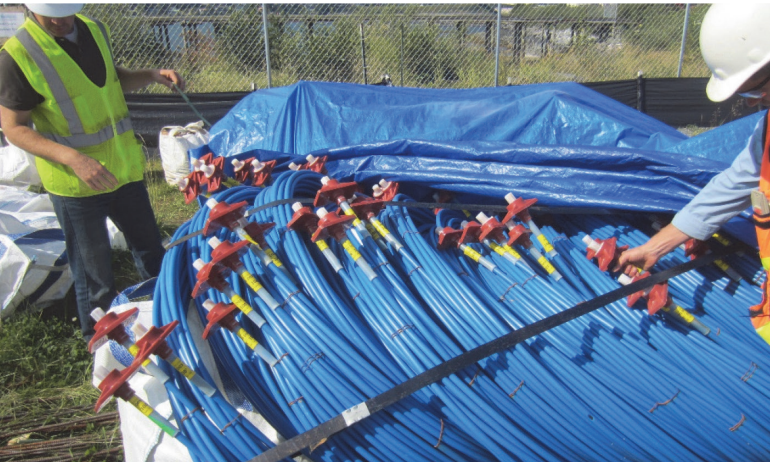
Fig. 16—Typical on-site storage with metal strapping.

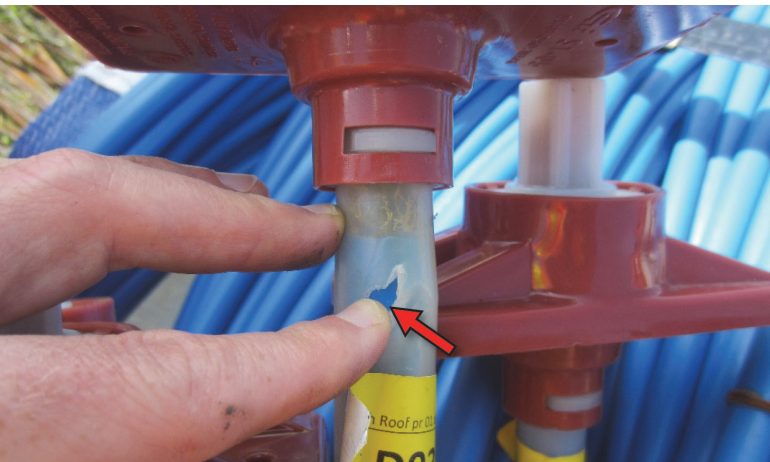
Fig. 17—Damaged PT sleeve prior to concrete placement.

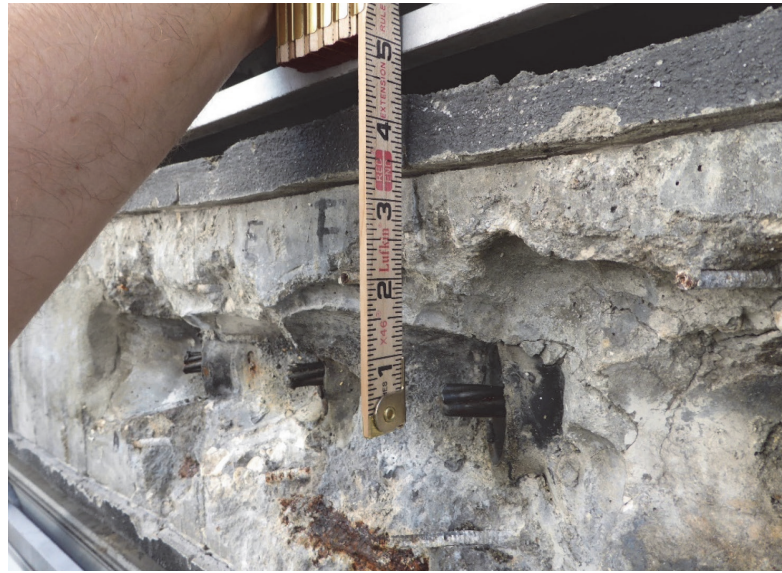
Fig. 18—Deficient strand tail length preventing proper seating of encapsulation caps.

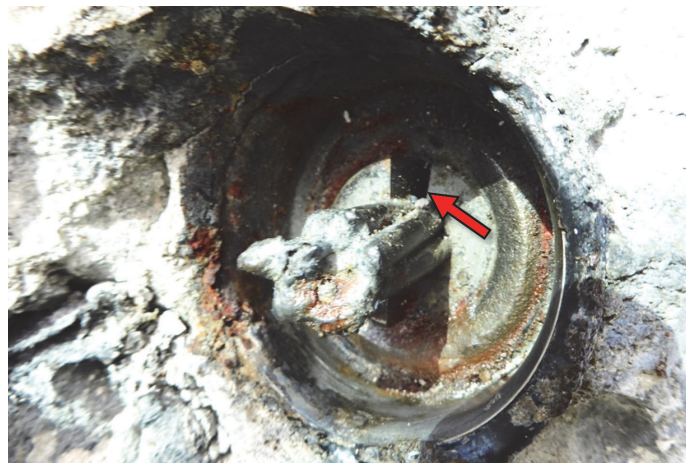
Fig. 19—Offset wedges at stressing anchor.

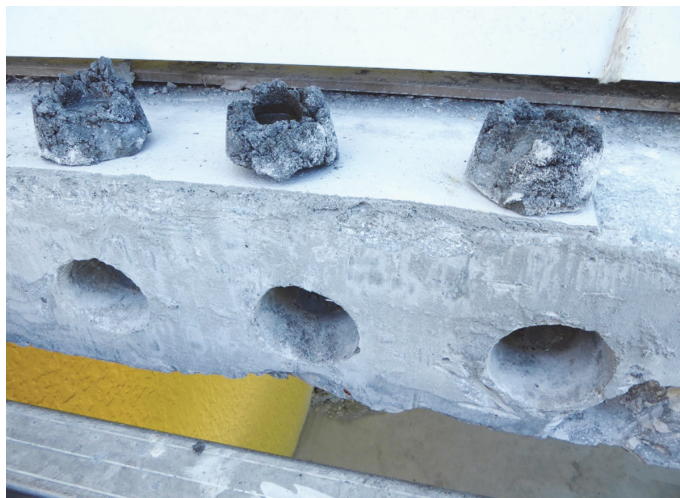
Fig. 20—Poor-quality grout with voids at stressing pockets.

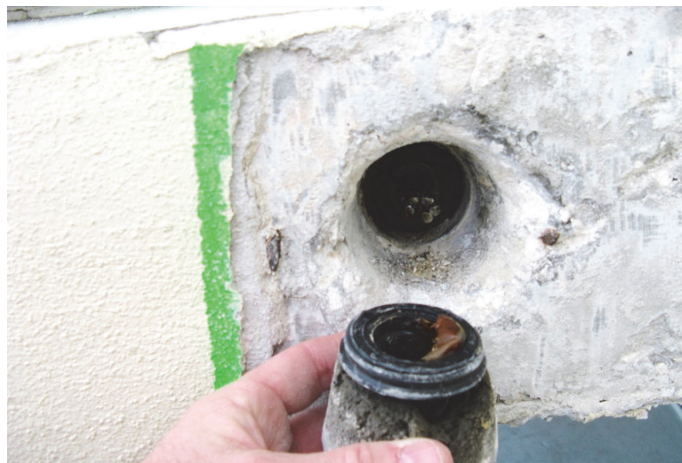
Fig. 21—Encapsulation cap not properly seated in anchor barrel bonded to grout plug.
