**PACIFIC MANOR PARKING GARAGE STRUCTURAL
REPAIRS**

By
LIAO HAIXUE AND GLENN MIYASATO

Authorized reprint from: December 2018 issue of the PTI Journal

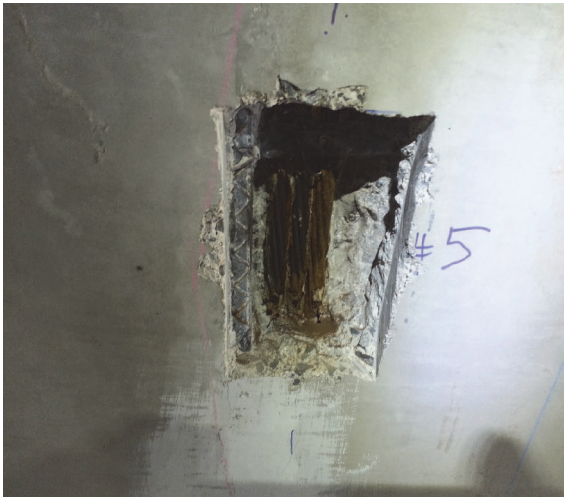
Fig. 1—Galvanic couple between strands and reinforcing bar, where the strands are the anodes and corroding, while the reinforcing bar is the cathode and protected.

- It appeared that there were galvanic couples between the strands and the reinforcing bar in which strands were corroding and protecting the reinforcing bar. (Fig. 1)

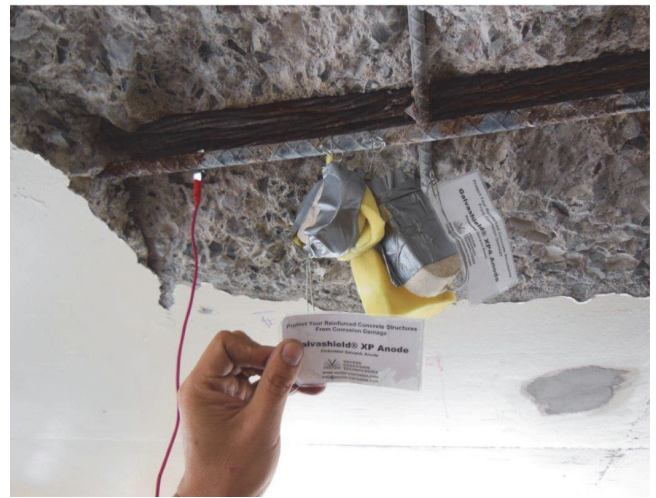
Fig. 2—Verifying conductivity of paper sheath, checking current flow from anodes to strands, and checking polarization of strands using a galvanic anode.

- Conductivity tests showed a significant amount of current could flow from the testing galvanic anodes to the strands through the paper sheath. Therefore, the paper sheath was found to be a good conductor that promotes corrosion of the strand (Fig. 2).

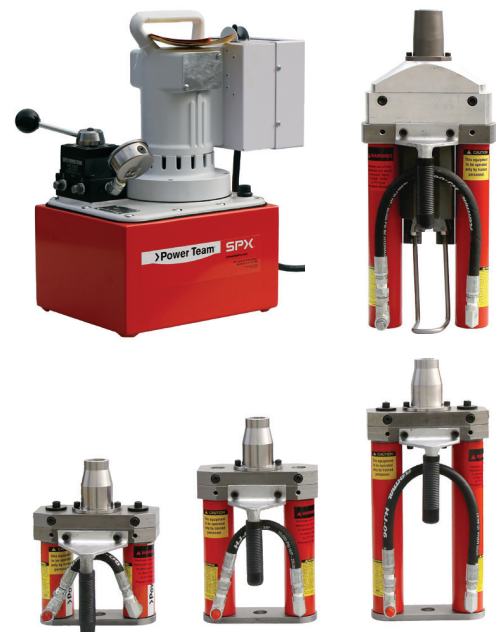
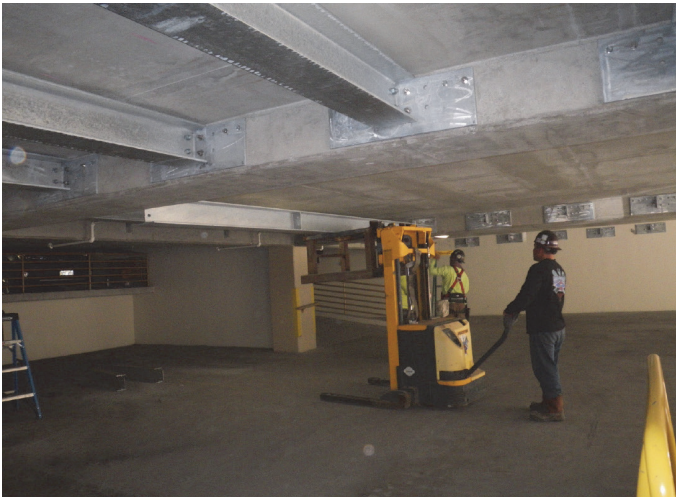
Fig. 3—Installing steel beams in some local areas where there were a significant number of broken tendons.

isolated corrosion of reinforcing and broken tendons (Fig. 3). This strengthening retrofit option was found to be feasible due to the large amount of mild reinforcing steel specified in the original design for most of the decks to the degree that only a small amount of additional reinforcement would need to be added by installing them in grooves cut into the deck. For one of the parking decks where this was not the case, steel beams were added under the deck as a precaution against significant fractured tendons. As these retrofits were provided only to provide adequate strength capacity, preservation of the existing tendons was relied on to maintain the slab deflections within acceptable limits.

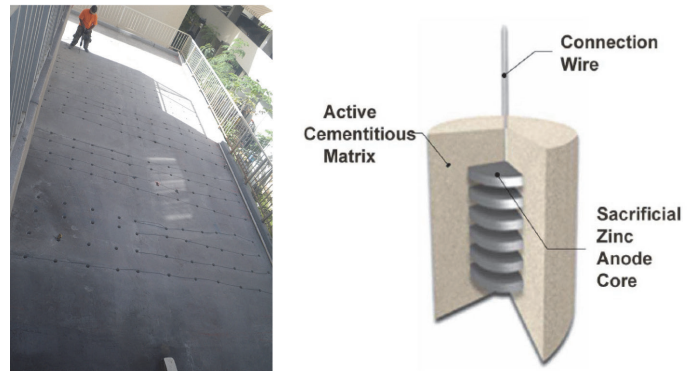
Fig. 4—Installing galvanic anodes along the tendons and connecting anodes to the steel.

To protect the tendons against future corrosion, it was decided to install embedded zinc anodes to provide cathodic protection to the tendons (Fig. 4). It is anticipated that this protection, in addition to properly repairing all spalled concrete and re-waterproofing the top surface of the decks, will greatly mitigate future corrosion and keep the tendons largely intact.
