A STITCH IN TIME SAVES NINE: A PT REPAIR CASE STUDY

Authorized reprint from: December 2017 issue of the PTI Journal

INTRODUCTION

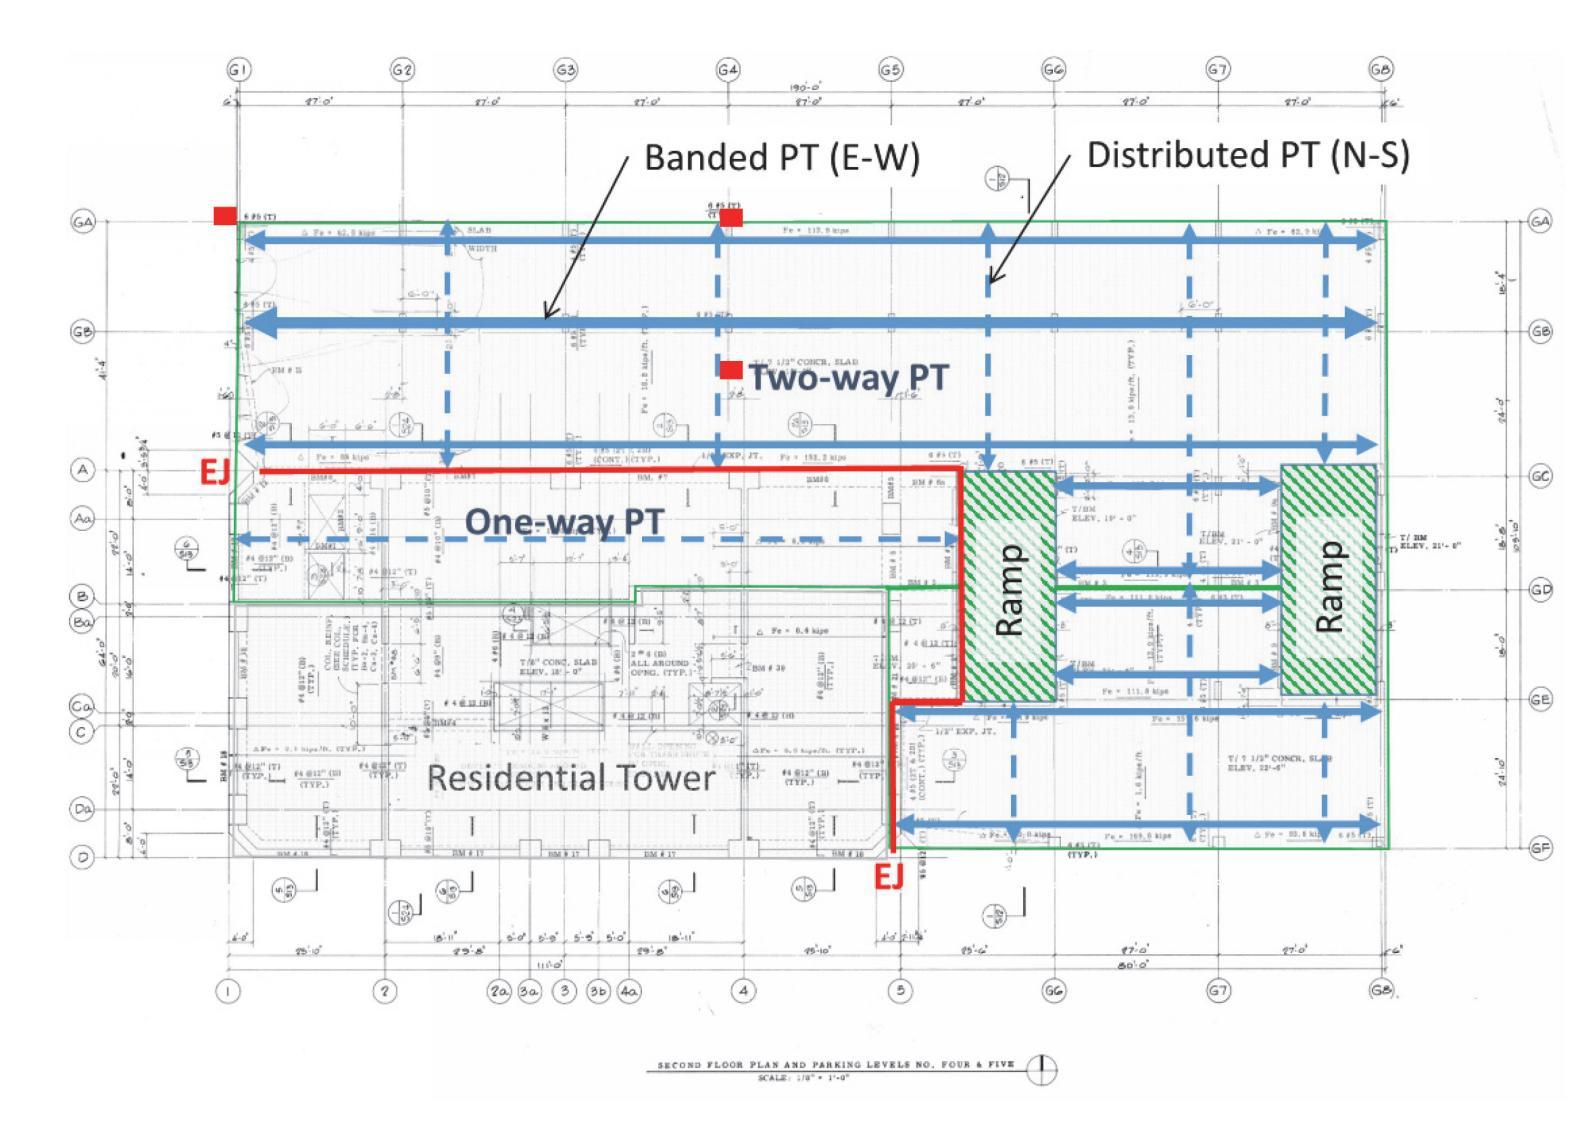
Fig. 2—PT layout of typical floor. Banded groups of tendons shown with solid lines and direction of distributed tendons indicated by dashed lines. Locations of tendon eruptions indicated by red boxes.

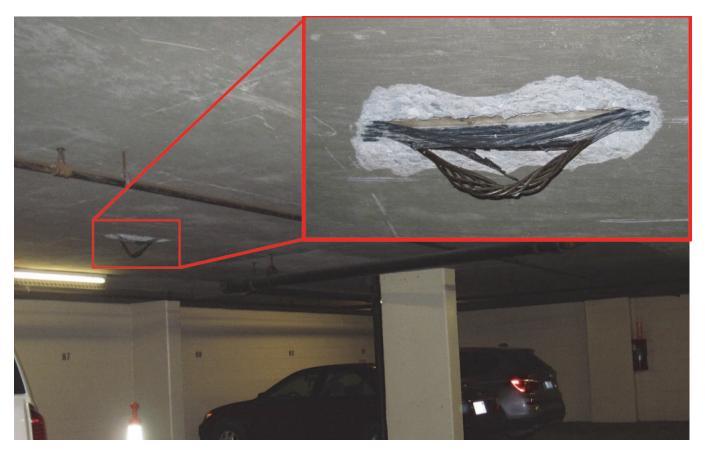
In the spring of 2015, one tendon in a banded group of 16 tendons erupted from the underside of the Level 4 floor slab (Fig. 4). A visual survey of the garage identified two additional locations of prior tendon eruption, also on the underside of the Level 4 floor slab. One of these older eruptions occurred at the west end of the garage along the same line of banded tendons; the other occurred near the south edge of the floor between the two ramps. The locations of these eruptions are shown in Fig. 2.

Fig. 4—Tendon eruption from underside of Level 4 slab.

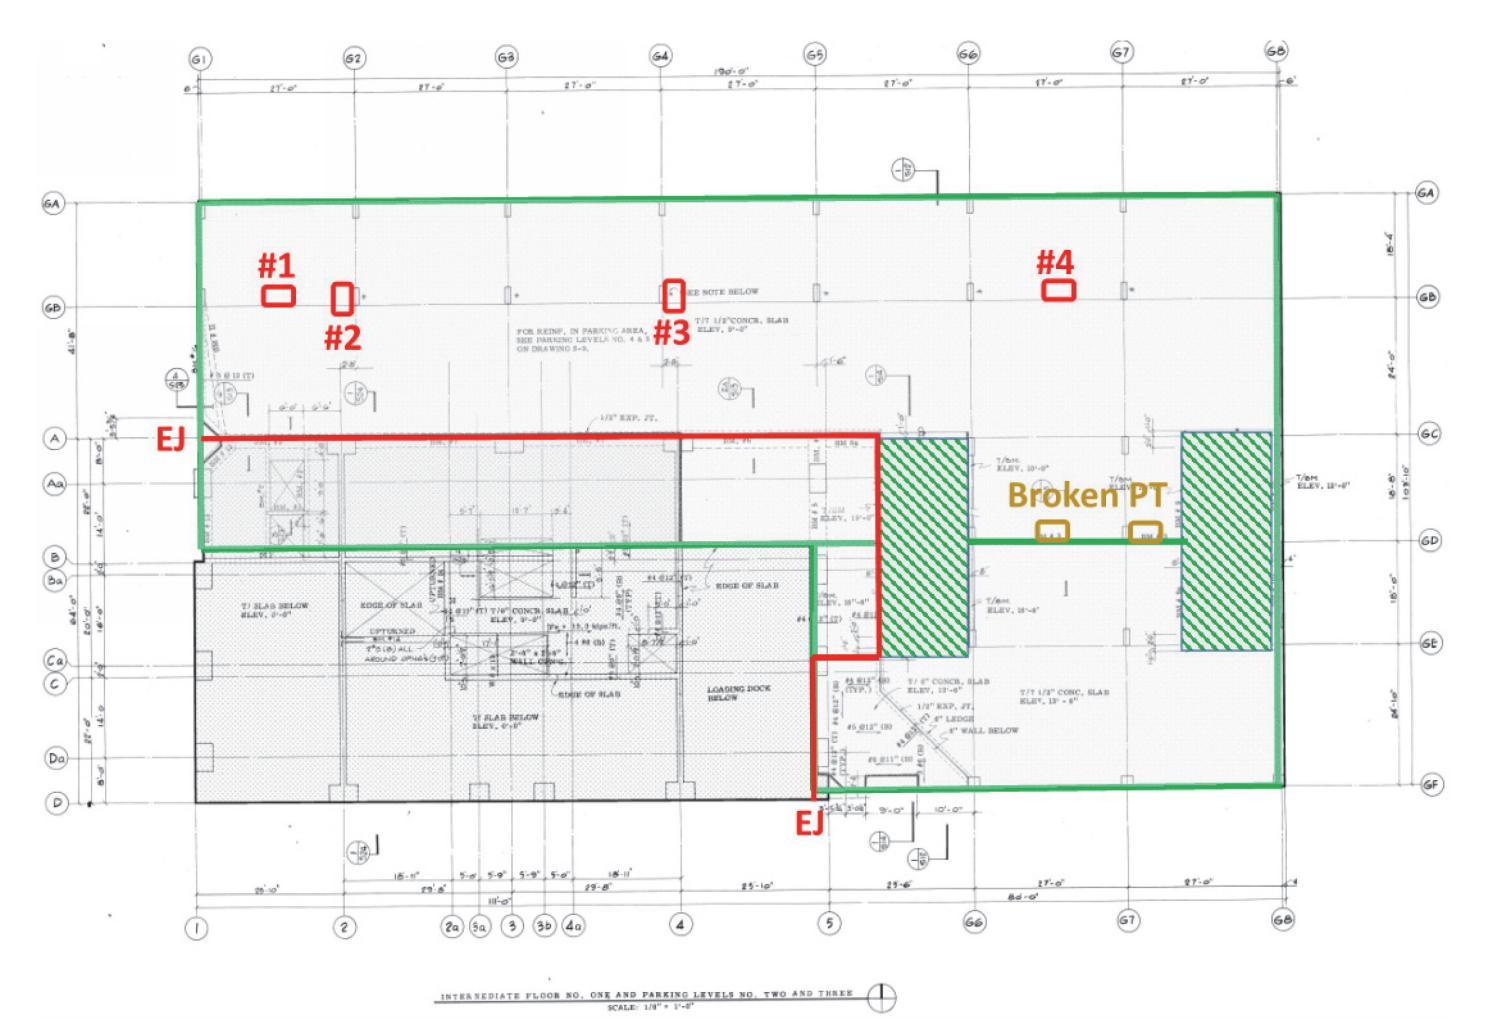
Four inspection openings were made along the banded group of tendons that exhibited multiple eruptions (Fig. 5). The locations were selected to obtain information on the condition of the failed tendons at the break and along their length away from the break location, and to determine if the other tendons in the banded group were still under tension. The investigation was also intended to help identify conditions that may influence repairs, such as evidence of moisture contamination, portions of strand with corrosion, or instances of physical damage. The openings were therefore made at locations more likely to reveal these conditions, as follows:

Inspection Opening No. 1 and 4 were made at the two eruption points. Inspection Opening No. 2 was made at an existing concrete repair at a column near the west end of

Fig. 5—Locations of inspection openings.

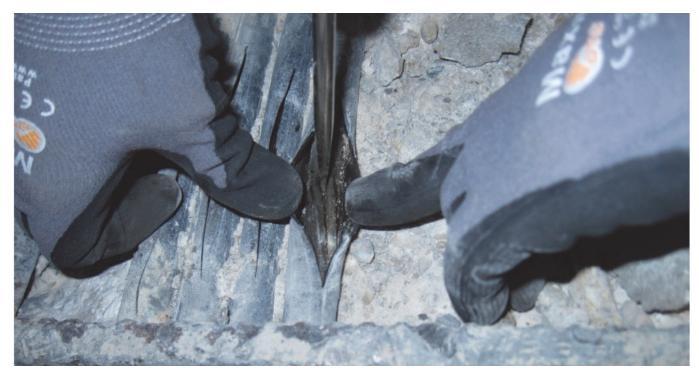
test (Fig. 6) was performed to evaluate if the tendon was holding force. The screwdriver penetration test consisted of attempting to drive a flathead screwdriver between individual wires of an exposed strand. If the screwdriver can penetrate between the wires, it is likely that the tendon is no longer fully tensioned. However, the test can return false positive results that the tendon may be holding tension if the tendon has significant corrosion that can interfere with separation of the wires or sufficiently bind the tendon to restrict movement.

Fig. 6—*Screwdriver penetration test.*

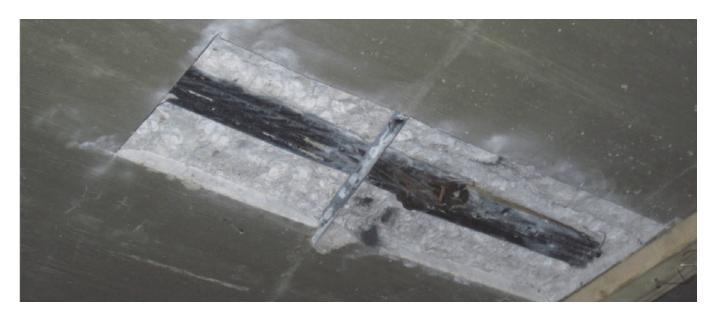
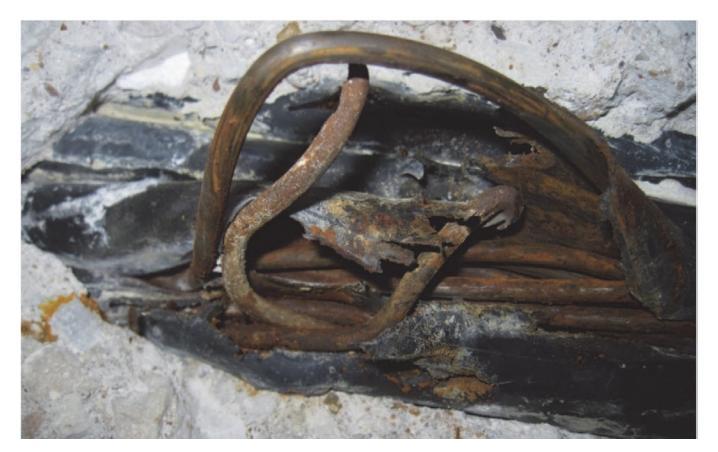
Opening No. 1—Located at tendon eruption location at west end of garage, on the underside of the slab (Fig. 7). Four tendons were exposed, and three of them were noted to be detensioned. Two of these tendons had splayed wires ("bird-caged") and exhibited light surface corrosion evenly on all surfaces of the

wires, indicating that the tendons had been exposed to atmospheric moisture for some time; after cutting the sheathing on the third loose strand, black corrosion by-product was visible in the grease. None of the exposed tendons had section loss or pitting on the exposed wire surfaces. The tendon that was still holding tension appeared to be in good condition.

(a) Overall view of Inspection Opening No. 1.

(b) Close-up view of birdcaged tendon. Fig. 7—Inspection Opening No. 1.

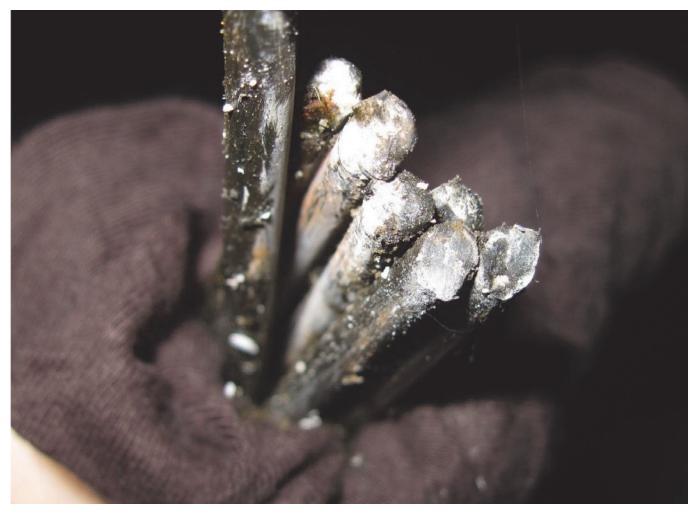
The three detensioned tendons were cut to allow them to be gripped by a hydraulic ram. Two of the tendons pulled out of their end anchors at the west edge of the floor slab, while the third remained secure at its anchor. One tendon was removed to inspect the end that had pulled out of the anchor. As shown in Fig. 8, it had very light surface corrosion and no visible pitting or section loss. The tendon was extracted from the slab east of the inspection opening to determine the location of the fracture. At the first low point, moderate surface corrosion, section loss, and pitting was found on the strand (Fig. 9). The point of failure was found to be approximately 80 ft to the east of the opening, at an existing concrete repair location. The broken end of the tendon exhibited heavy corrosion and full section loss (Fig. 10). Importantly, the condition of the tendon between the first low point and the failure was good, with no signs of corrosion on the steel.

Fig. 8—Tendon pulled out of end anchor.

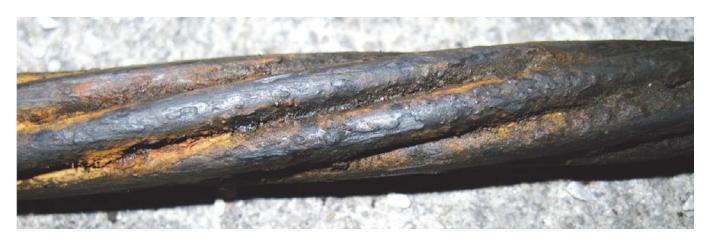
Fig. 9—Pitting and section loss from corrosion at low point of tendon profile.

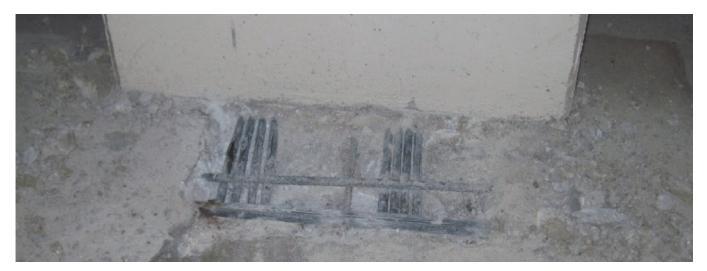
Opening No. 2—Located at the first high point of the tendon drape, on the top surface of the slab and at the first interior column from the west slab edge. The opening was made through an existing concrete repair. Eight tendons were exposed in the east-west banded group, and two additional tendons were exposed oriented in the north-south direction (Fig. 11).

All the east-west tendons were found to be in good condition, with no evidence of moisture contamination or corrosion. Four of the eight tendons were found to no longer be holding any tension, consistent with Opening No. 1. The sheathing on all the east-west tendons had been damaged by chipping as part of previous concrete removal, and light surface corrosion was visible on the exposed steel.

Fig. 11—Inspection Opening No. 2.

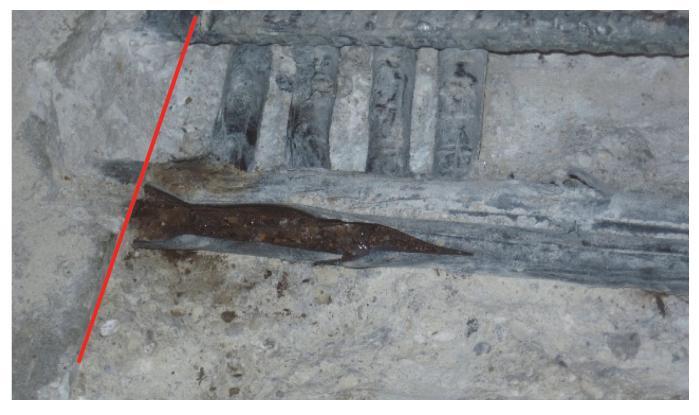
The sheathing of two of the north-south tendons were found to have been damaged by the saw-cutting operation along the perimeter of the prior concrete repair, and no evidence of attempted sheathing restoration was noted. Both tendons were heavily corroded, as shown in Fig. 12, with at least one wire completely corroded through on one of the tendons. The screwdriver penetration test failed to separate the wires in the tendons, but based on the exposed tendon condition, this was likely due to the significant corrosion buildup and was judged to be a false positive.

Fig. 12—Close-up view of damaged north-south tendons where sheathing was saw-cut during past concrete repairs. Line of saw-cut shown in red.

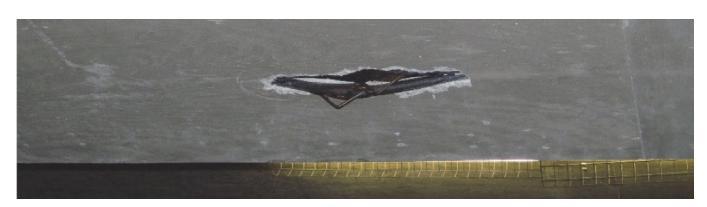
An additional inspection was made at the two failed slab PT tendons that erupted near the south edge of Level 4 (Fig. 13). The tendons were exposed on the top surface of the slab at a column, where they had been placed too high during the original construction and had no concrete cover (Fig. 14). The heat-sealed seam in the sheathing separated, allowing moisture to enter the sheathing. The strand was heavily corroded, as seen in Fig. 15, and both tendons were fractured due to section loss.

Fig. 13—Eruption from underside of slab near south edge of Level 4.

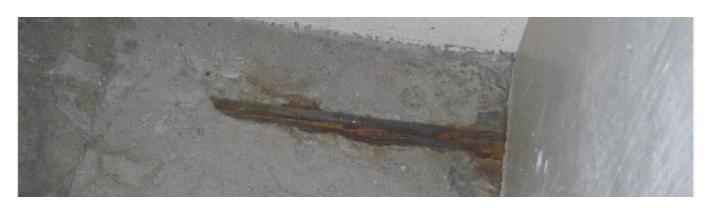
Fig. 14—Tendon exposed on top surface of slab due to initial construction defect.

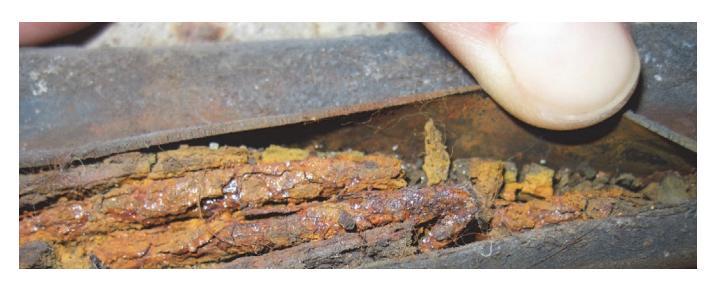
Fig. 15—Close-up view of deterioration where heat-sealed seam split on sheathing exposed on top surface of floor slab.
