## 2017 PROJECT OF THE YEAR: THE RITZ-CARLTON RESIDENCES WAIKIKI BEACH, PHASE 1

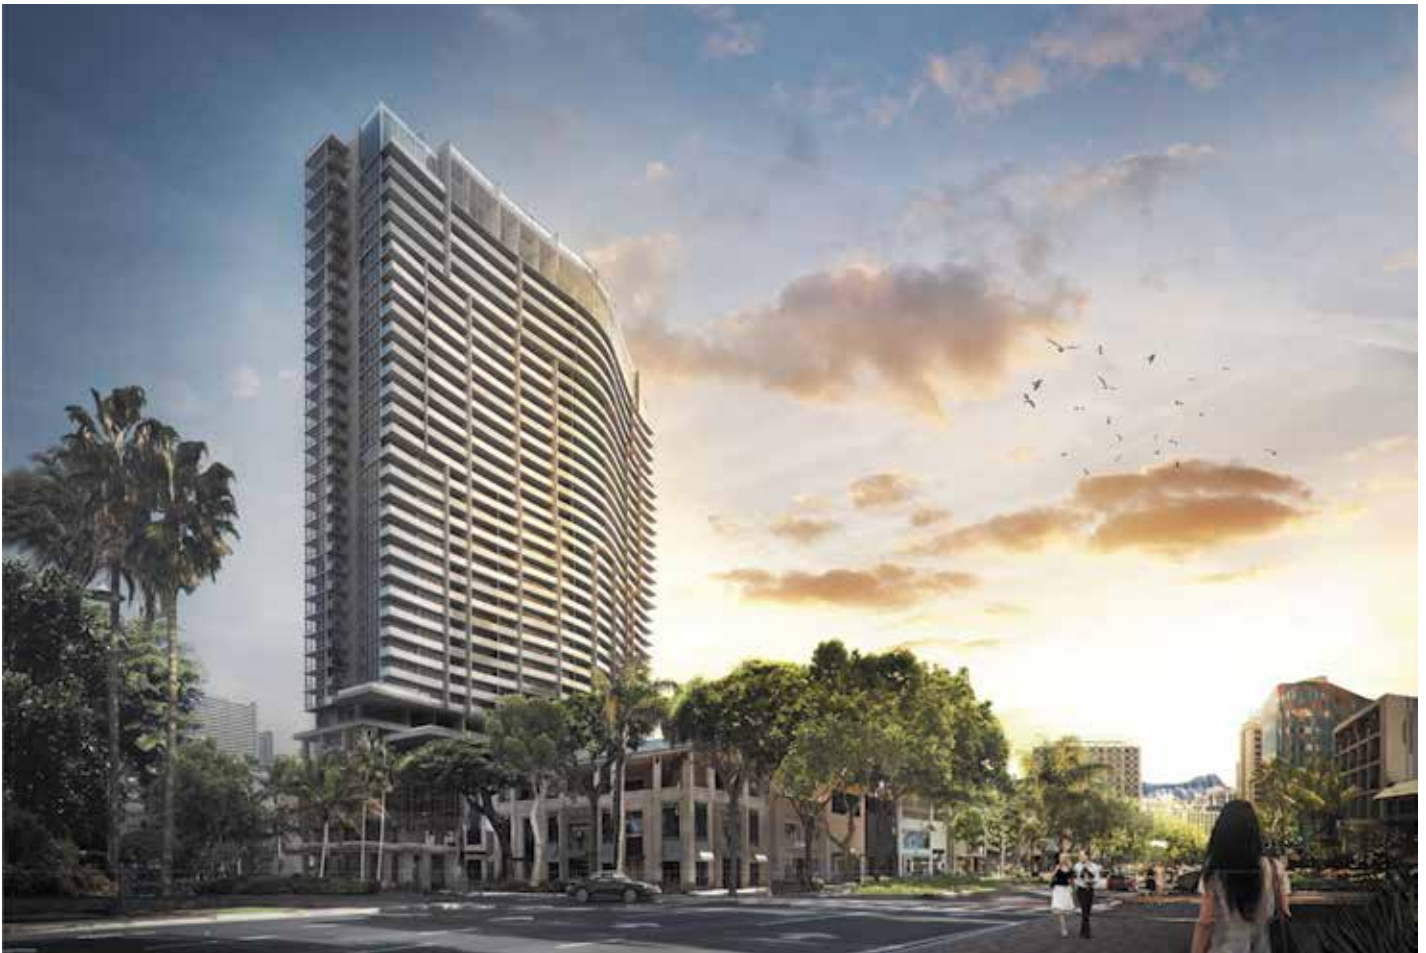
Fig. 1—The Ritz-Carlton Residences Waikiki Beach, Phase 1.

Waikiki. The Ritz-Carlton. The former is one of the world's premier vacation destinations and the latter is synonymous with luxury development (Fig. 1). The union of these two is The Ritz-Carlton Residences Waikiki Beach. Constructed in two phases, this project is the largest, most recent new resort development and includes approximately 900,000 ft<sup>2</sup> (84,000 m<sup>2</sup>) in two complementary 38-story towers, each 350 ft (107 m) tall. Phase 1 of this luxury hotel and condominium project

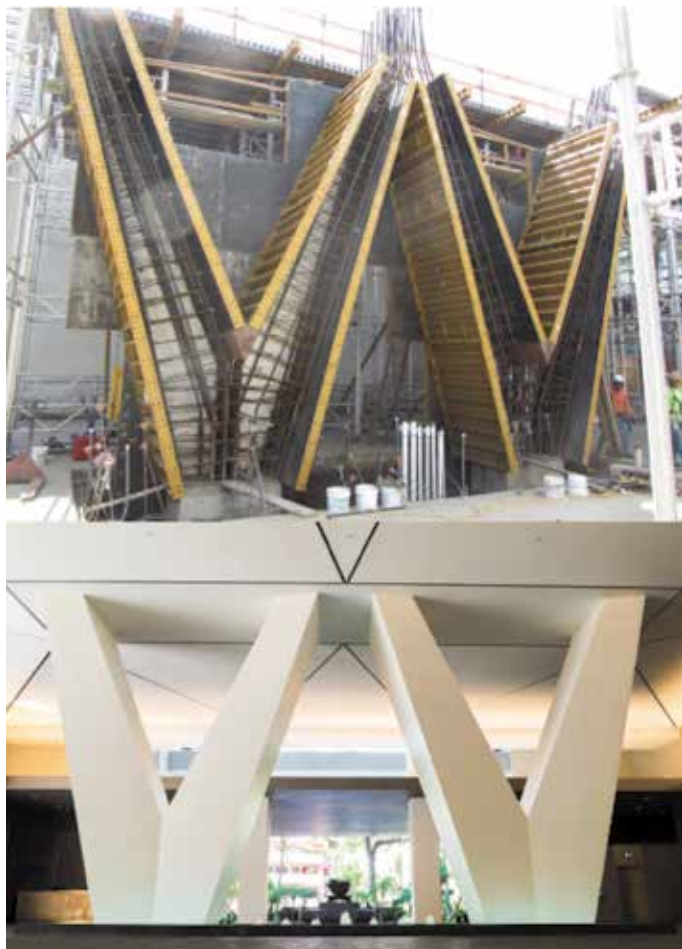
Fig. 5—W column under construction (top) and completed (bottom).

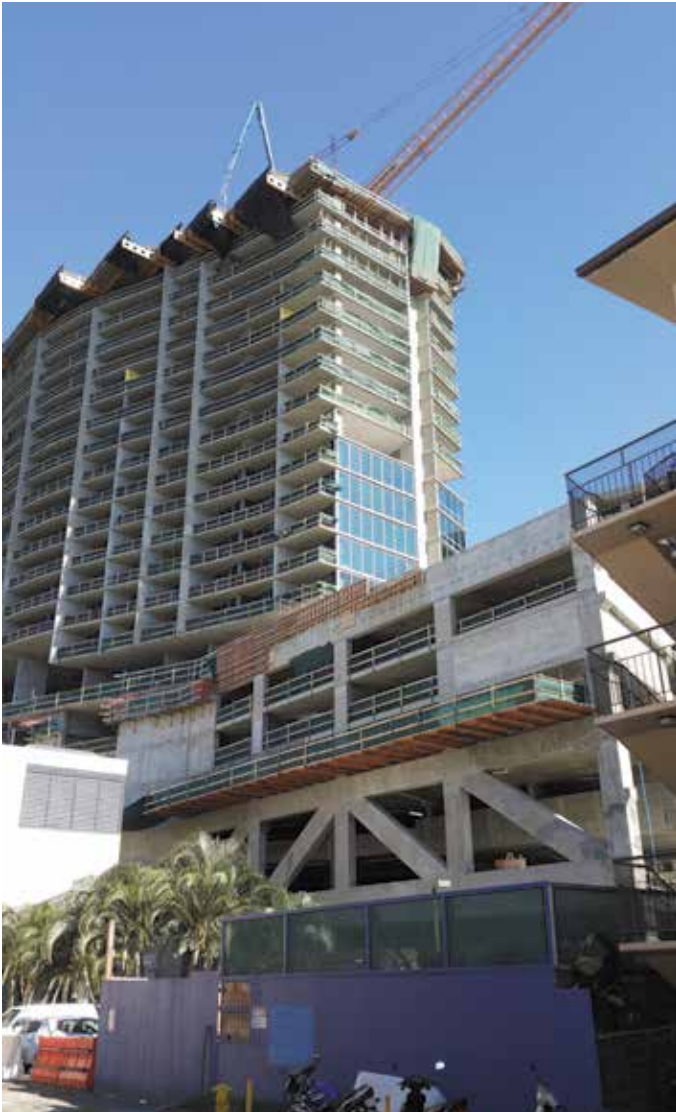
Fig. 10—PT concrete truss under construction.

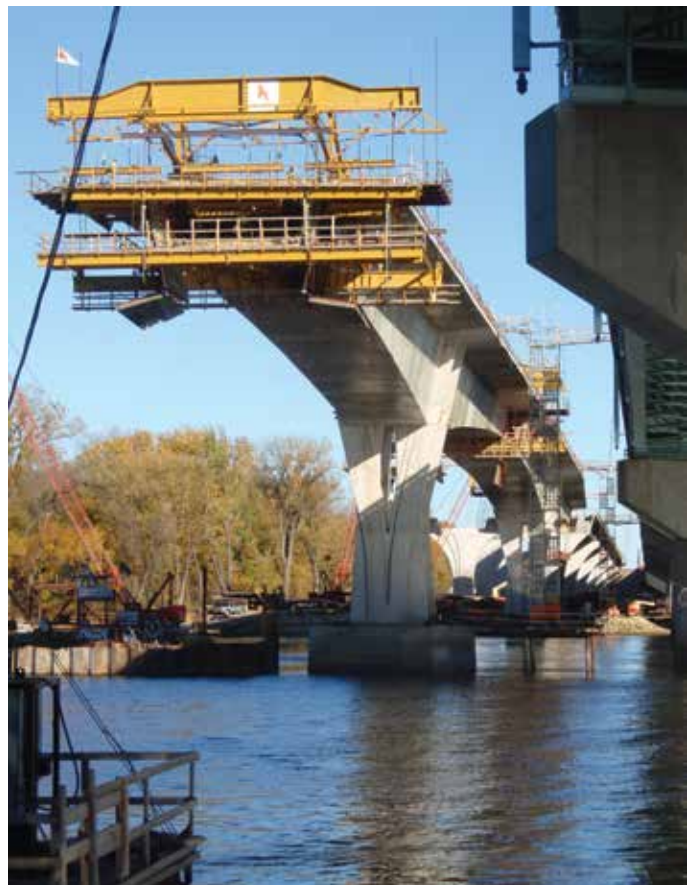
Fig. 2—Form travelers in balanced cantilever.

closures are made between adjacent cantilever tips to form a continuous span. The combination of 27-0.6 in. (15 mm) diameter strand external draped tendons and 19-0.6 in. (15 mm) diameter strand bottom slab tendons serve as continuity post-tensioning to resist superimposed dead load, live loads, and the redistribution of the forces as the structure migrates from a cantilever state to a continuous state. Post-tensioning allows for residual longitudinal compression of the deck under normal service loads. Coupled with transverse post-tensioning, this bi-directionally pre-compressed structure minimizes cracking, which enhances the durability of the structure. Structural elements such as pier diaphragms and deviators also include post-tensioning designed to resist service loads and maximize durability.

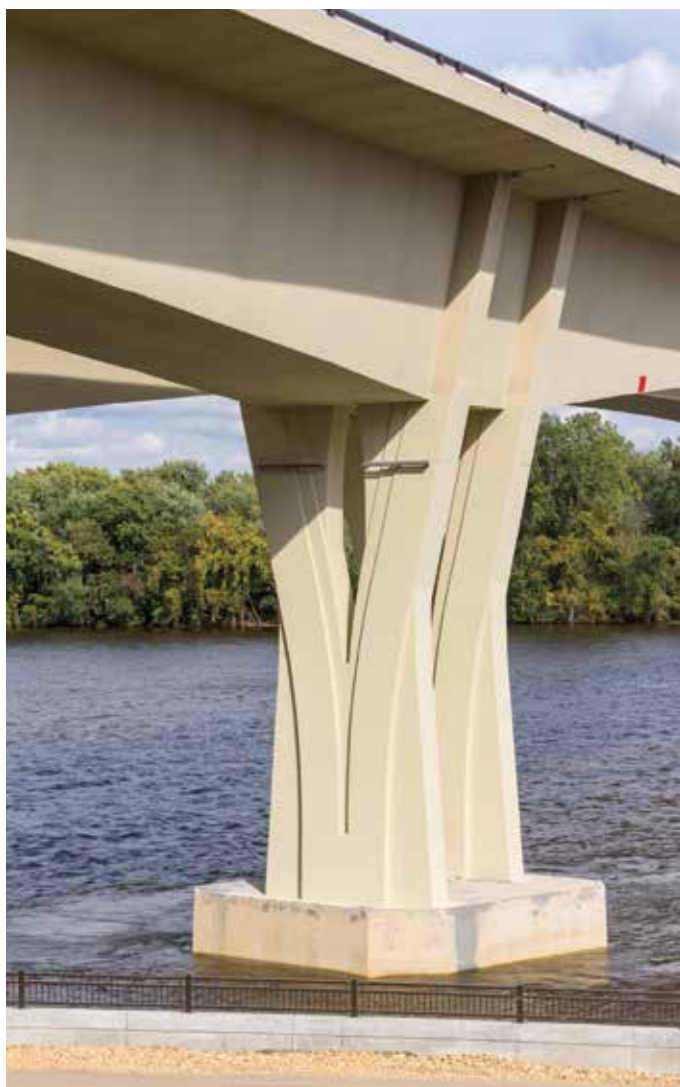
Fig. 4—Bridge piers.

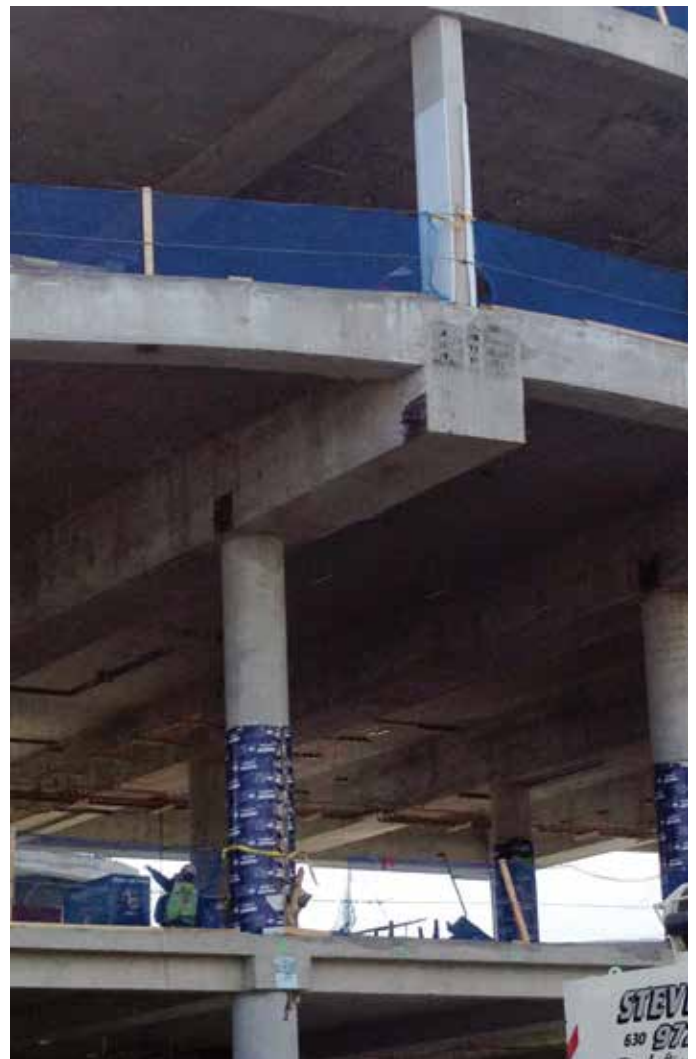
Fig. 4—Cantilevered post-tensioned transfer beam.

Amid numerous structural challenges, the most prevalent was supporting 169 transfer columns in the upper three levels of the building. These transfer columns, which are necessary due to the dissimilar column grids of the lower level classrooms and the upper-level offices, are supported by a network of large post-tensioned transfer beams (Fig. 4 and 5) behaving as “foundations in the air.” The transfer columns at the perimeter of the upper levels are set outboard of the levels below, resulting in dramatic post-tensioned transfer cantilevers up to 19 ft (5.8 m) in length (Fig. 4).

The advantage of post-tensioning in these transfer beams is that long spans and cantilevers are achievable with minimum structural depth and deflection, which is a critical concern for transfer columns. The curving nature of

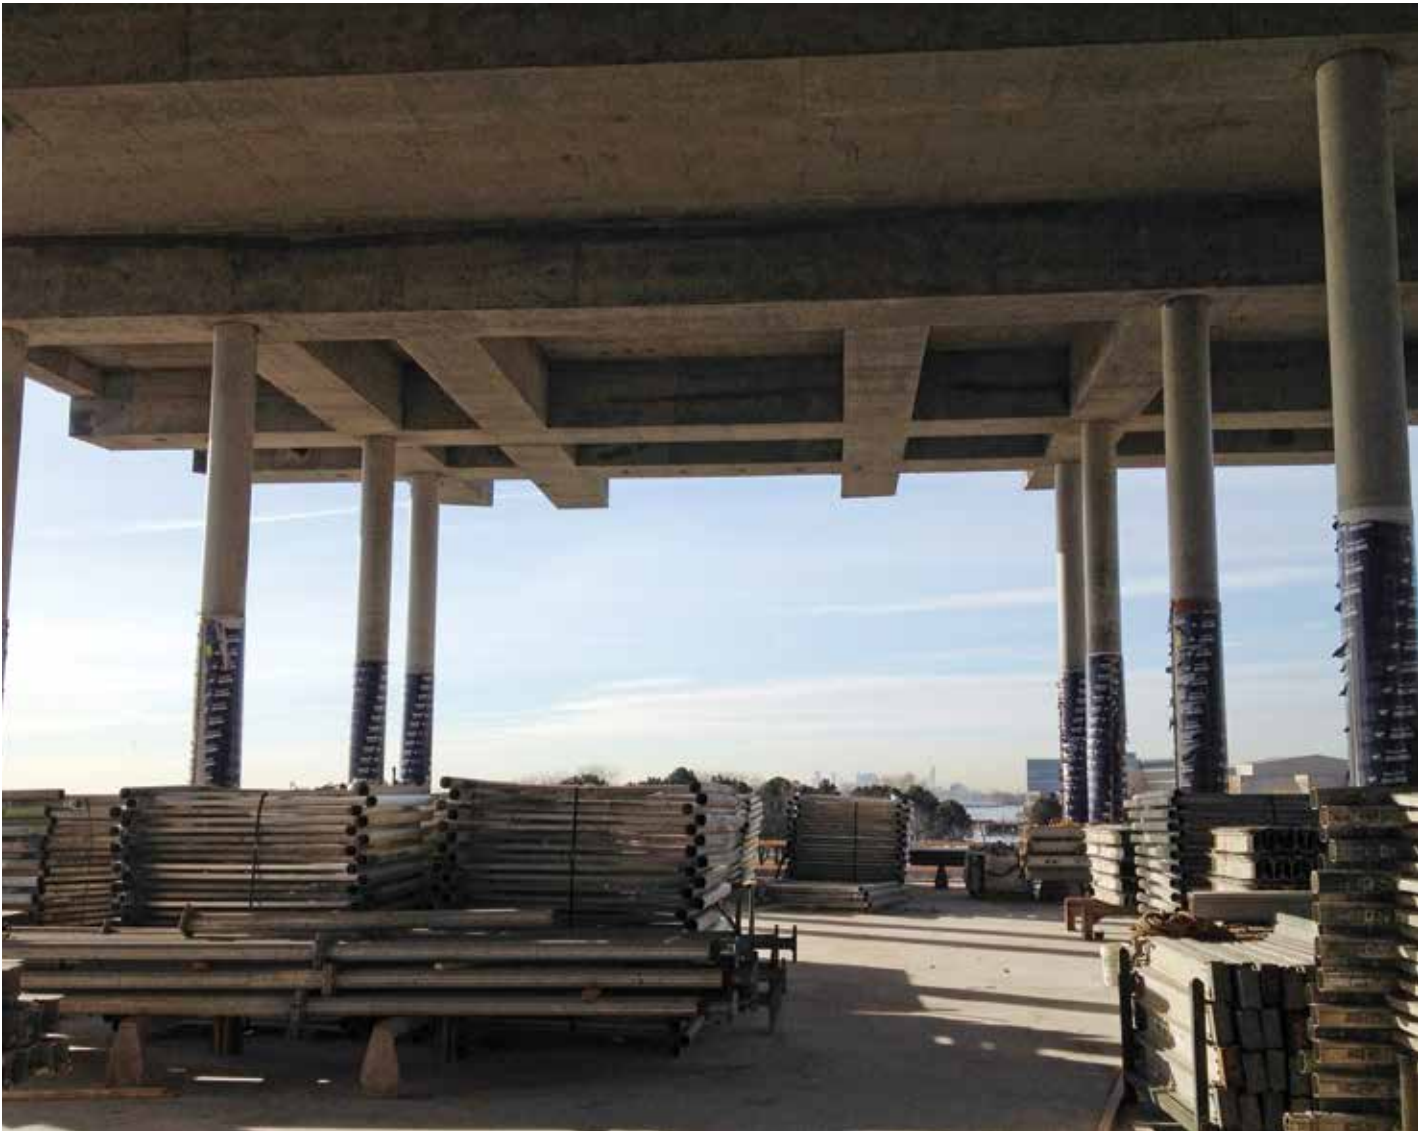
Fig. 5—Post-tensioned transfer beams.

the floor plates also creates complicated PT transfer beam intersections (Fig. 5), which were a key constructibility consideration during the design phase. Many of the post-tensioned transfer beams were stressed in multiple stages to manage the varying loading conditions that occurred during construction without overstressing the beams.

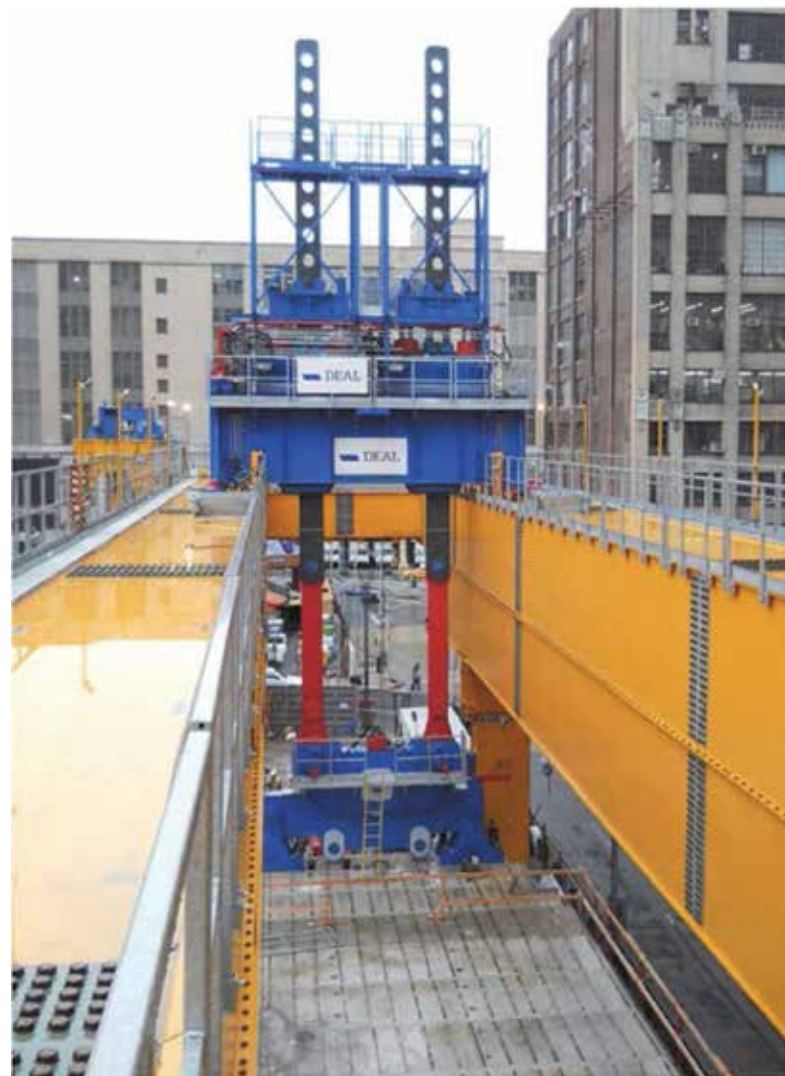
Fig. 5—Lowering system.

The LG was basically a gantry able to move sideways on rails and its main components were a winch and a lowering system (Fig. 5). The gantry could move 10 ft (3 m) per minute and lowered the girders into place at a rate of 0.5 ft per minute with a 1/4 in. (6 mm) precision. The lowering system consisted of hydraulic cylinders

with pins and slotted bars (Fig. 5). On each slotted bar, there were two pins that were used alternatively for lifting the girder and for keeping it in position while the jacks restroked. This was a very important feature for the railways' safety: there was, at all times, a positive connection between the bridge and the erection equipment. Even in case of a hydraulic failure, the load would have always been secured by the pin connection. On top of that, the LG was remotely connected with the engineers and technicians in Italy to monitor the functioning and ensure that all the sensor and indicators were working properly. After the first two girders were set, the TPP was removed and the underslung assembly bed was relocated over Span 3 and 4 and used as the stage from which subsequent girders were fabricated.

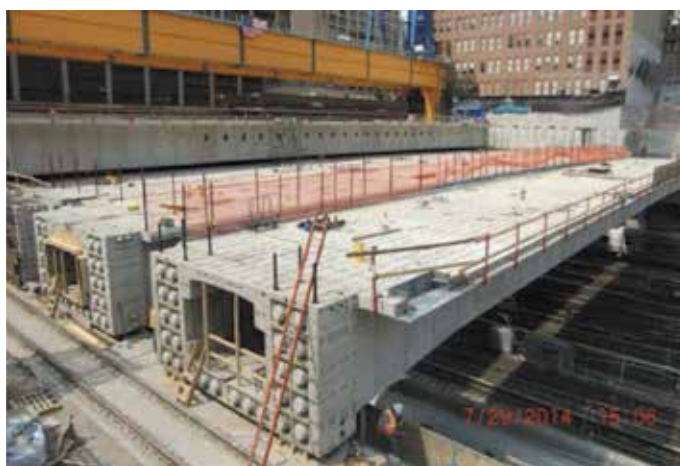
Fig. 6—Post-tensioning on face of pier segments.

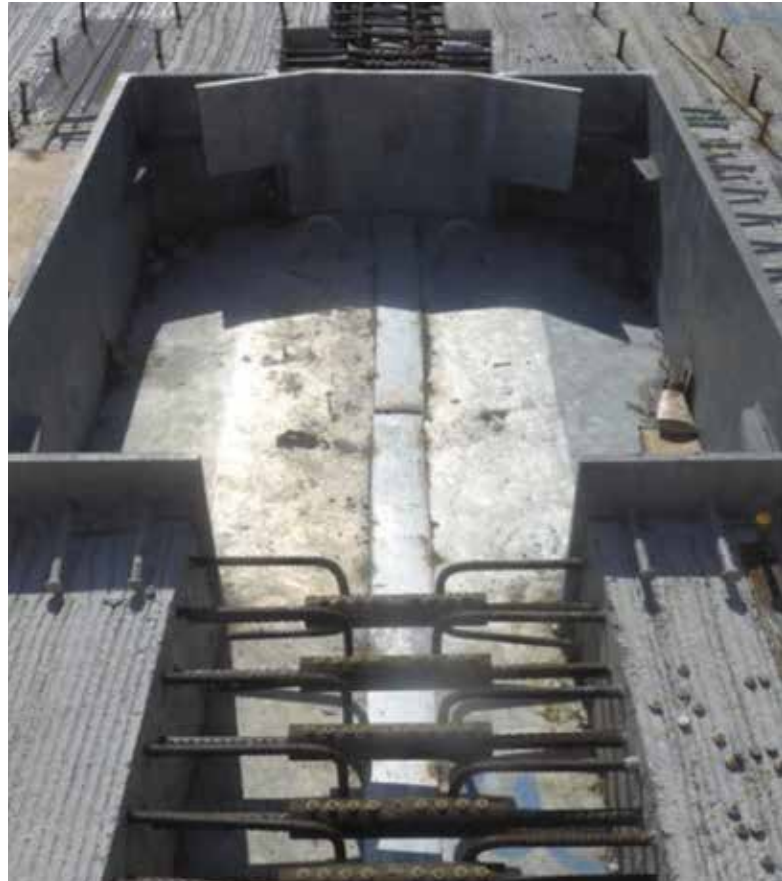
Fig. 9—Column openings.

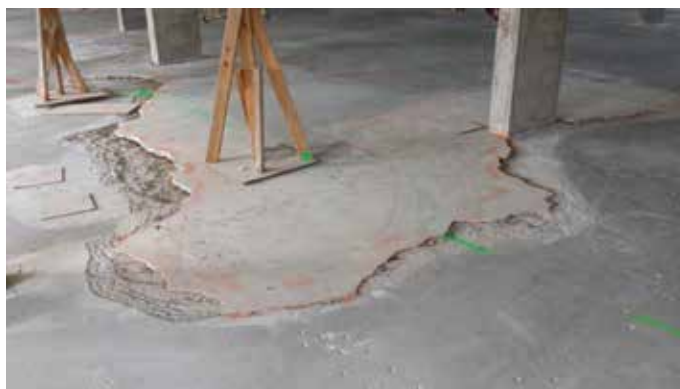
Fig. 2—Shear crack failure.

Although no "trigger" was identified, the failure was determined to be punching shear caused by a combination of inadequate design for overlapping punching shear perimeters, low-strength concrete, poor-quality concrete, inadequate consolidation, and inadequate reinforcing steel detailing.

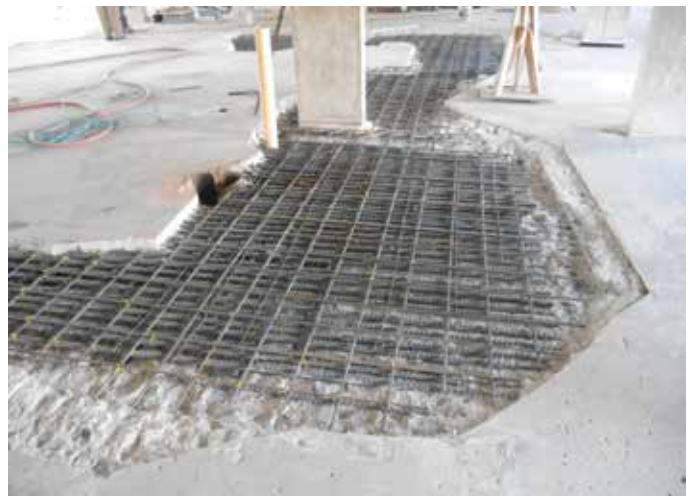
Fig. 4—Level 4 crack repair.

four column bays. The repair comprised conventional selective demolition (Fig. 4) and replacement along with epoxy injection. This would further weaken the already-damaged transfer slab, so additional shoring was installed. In all, 80 gal. (300 L) of epoxy was used in this process. Additional steel was added to the repair areas where concrete was removed, and the floor was repoured to its original level.

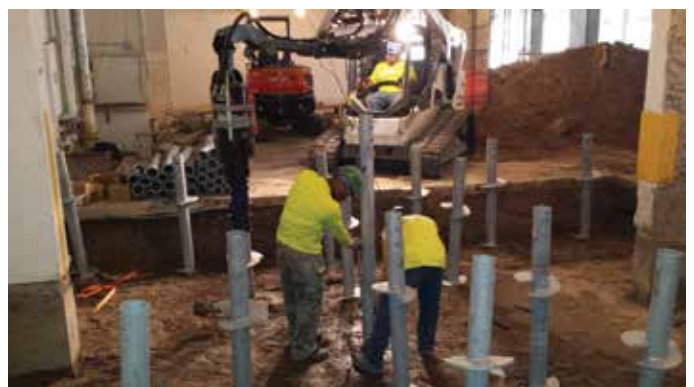
Fig. 5—Installation of helical piles.

Simultaneously, work began on Phase 1 of the foundation strengthening. This phase consisted of areas that fell outside the existing shoring and could easily be accessed. The foundation work consisted of demolishing and removing the slab-on-ground concrete, excavating down to the existing concrete pile caps, installing new steel helical piles (Fig. 5), placing steel reinforcement, and pouring of the new expanded pile caps.

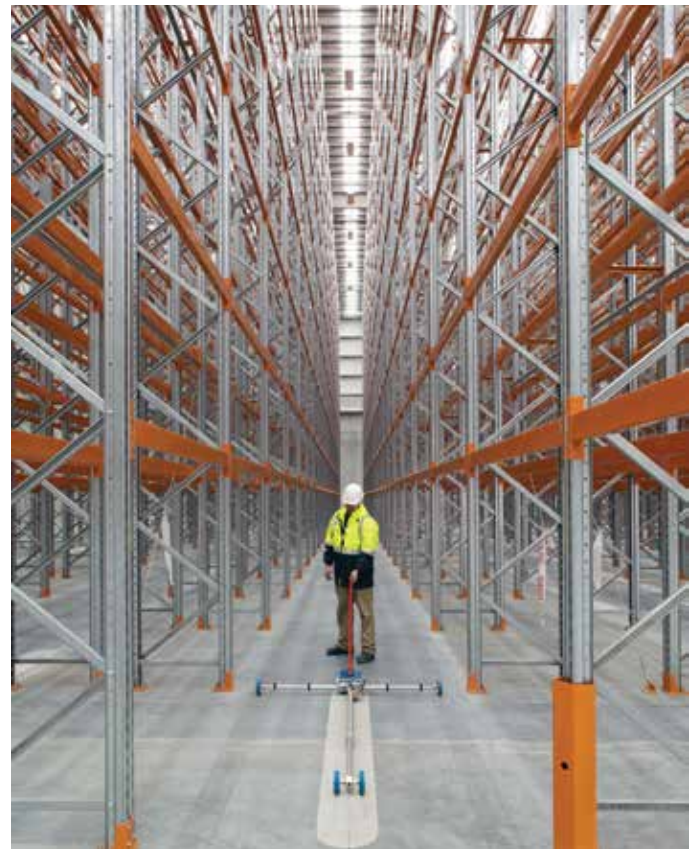
Fig. 5—FACE Consultants Profileograph surveying of the JPL Distribution Center.

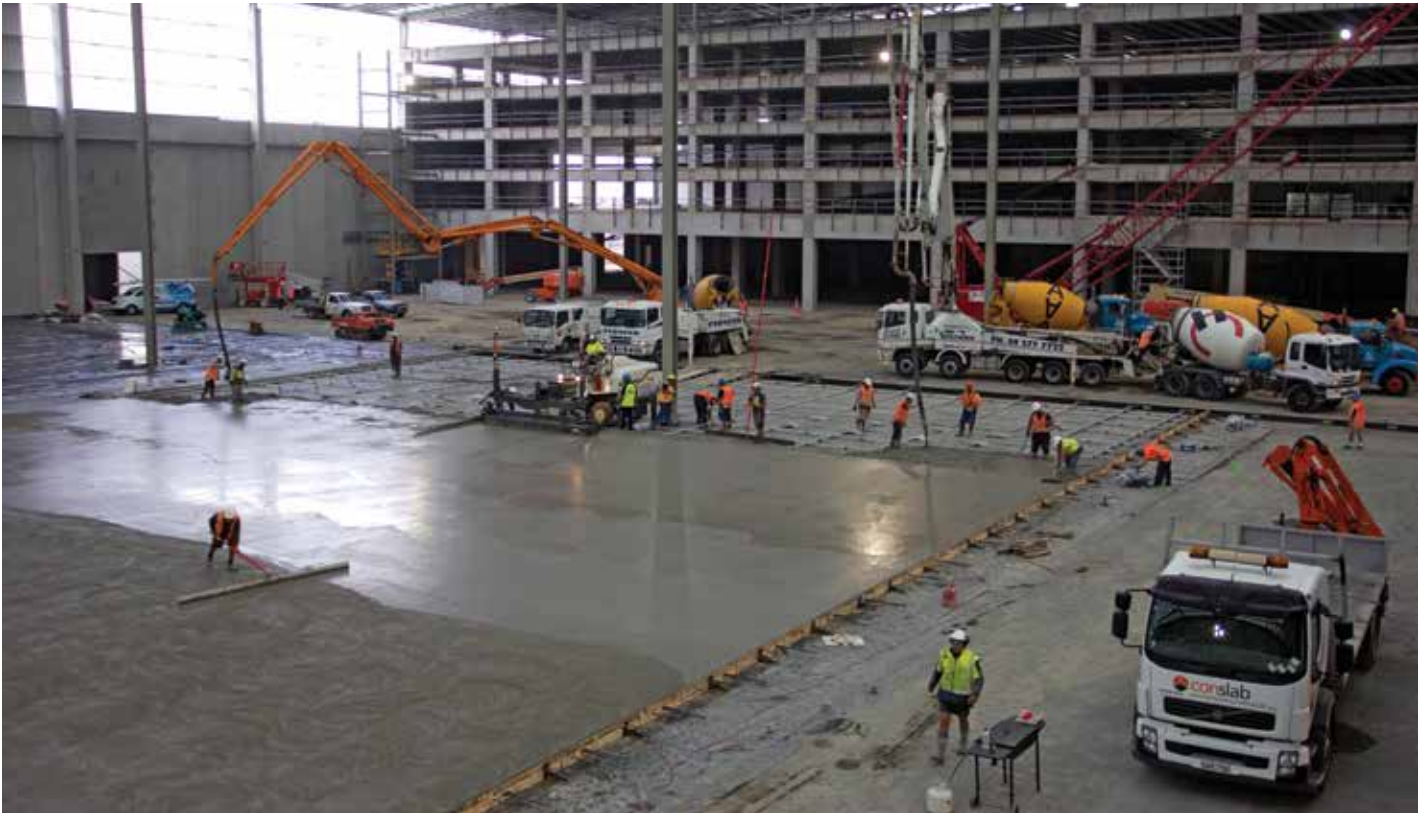
Fig. 8—Large bay post-tensioned floor pour at JPL.

The trade off of constructing the floor in large bays was that the finishing process could no longer be optimized to focus on individual VNA aisles. The benefit of the traditional approach of constructing VNA floors in long narrow strips is that the floor flatness can be controlled meticulously in the one location that really matters: the aisle. In contrast, when constructing using a large bay approach, the floor can achieve a very high overall

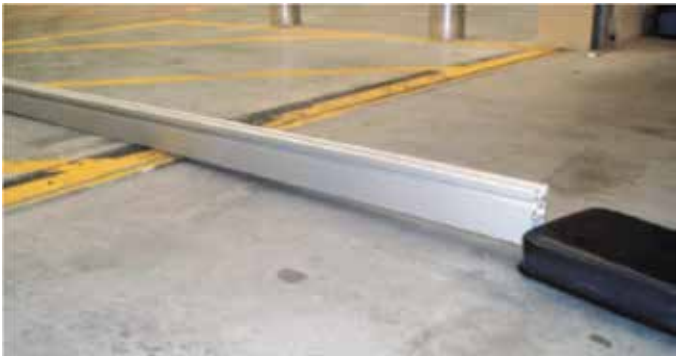
Fig. 9—Slab curl in a typical New Zealand floor.

For a facility such as the JPL distribution center, curl would be a significant issue—it would compromise the floor flatness required for the cutting edge VNA system and could present a significant maintenance burden over the lifetime of the building. To mitigate the issue of slab curl, the number of opening joints in the floor was minimized by using a PT floor design. The joints that were required were then installed in the lowest traffic areas possible, and a special New Zealand designed joint system called “Rhino Joint” was installed (Fig. 10). The Rhino joint

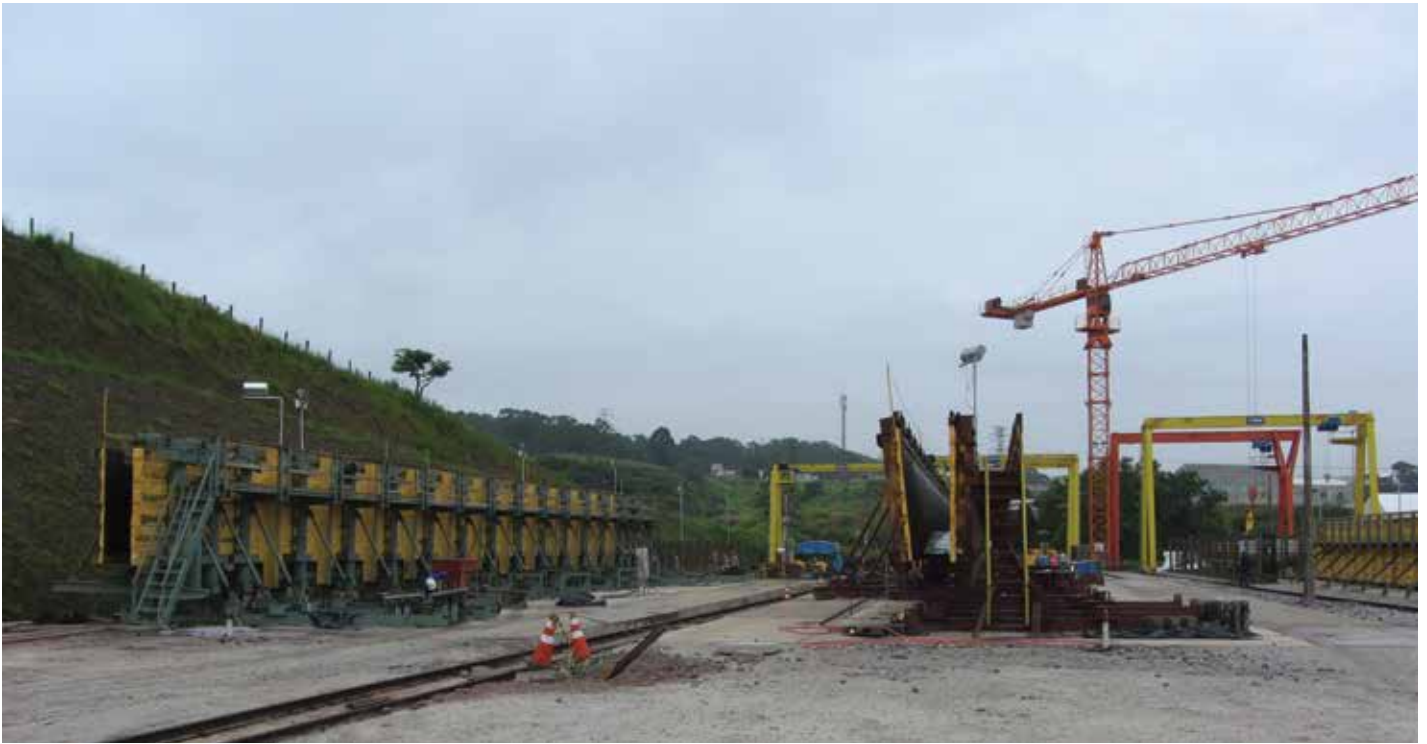
Fig. 7—Post-tensioned concrete beams in the casting yard.

One unique feature for monorail construction is that the precast beam is also the vehicle riding surface. There is no opportunity to correct any imperfections in the beams with a wearing surface or with a cast-in-place deck of any type. This requires precision during the casting of the guideway beams using specifically developed concrete

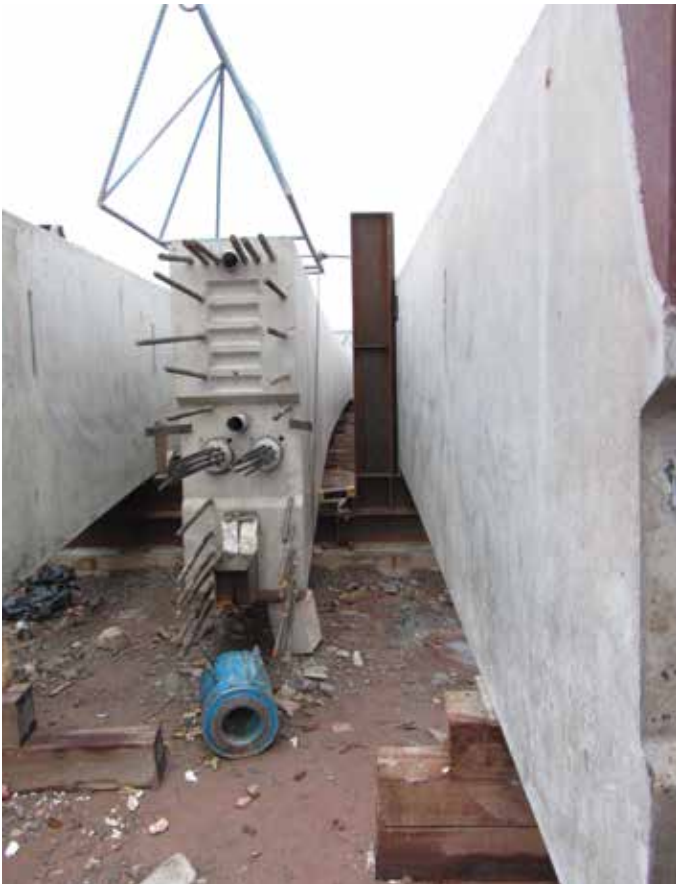
Fig. 8—Post-tensioned concrete beams at first stage stressing.

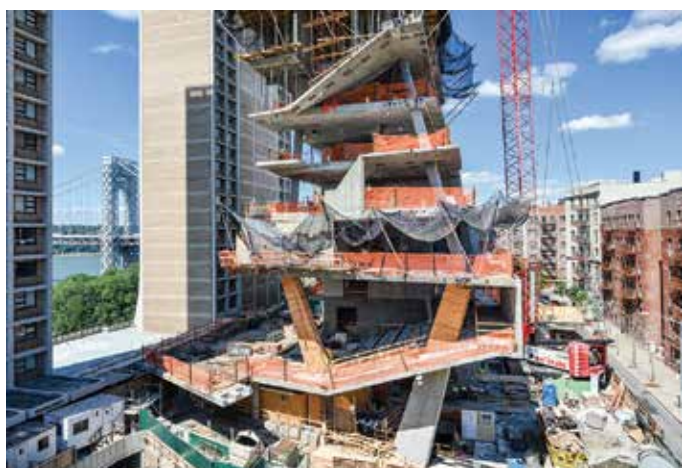
Fig. 2—Inclined columns from the foundation level up to the eighth floor.

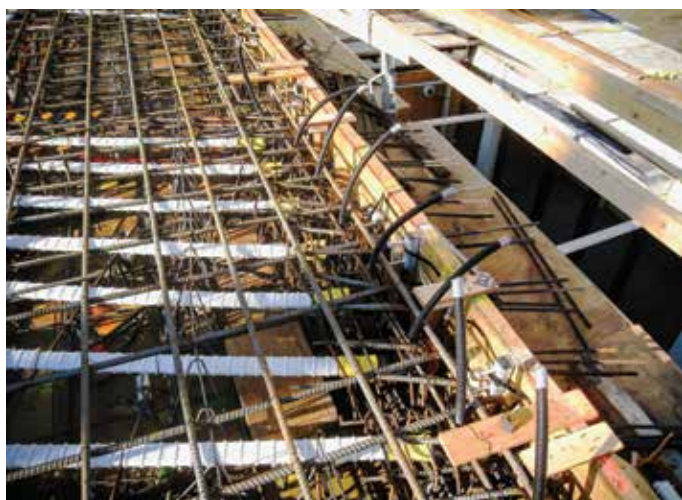
Fig. 3—Bonded post-tensioning system.

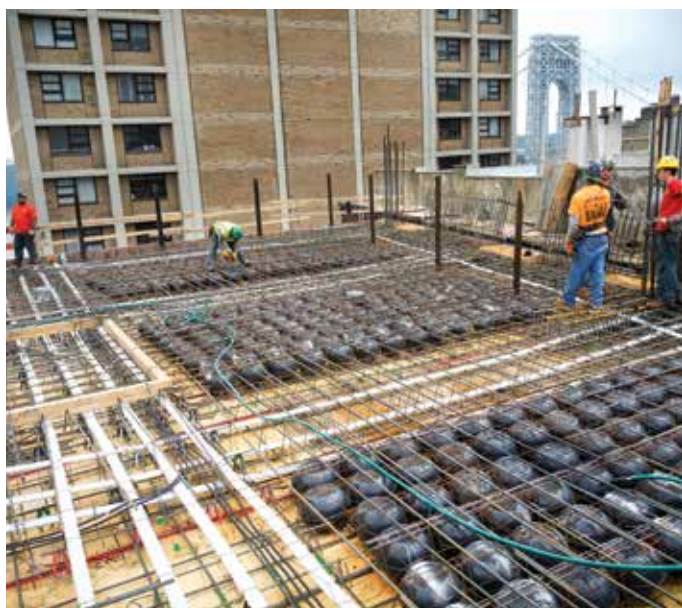
Fig. 4—PT and void formers.

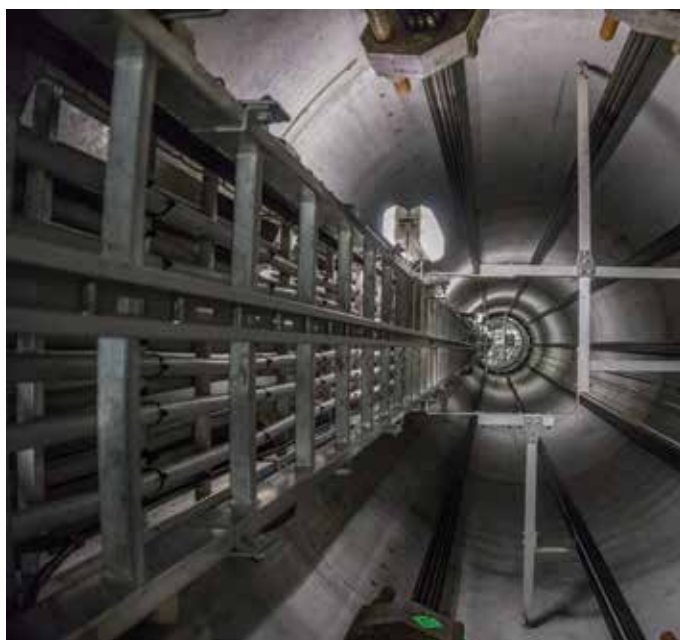
Fig. 7—Nineteen-strand external tendons around perimeter of tower.

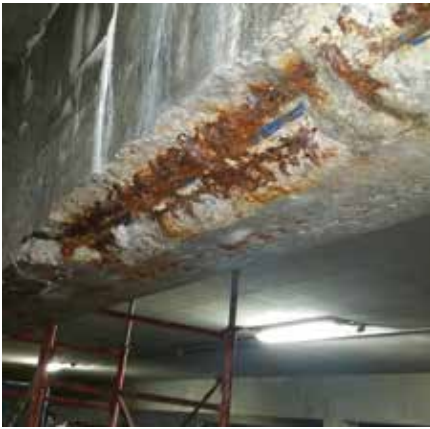
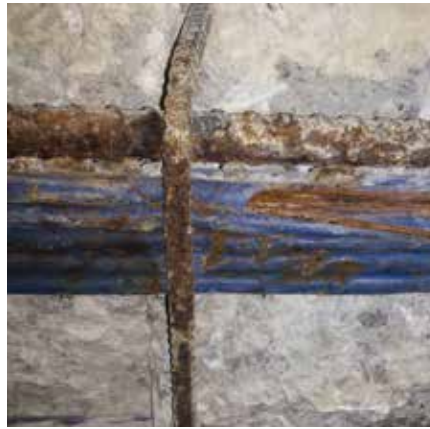
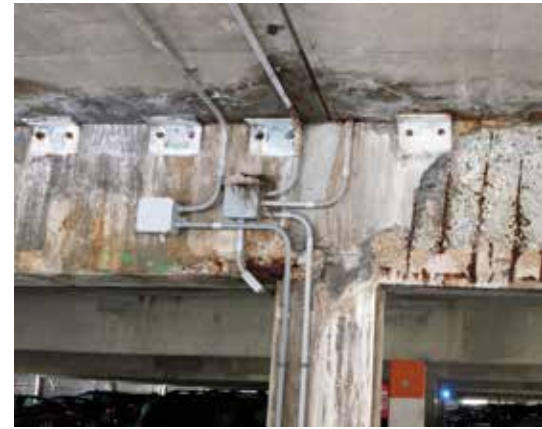
Fig. 2—Column line 15 before repairs.

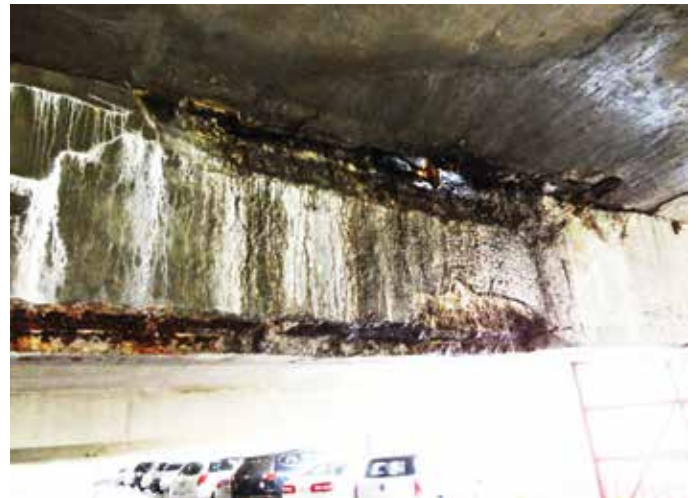
Fig. 3—Column line 9 before repair.

Phase 2 involved repairs to the PT beam and east PT slab located at the expansion joint on column line 9, which were both severely damaged due to water penetration and a failure to properly construct a sliding slab connection for the expansion joint to properly function. These repairs took place in two separate phases to allow continuous flow of traffic in the levels of the garage below. During demolition of the spalled beam concrete, it was discovered that five 0.5 in. (13 mm) diameter PT tendons were broken,

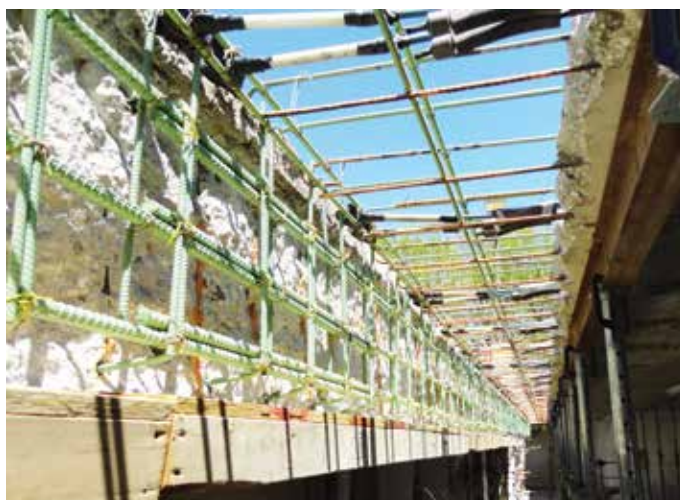
Fig. 5—Column line 15 new reinforcing bar and PT cables.

repair of the top deck ramp infill slab at column line 15 (Fig. 4 through 6), structural repairs to the PT beam below the top deck at column line 9 (Fig. 7 through 11), partial-depth and full-depth concrete repairs throughout the top deck (Fig. 12 and 13), repair of damaged/broken PT cables within the top deck slab, and the installation of new watertight expansion joint at column line 9. After the top deck was structurally restored to satisfy all code-required live and dead loads, an epoxy leveling coat was installed to provide a structurally sound and level surface capable of supporting a traffic-bearing waterproofing membrane that had a service life of 10 years (Fig. 14). Deck drains were added at all areas experiencing ponding water to immediately remove all surface water from the top deck, which will help prevent ice buildup during winter storms. These repairs would ensure continued use of the parking structure and more importantly prevent further damage to structural elements on the lower levels of this facility until additional phases of repair could take place.

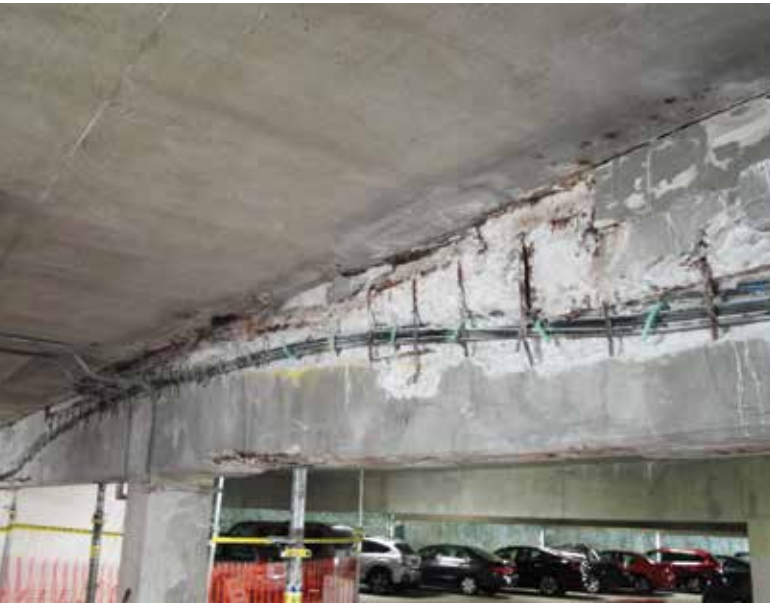
Fig. 7—Column line 9 new 0.6 in. PT cable.

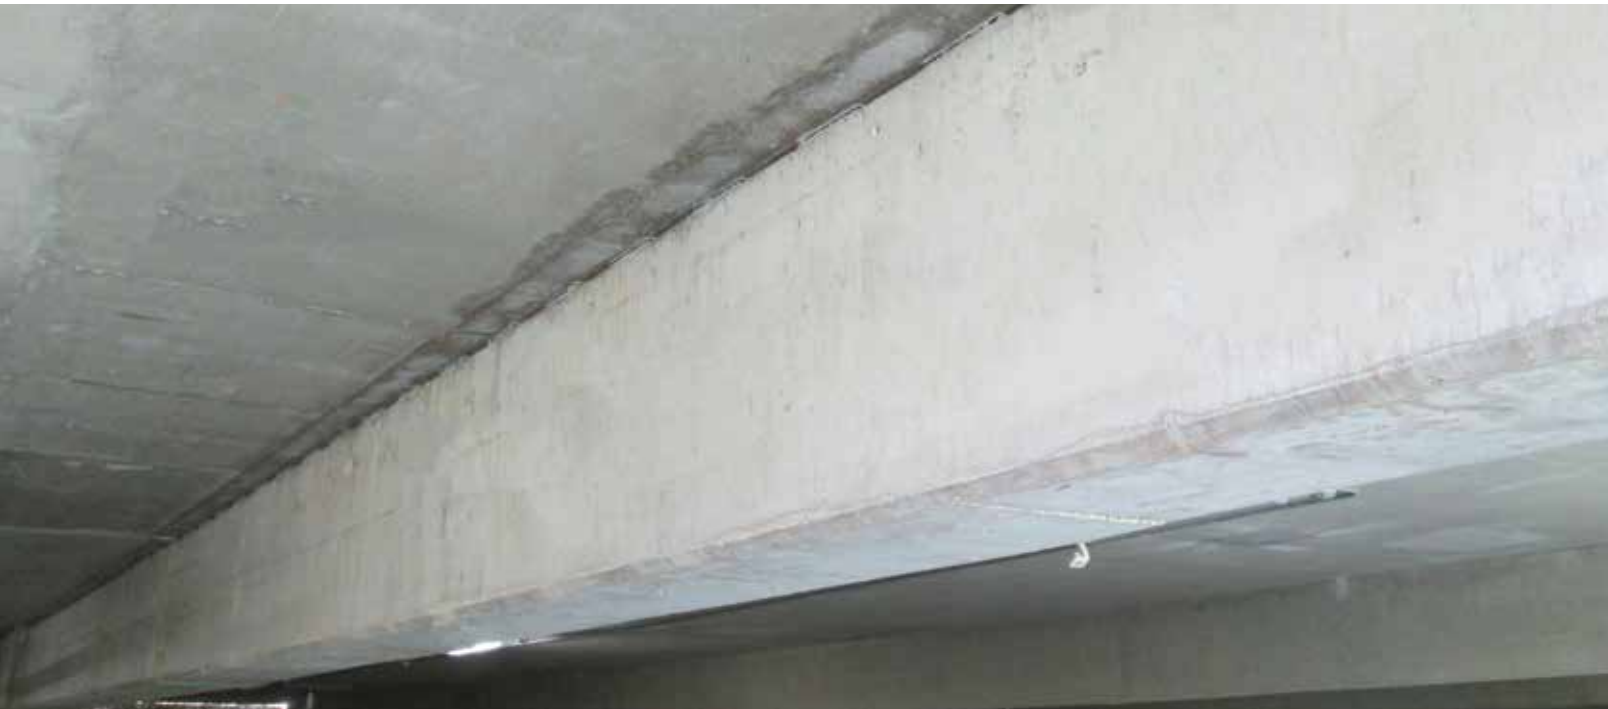
Fig. 11—Column line 9 finished repair.

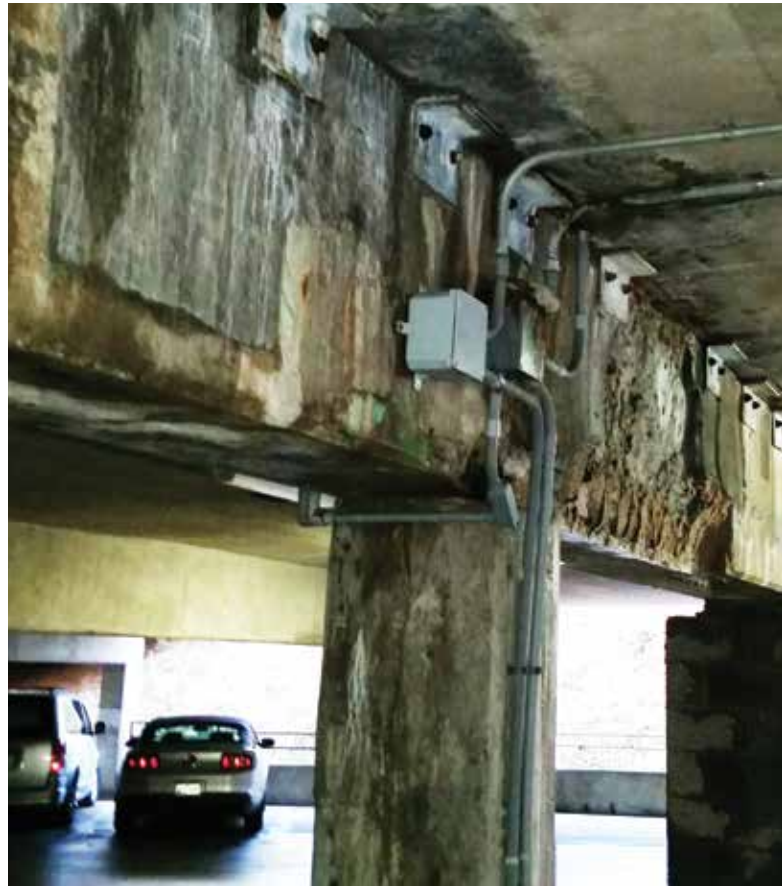
Fig. 15—Before repair, metal angles supporting slab.

Phase 1 was to make repairs to the post-tensioned support beam that supports the former access ramp PT infill slab at column line 15. The existing support was several steel angles, which had become severely rusted and

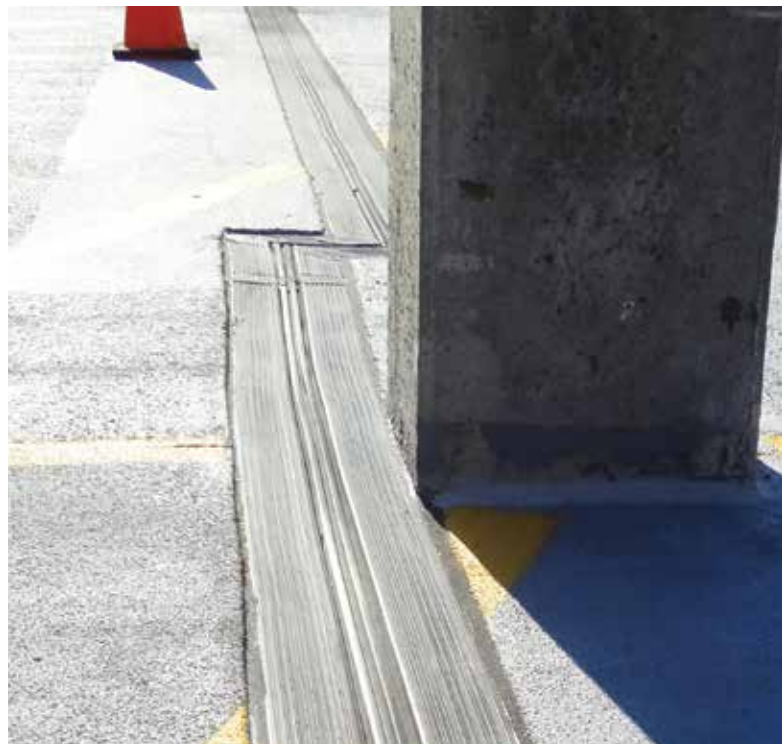
Fig. 16—Column Line 9 new expansion joint and coating.

thermal and moisture/volume changes at the expansion joint, it was necessary for the contractor to install a new sliding assembly consisting of a PTFE pad and stainless steel plate under the existing east slab, which required a one-weekend shutdown of the garage to complete the installation. This installation process required that the east slab be shored for two garage levels. A hydraulic jack assembly was developed that lifted the slab approx-

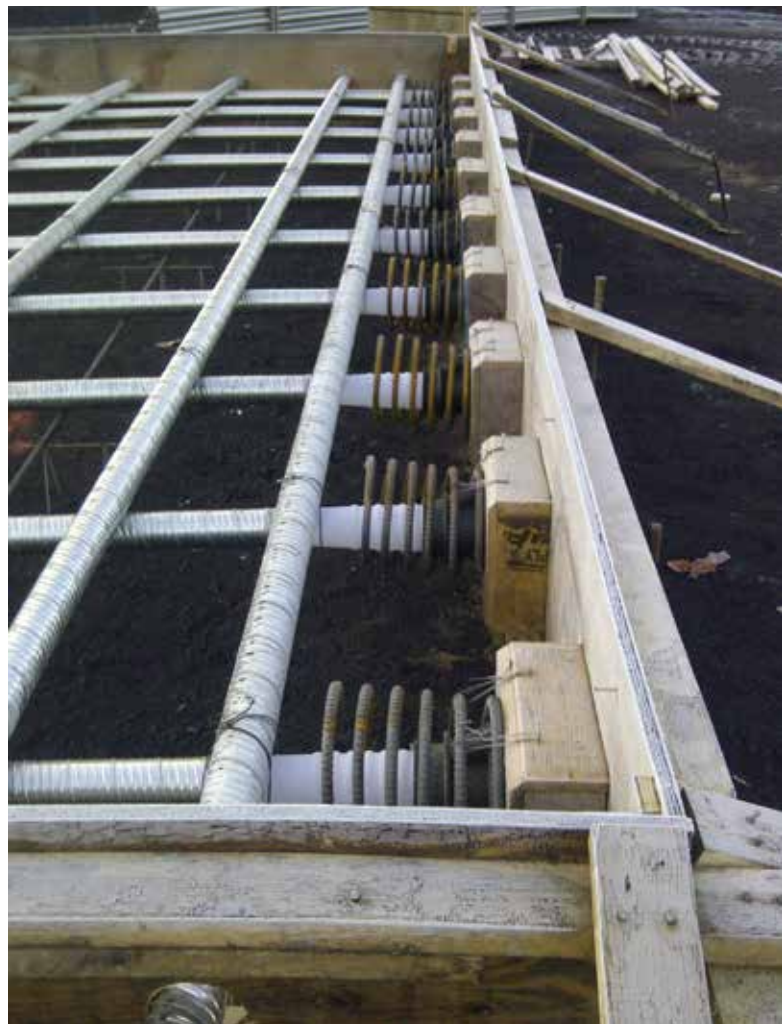
Fig. 3—Bonded PT anchorages.
