## 2017 PROJECT OF THE YEAR: THE RITZ-CARLTON RESIDENCES WAIKIKI BEACH, PHASE 1

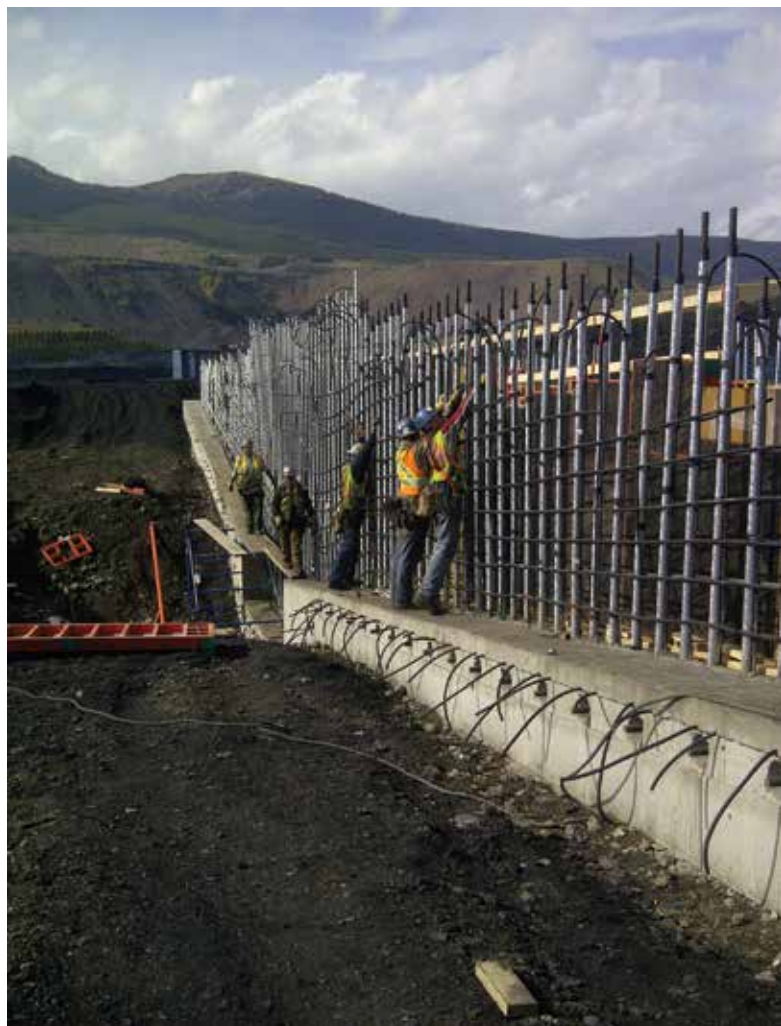
Fig. 6—Walls of tank with vertical PT bars and horizontal encapsulated unbonded tendons.

in the longitudinal direction because of the ability to follow the base contour. Stressing bars of 1.4 in. (36 mm) diameter were used transversely across the base and for the vertical walls of the tank due to the ability to be both self-standing and to be accurately tensioned over short lengths. Horizontally, the walls were post-tensioned using 0.6 in. (15 mm) fully encapsulated unbonded mono-strand tendons placed in pairs, one on each side of the vertical 1.4 in. (36 mm bars) (Fig. 6). All post-tensioned elements were grouted following the tensioning operation except for the encapsulated unbonded tendons. All walls and the tank base are a nominal 23.6 in. (600 mm) in thickness for simplicity and water retention requirements. The average compression from post-tensioning is equal in all three axes of the tank. The entire tank is equally supported on the compacted tailings and is fully integrated with the raft slab (Fig. 7).

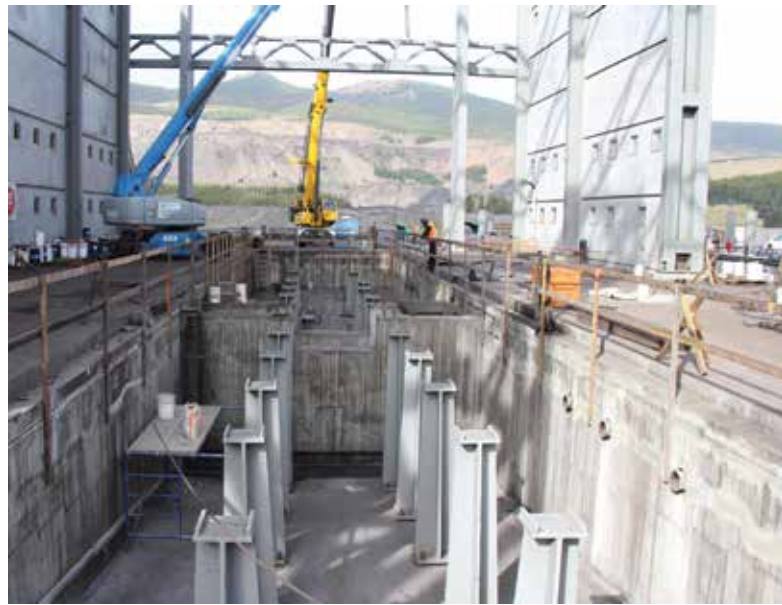
Fig. 7—Tank fully integrated with raft slab.
