Material and Corrosion Evaluation of Deficient PT Grout with Enhanced Sulfate Concentrations

**Krishna Vigneshwaran.K.K,
Samanbar Permeh and Kingsley Lau**

Florida International University , Department of Civil and Environmental Engineering,
Ivan Lasa

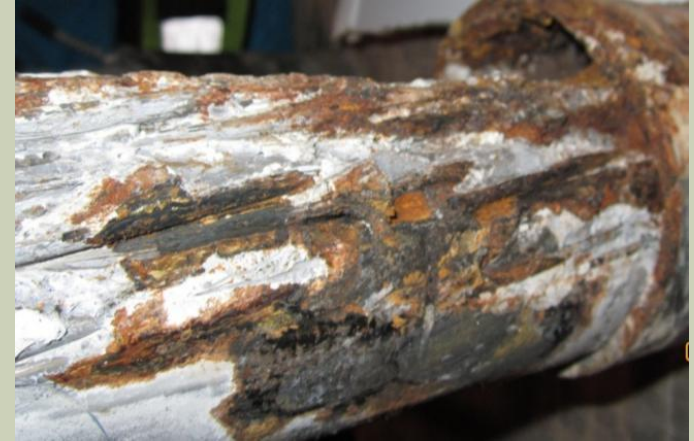
photo courtesy of FDOT

- Corrosion failures of post-tensioned tendons in a Florida bridge utilizing pre-packaged thixotropic grout products were recently documented.
- Localized occurrences of severe corrosion of the steel strand was not always consistent with the presence of voids .
- Severe corrosion were well associated with the deficient grout .
- Deficient grout characterized as having poor cohesive bulk properties, high moisture content and enhanced sulfate ion concentrations in the pore solution.
- Limited information is available on the corrosion behavior of PT strand in grout materials with enhanced sulfate content.
- Uniform description of corrosion activation processes of steel in relevant grout environments is needed.

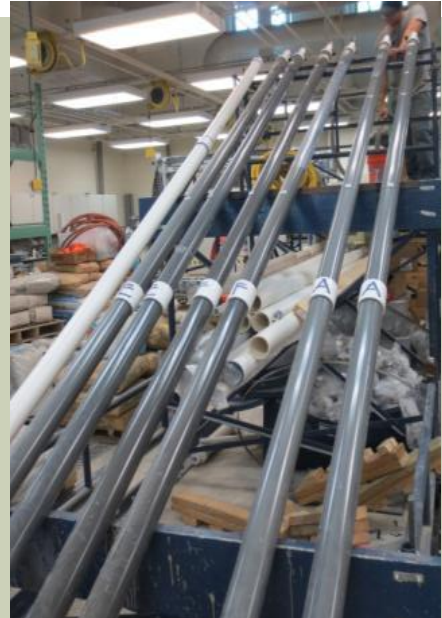
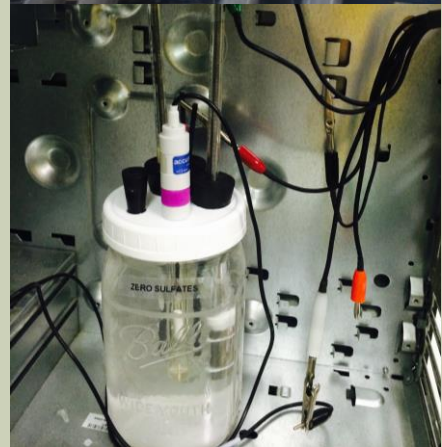
Grout segregation

- Varied levels of grout segregation due to improper mixing conditions, pre-exposure of grout, and sample geometry.

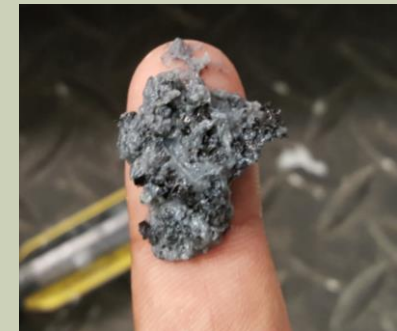
Expired grout condition-Mock up
Tendons (15 % excess water)

- 15' long tendon mockups cast at 30° incline
- Expired grout and 15% excess mix water
- Sulfate additions (0 ppm, 20,000 ppm, 150,000 ppm Na_2SO_4)
- 0.08% , 0.2 % chlorides by cement weight.

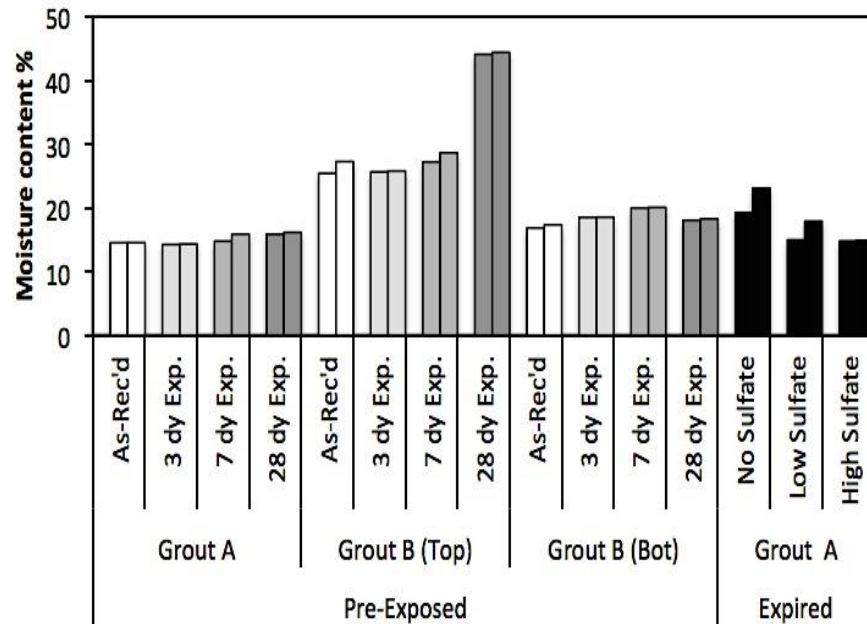
MOISTURE AND VOID CONTENT

- The segregated top portion of cast samples from Grout B showed higher moisture content and void content.
- In expired grout samples, the grout cast with enhanced sulfate concentrations in its mix water showed lower moisture and void content.

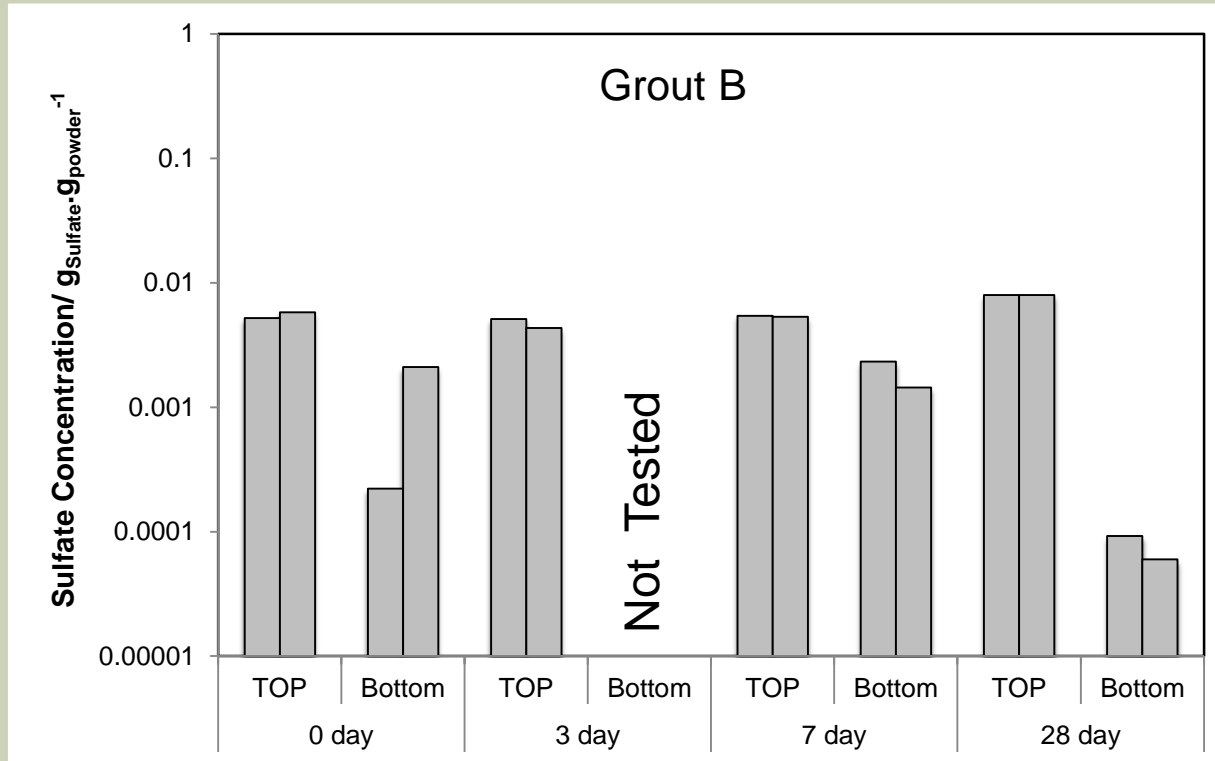
RESULTS: SULFATE CONTENT (PRE-EXPOSED - GROUT B)

- Enhance sulfate concentration in segregated grout.
- The top segregated portion showed enhanced sulfate level concentrations.

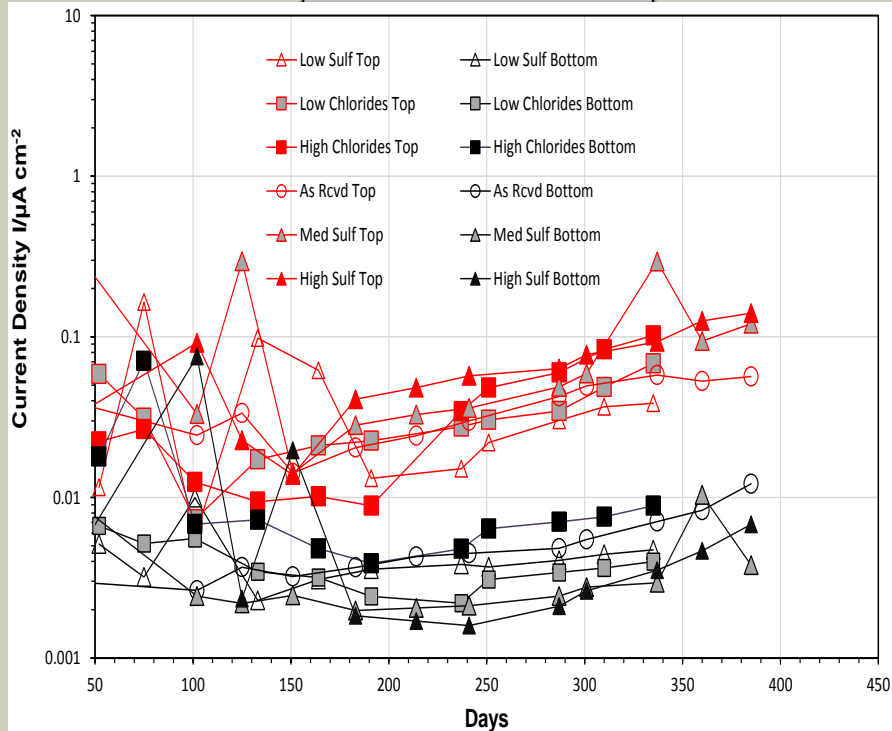
Current Density

- Potentials indicative of possible active corrosion in top portion of tendon with both enhanced sulfates and chlorides .
- Active corrosion also apparent for steel with crevice including control condition.

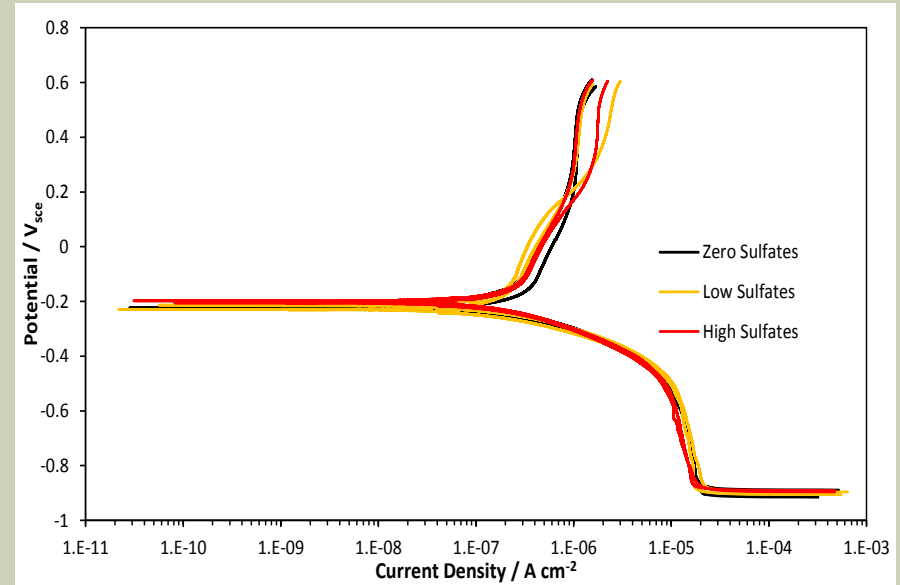
Corrosion Behavior in Sulfate Concentration(Room Temperature)

- Indication of Passive-like behavior for all test scenarios
- Increase in passive current for the steel in sulfate solution was greater which may indicate some adverse role of sulfate.
- Initial tests in the conditions described do not show strong capacity for sulfates to disrupt passive film formation.
- ❖ Further testing on the role of higher sulfate concentrations ,lower pH and other parameters in crevice environments are in progress.

- Anodic polarization tests of steel in pH 13 and 20,000 ppm sulfate solution with preconditioning to large negative polarization (-1,000mVSCE) do not indicate strong tendency to disrupt passive film formation.

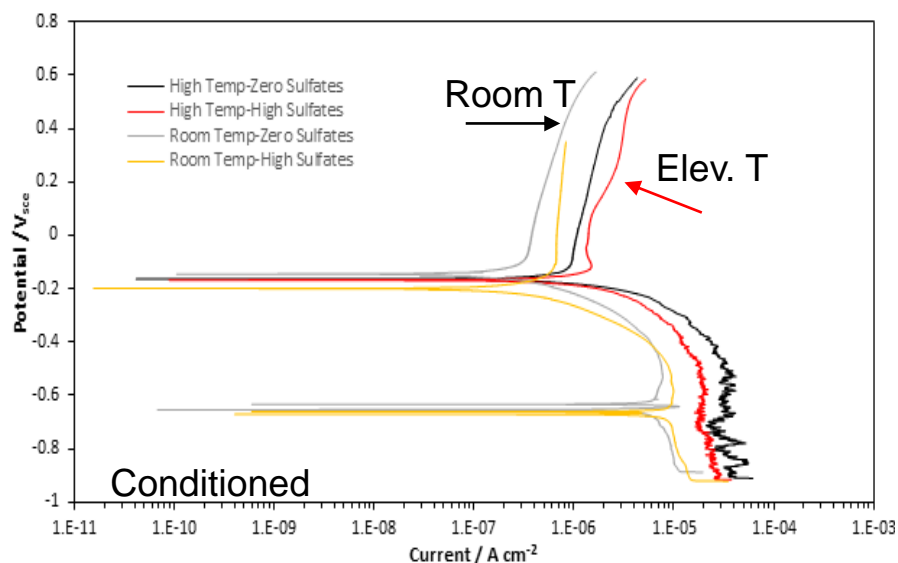
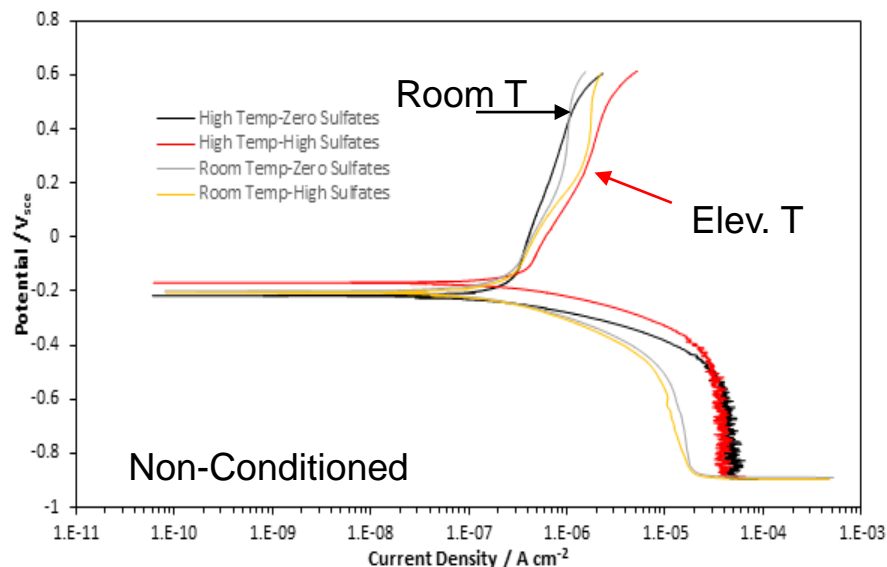
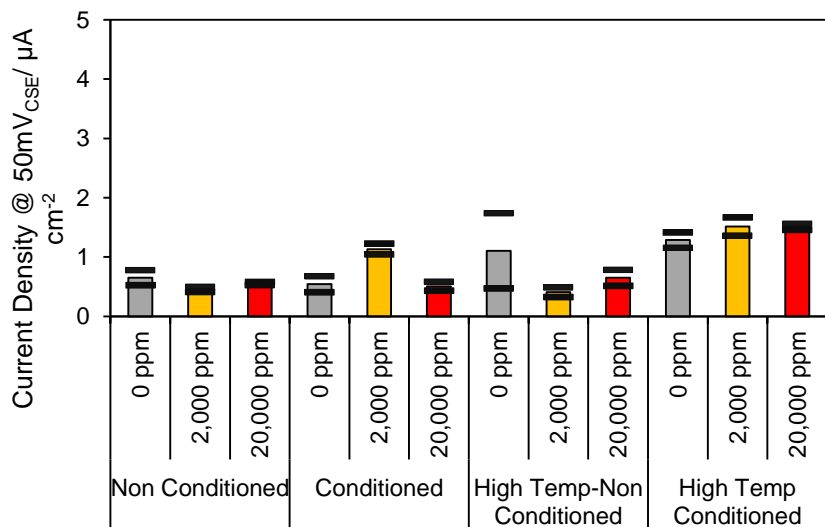
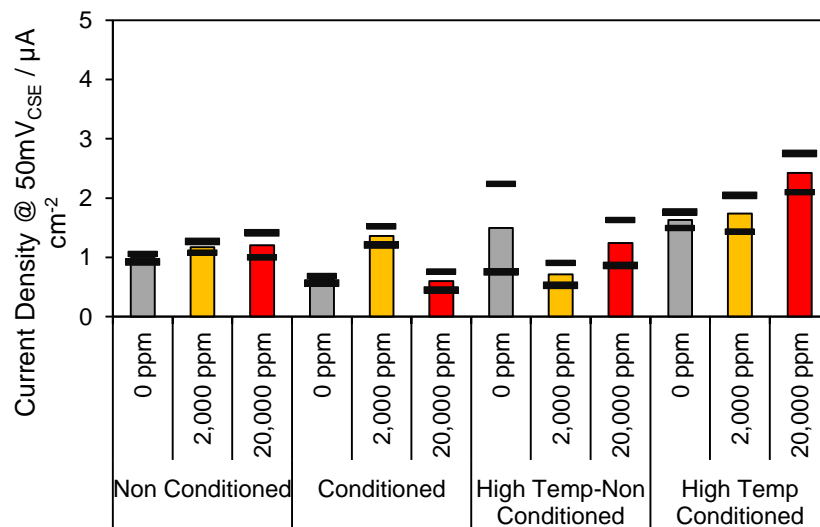
Corrosion Behavior In Sulfate Solution (Elevated Temperature)

- Greater corrosion activity in elevated temperature as expected.
- Enhanced corrosion activity with cathodic pre-conditioning (early passive film destabil.)
- Generally larger passive-like currents in sulfate solutions.

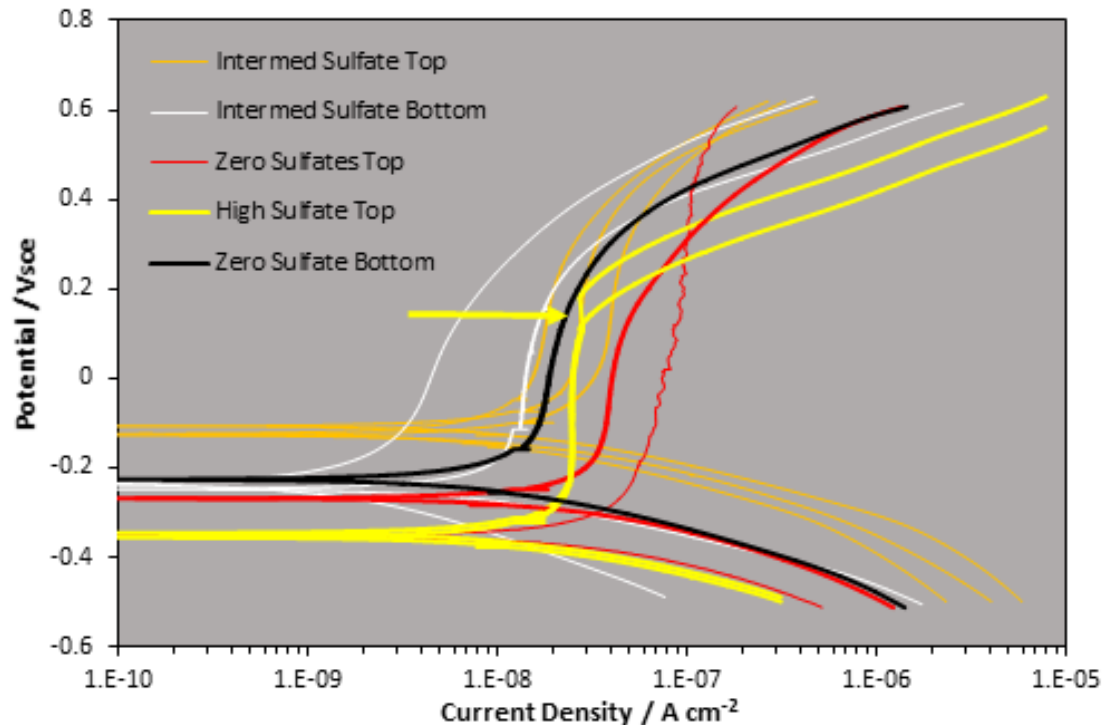
Anodic Characterization of steel in Mock-up Tendons

- Steel in top portion of mock-up tendon showed greater corrosion conditions than at bottom in steady-state condition, as expected.
- Indication of passive film development. Larger passive currents in higher admixed sulfate conditions.
- However, breakdown of passive-like conditions in high admixed sulfate conditions.
- ❖ Indication of possible role of sulfates in steel corrosion initiation. Severe corrosion occurred for steel in alkaline grout conditions with enhanced sulfate content. Sulfates were thought to be related to localized corrosion process by reaction such as :

- Anodic polarization tests in mock-up tendons with enhanced sulfate concentrations showed propensity of development of passive film breakdown. Further testing in progress for verification and to resolve inconsistency observed in sulfate solutions.
