Sulfate Limits for Corrosion of Steel Strand in Deficient Grout

2016 PTI Convention, Long Beach, California

Krishna Vigneshwaran.K.K,
Samanbar Permeh and Kingsley Lau
Florida International University, Miami, Florida

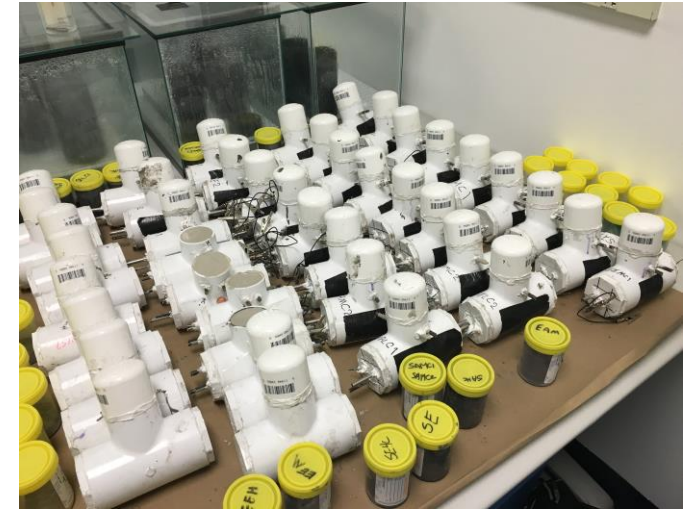
Inverted Tee Test– (INT)

- Cast in (2×2×1½" Ø, 4 ¾" length) PVC tees
- Tee was expected to facilitate volume displacement of deficient grout to the top
- Raw grout product were kept in 100% relative humidity for one month
- 20% excess water than recommended
- Control case mix as recommended

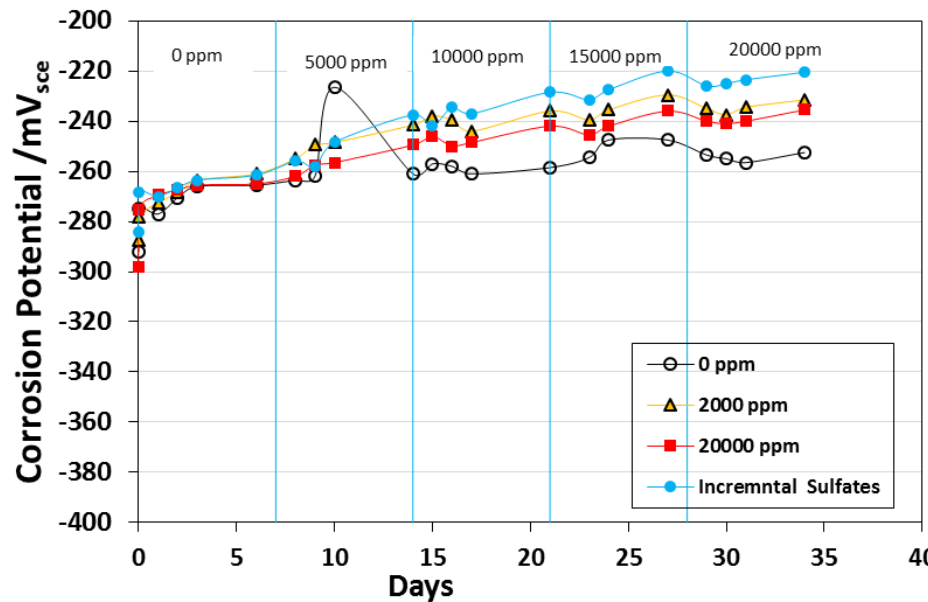
Corrosion Potential

- Passive like potentials in all test conditions in 13.3 pH.
- The corrosion current density was low (approx. $< 0.01 \text{ mA/cm}^2$)
- Levels of sulfates showed mild effect on increasing the potentials more noble than in control case.
- No corrosion activity measured for samples with incrementally added sulfates as high as 20,000 ppm sodium sulfates

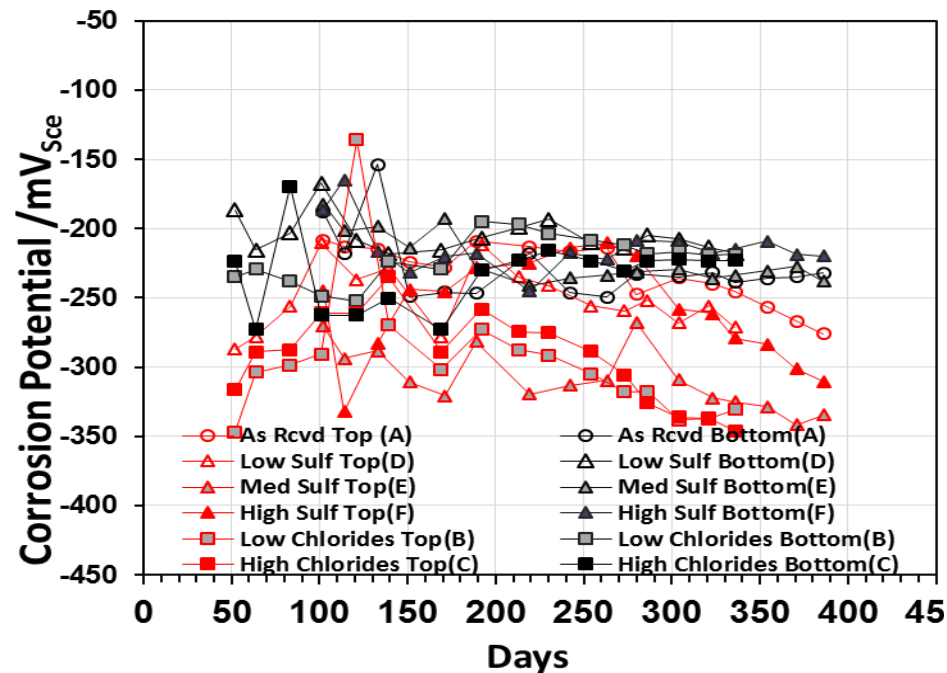
Corrosion Potential

- Corrosion potentials ($\sim < -300\text{mV}_{\text{SCE}}$) and current density ($\sim 0.1 \text{ mA}/\text{cm}^2$) indicative of greater corrosion activity in top portion of all tendon including zero admixed sulfate condition.
- Greater corrosion activity for steel at the top portion of tendon where deficient grout is found.

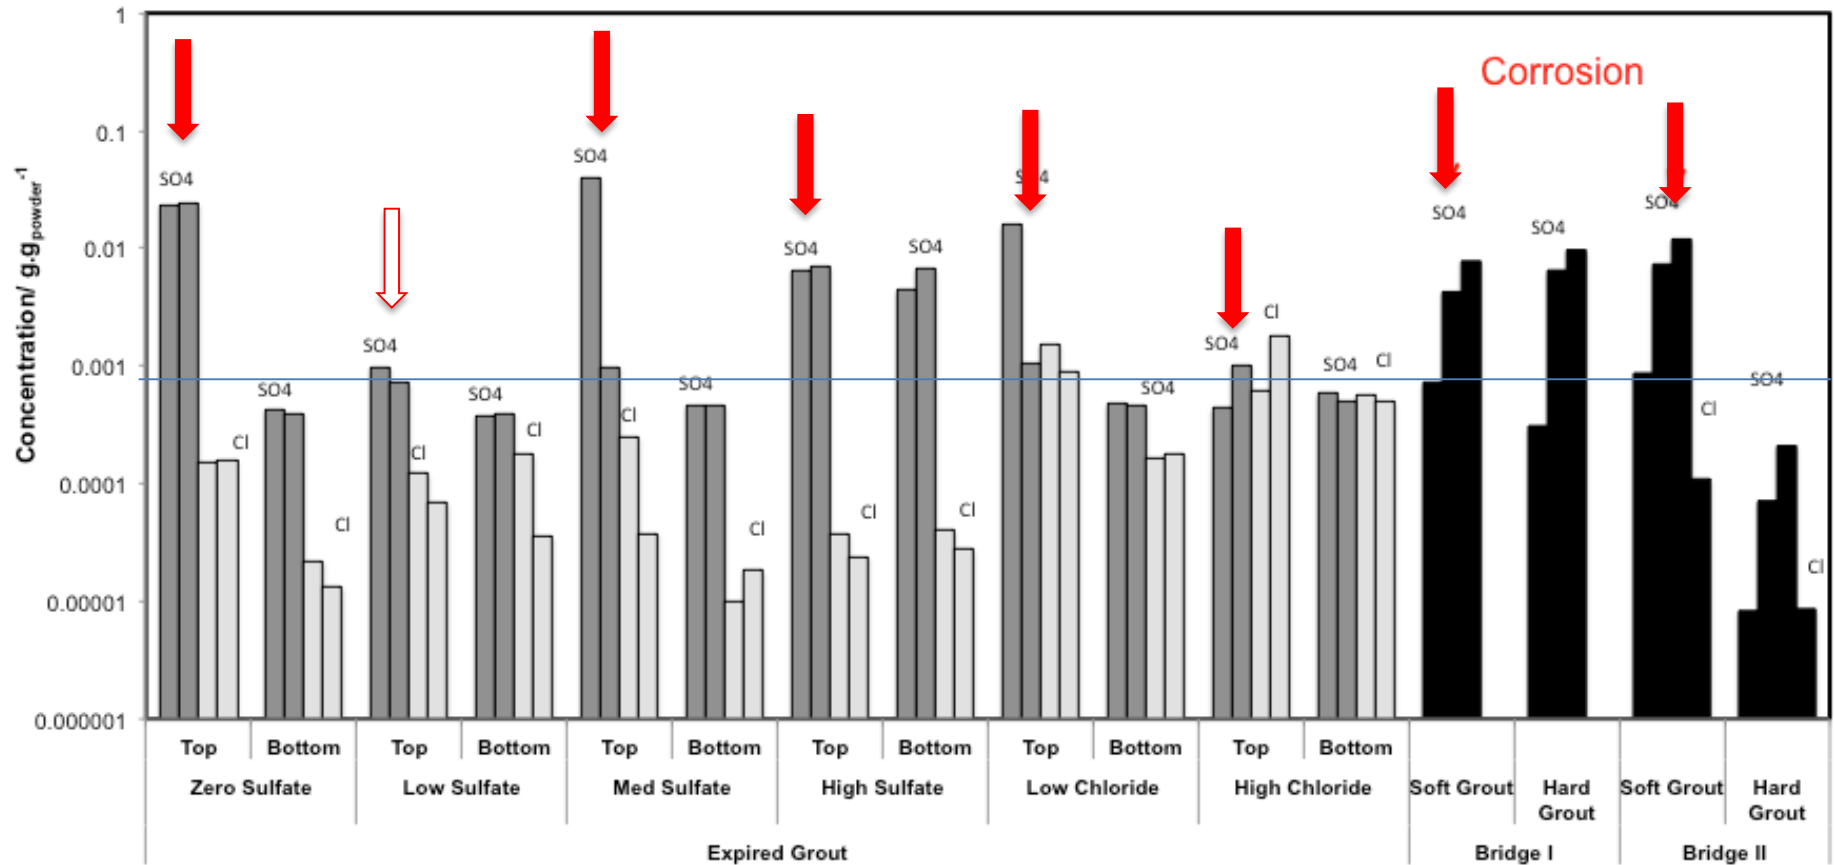
Sulfate Content in Modified Inclined Tube

- The test results indicate the top part of the tendons tend to have higher levels of sulfate concentrations.
- In comparison to the resolved sulfate content measured in grout from Bridge I and II, it is seen that separation of grout material can allow for accumulation of sulfate ions without external sulfate sources.

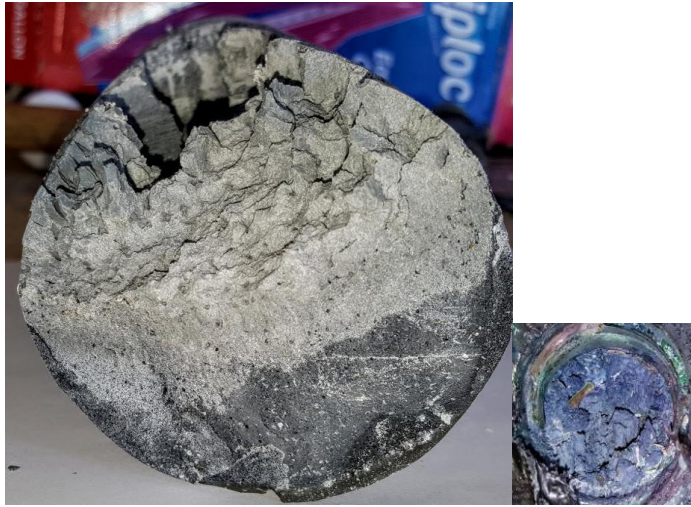
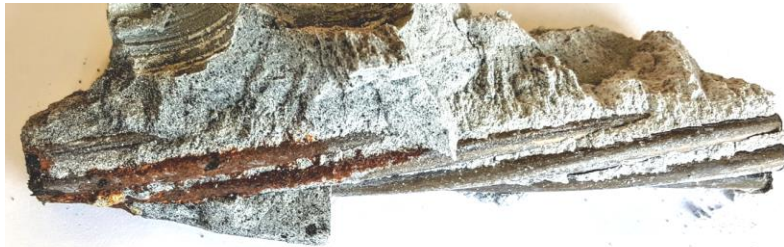
Corrosion in Modified Inclined Tube Test (MIT)

- Steel corrosion only observed in deficient grout.
- Deficient grout localized only at high elevations.
- pH of grout ranged from 11 to 13 (pH indicator)
- Corrosion of steel in deficient grout with ~ 0.0004 to $0.04 \text{ g}_{\text{sulfate}}/\text{g}_{\text{powder}}$ (typ $>0.0007\text{g/g}$)
- Similar values to steel corrosion in deficient grout in bridges ~ 0.0007 to $0.012 \text{ g}_{\text{sulfate}}/\text{g}_{\text{powder}}$

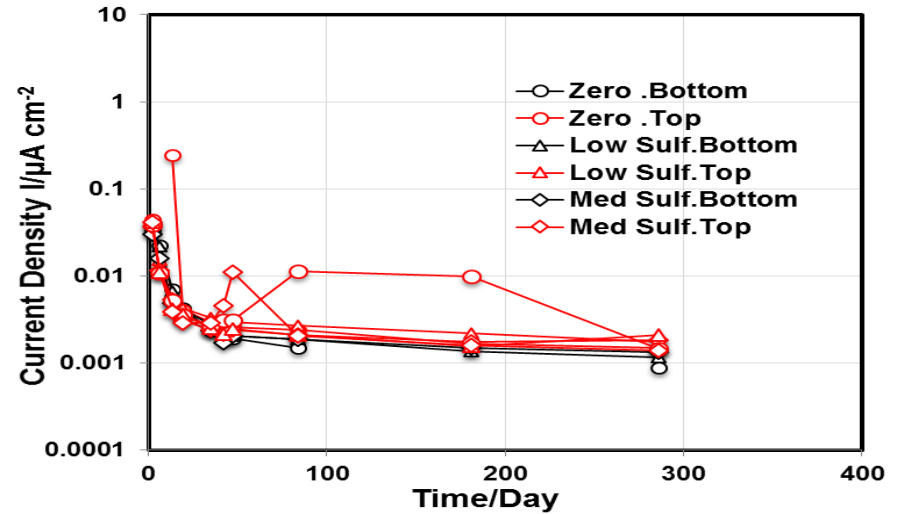
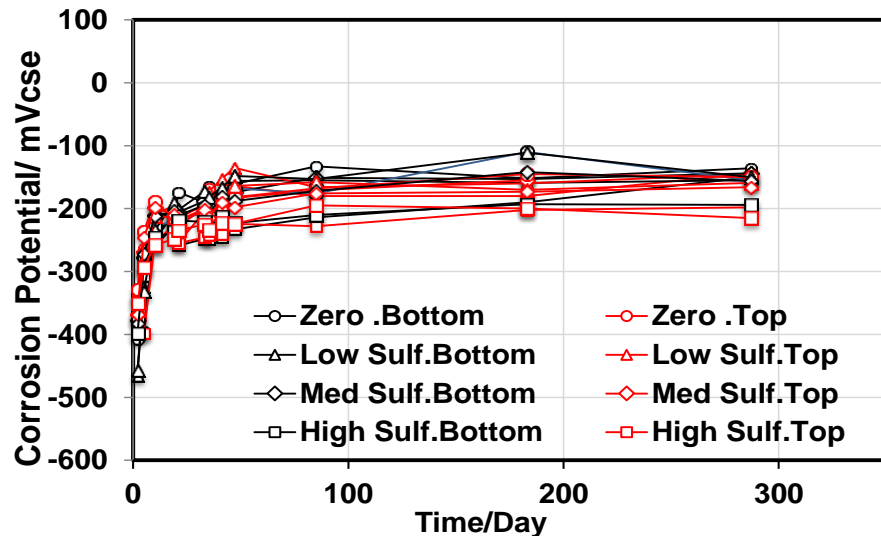
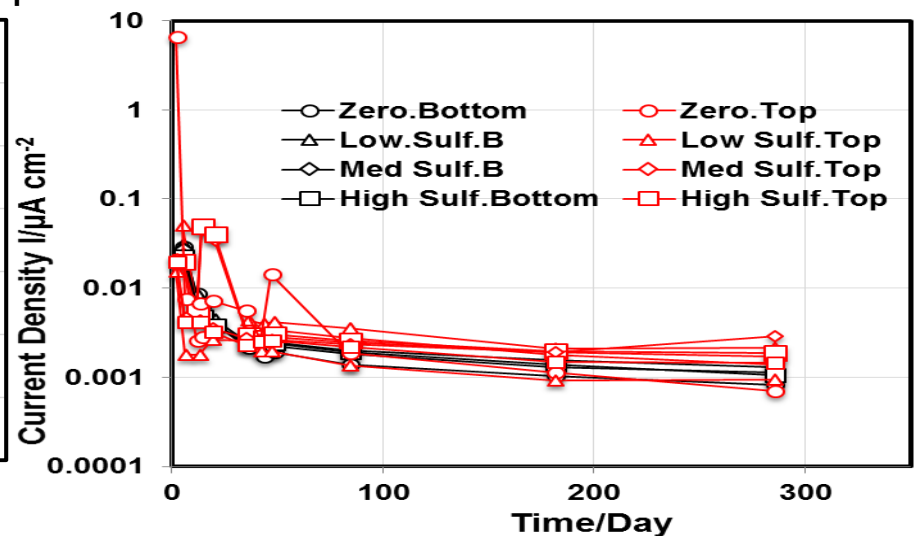
- Steel samples in Grout B did not exhibit active corrosion behavior in all test conditions.

(Low Sulf: 2,000ppm /Med Sulf: 20,000ppm/High Sulf: 100,000 ppm)

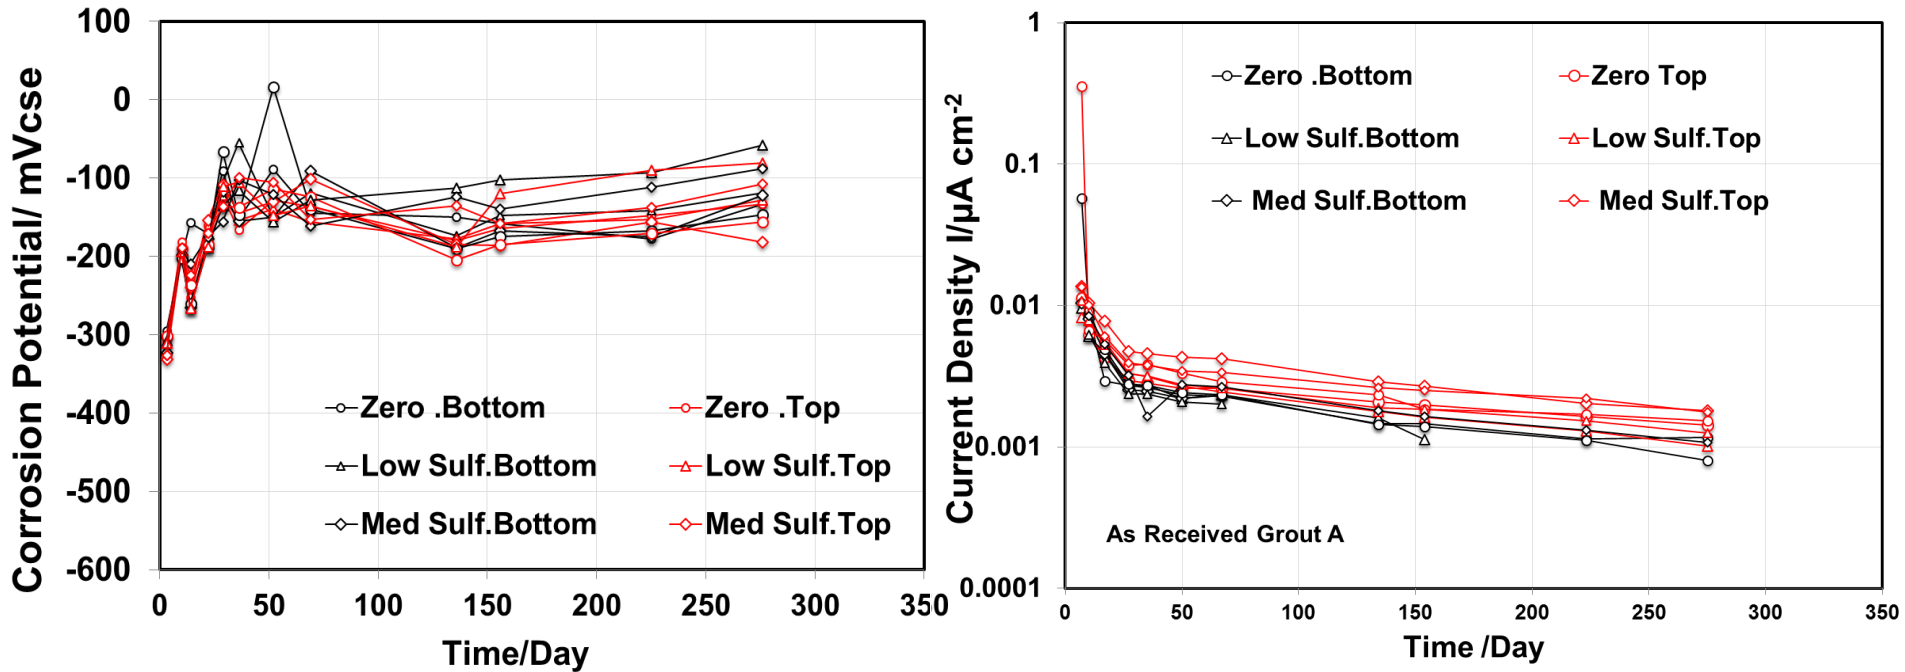
Grout A (As Received)

- Steel samples in Grout A did not exhibit active corrosion behavior in as-rec'd test conditions.
- Sulfate level in tee header $< 0.00052 \frac{\text{g}_{\text{sulfate}}}{\text{g}_{\text{powder}}}$

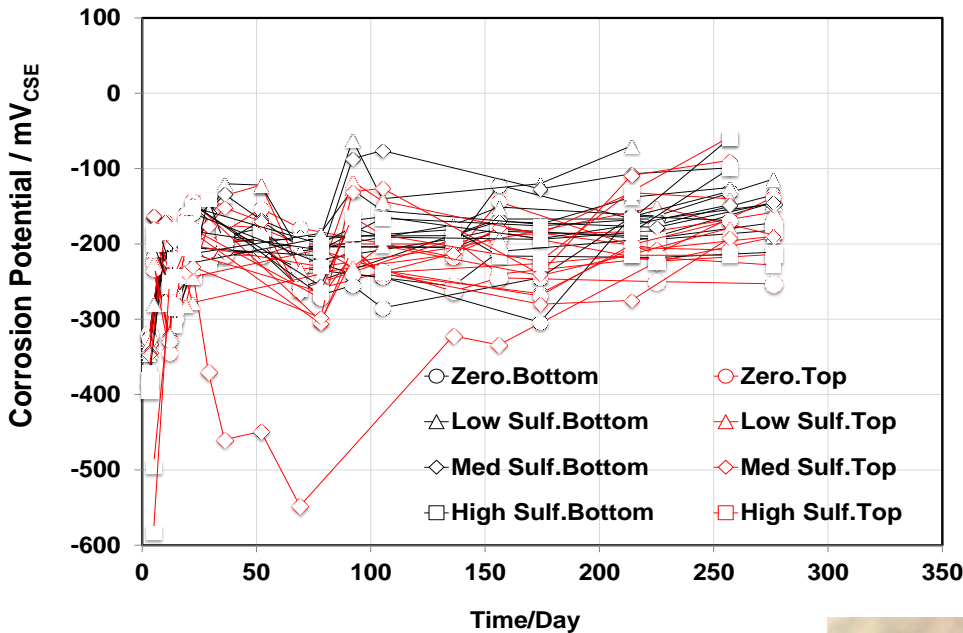
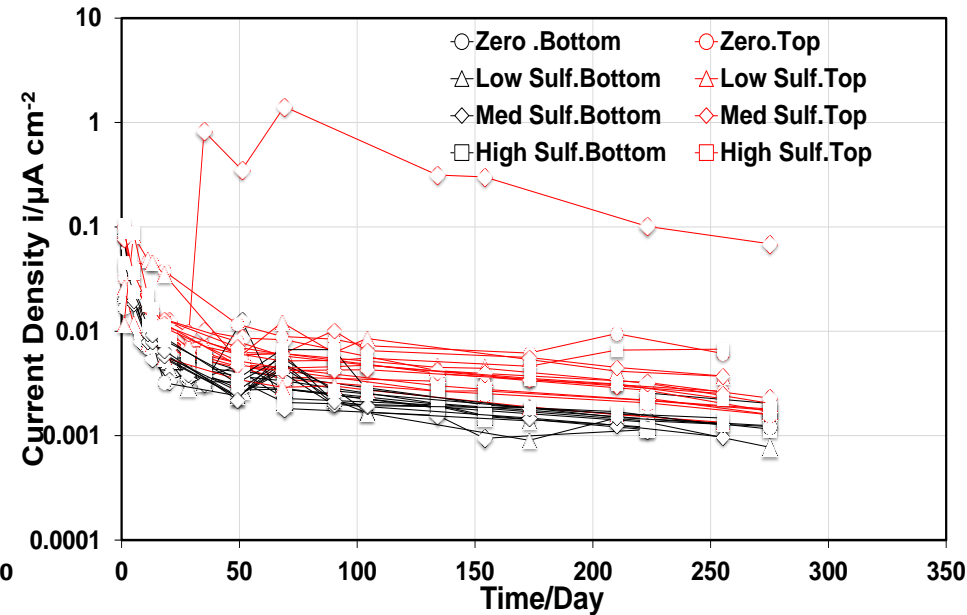
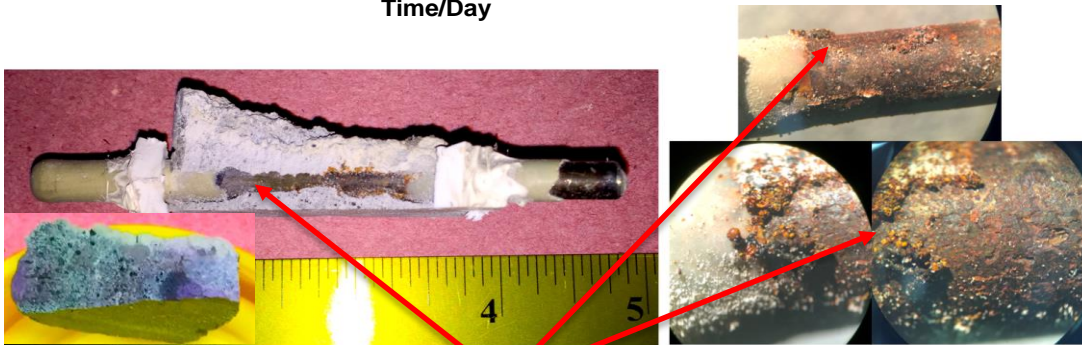
Admixed Sulfates

- Corrosion of steel in deficient grout observed ($i > 0.1 \mu\text{A/cm}^2$)
- Deficient grout in tee header
- Corrosion of steel in tee header with $> 0.0164 \text{ g}_{\text{sulfate}} / \text{g}_{\text{powder}}$

□ INT and MIT test methods can promote grout segregation and differentiate grout robustness to adverse mix conditions and identify corrosion activity

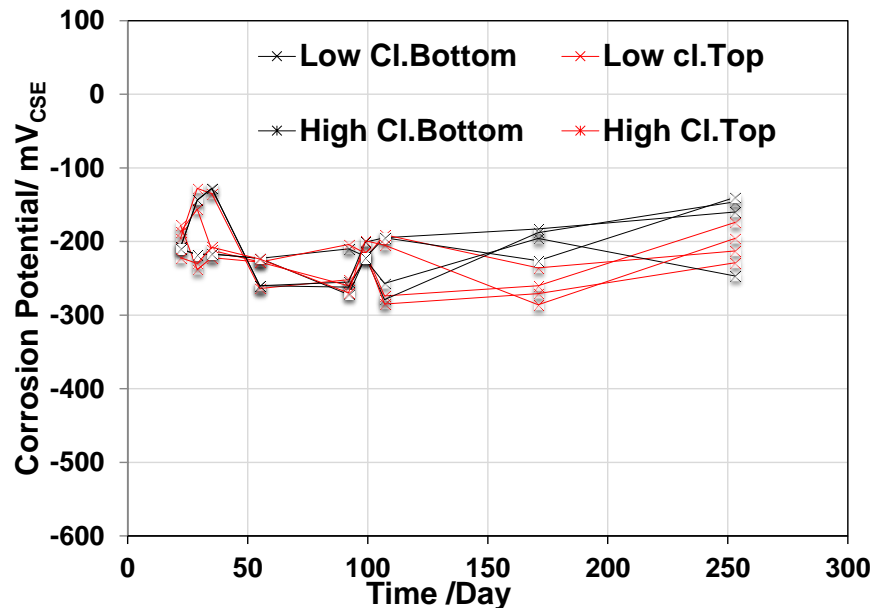
Corrosion Potential

- No indication of corrosion development in presence of admixed chlorides up to 0.2%.
- The physical consistency of the grout in the tee header for these samples was not the wet and highly friable material characteristic of corrosive deficient grout observed elsewhere

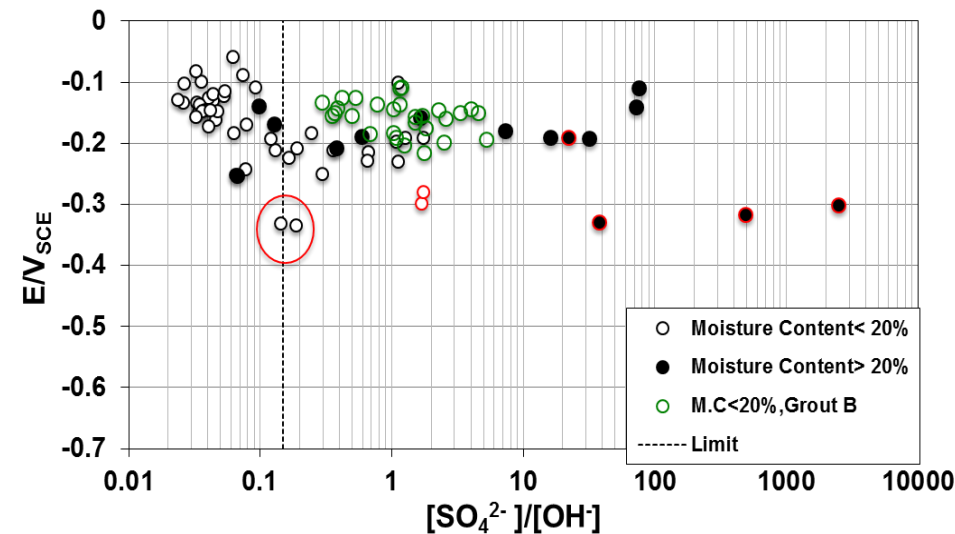
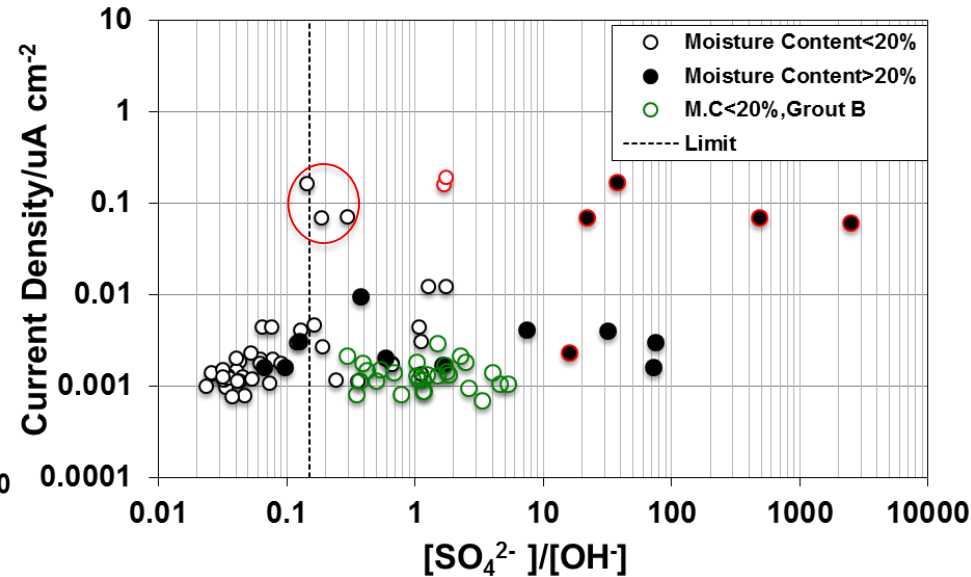
Recommendations for Sulfate Threshold Limits

- Changes in pore water chemistry can affect the corrosion initiation in the presence of sulfate ions.
- Conservative threshold limit based on active corrosion conditions ($E_{corr} < -300 \text{ mV}_{SCE}$ and $i_{corr} > 0.1 \text{ mA/cm}^2$)
- $[SO_4^{2-}]/[OH^-] = 0.15$ may be considered as a conservative limit.**

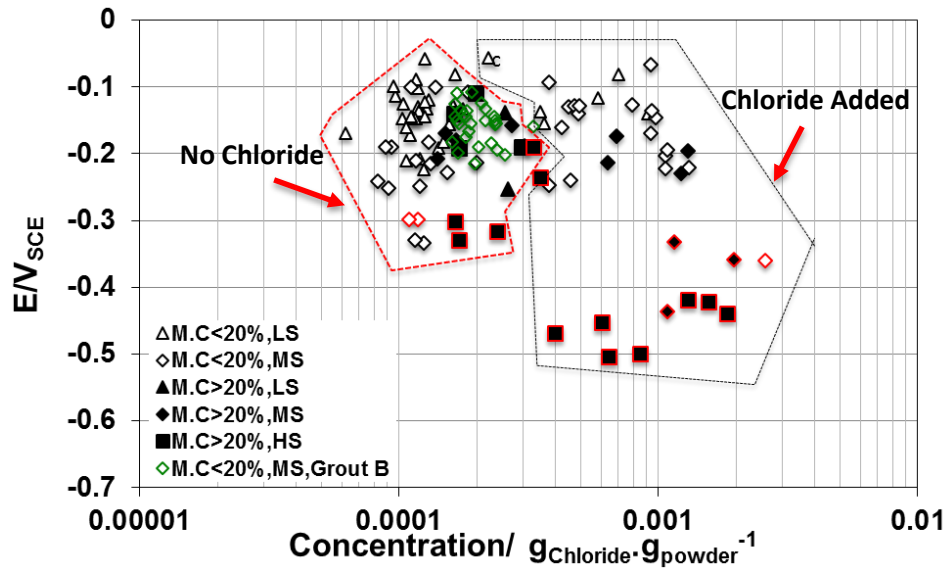
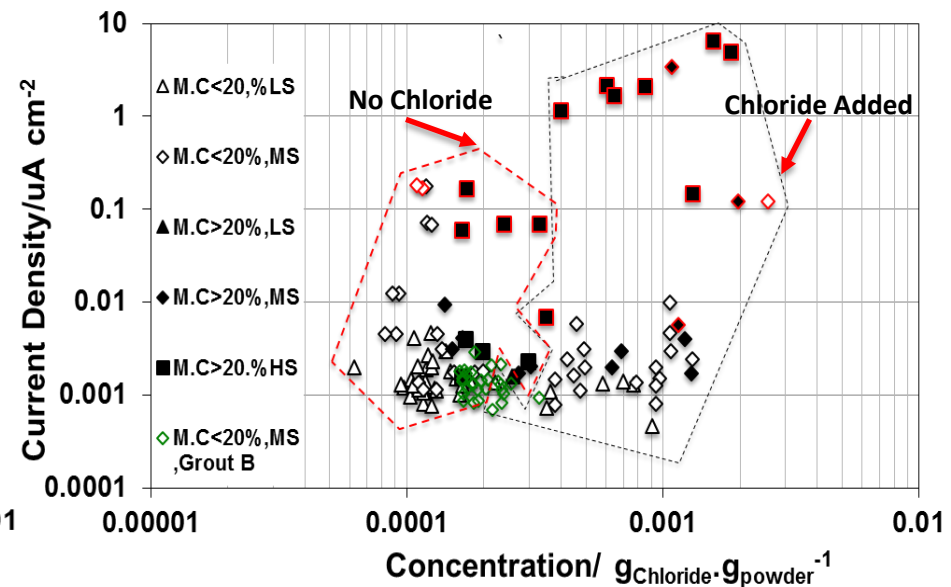
Recommendations for Sulfate Threshold Limits

- Sulfate accumulation by segregation can cause corrosion initiation. However addition of low amount of chloride (0.08% by cement weight) can increase the corrosion rate.

Low Sulfate (LS) $< 0.0004 \text{ } g_{\text{sulfate}}/g_{\text{Powder}}$
Med Sulfate (MS) $0.0004 < g_{\text{sulfate}}/g_{\text{Powder}} < 0.01$
High Sulfate (HS) $> 0.01 \text{ } g_{\text{sulfate}}/g_{\text{Powder}}$

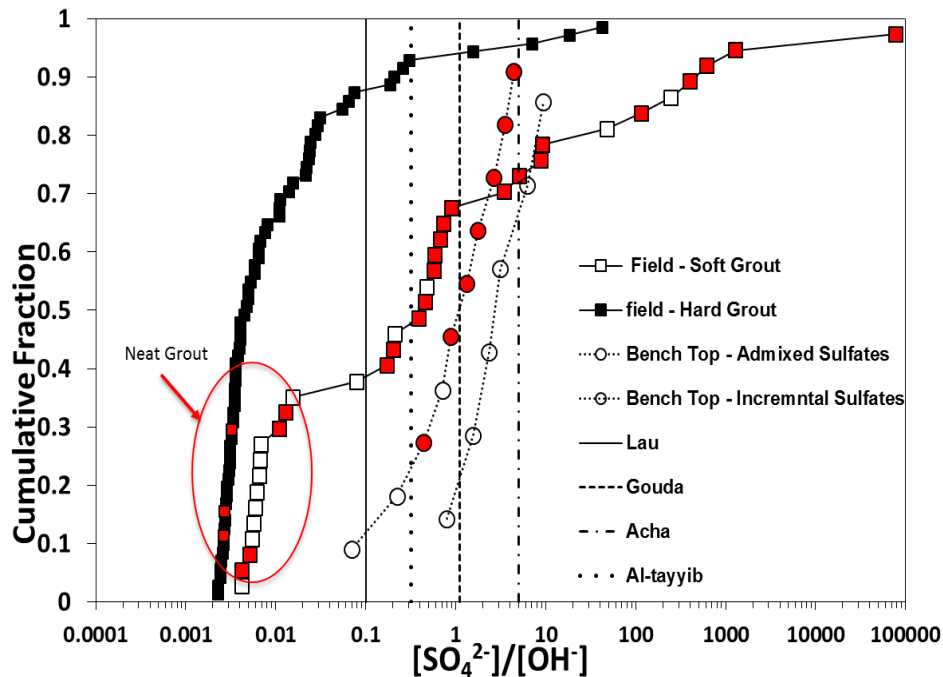
Solution Tests

- Steel corrosion was observed in deficient grout when $[SO_4^{2-}]/[OH^-] > \sim 0.15$ in grout pore water.
- This range of sulfates corresponds to 600 ppm to 3000 ppm in pH range 12.6 to 13.3 in pore water solution. (The corresponding samples showing the conservative values had sulfate concentration 0.0007g/g).
- Comparable limits suggested for concrete durability in sulfate environment.

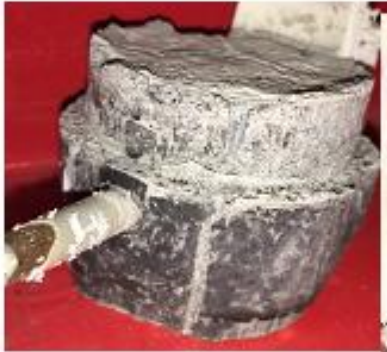
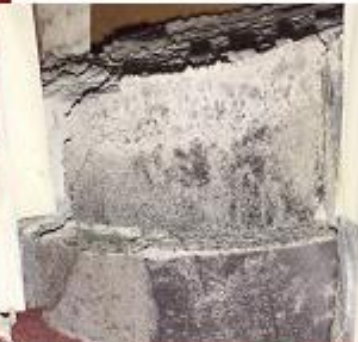
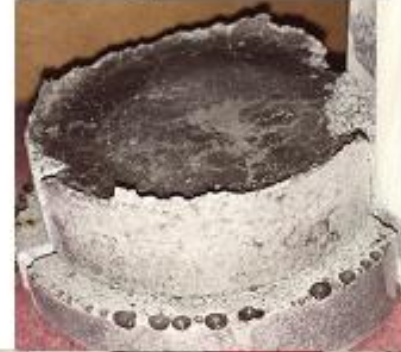
Zero Sulfate

High Chloride
