Corrosion Mitigation using Impregnation on Bonded PT

PTI April 2016

Garth Fallis, P. Eng.

Vector Corrosion Technologies

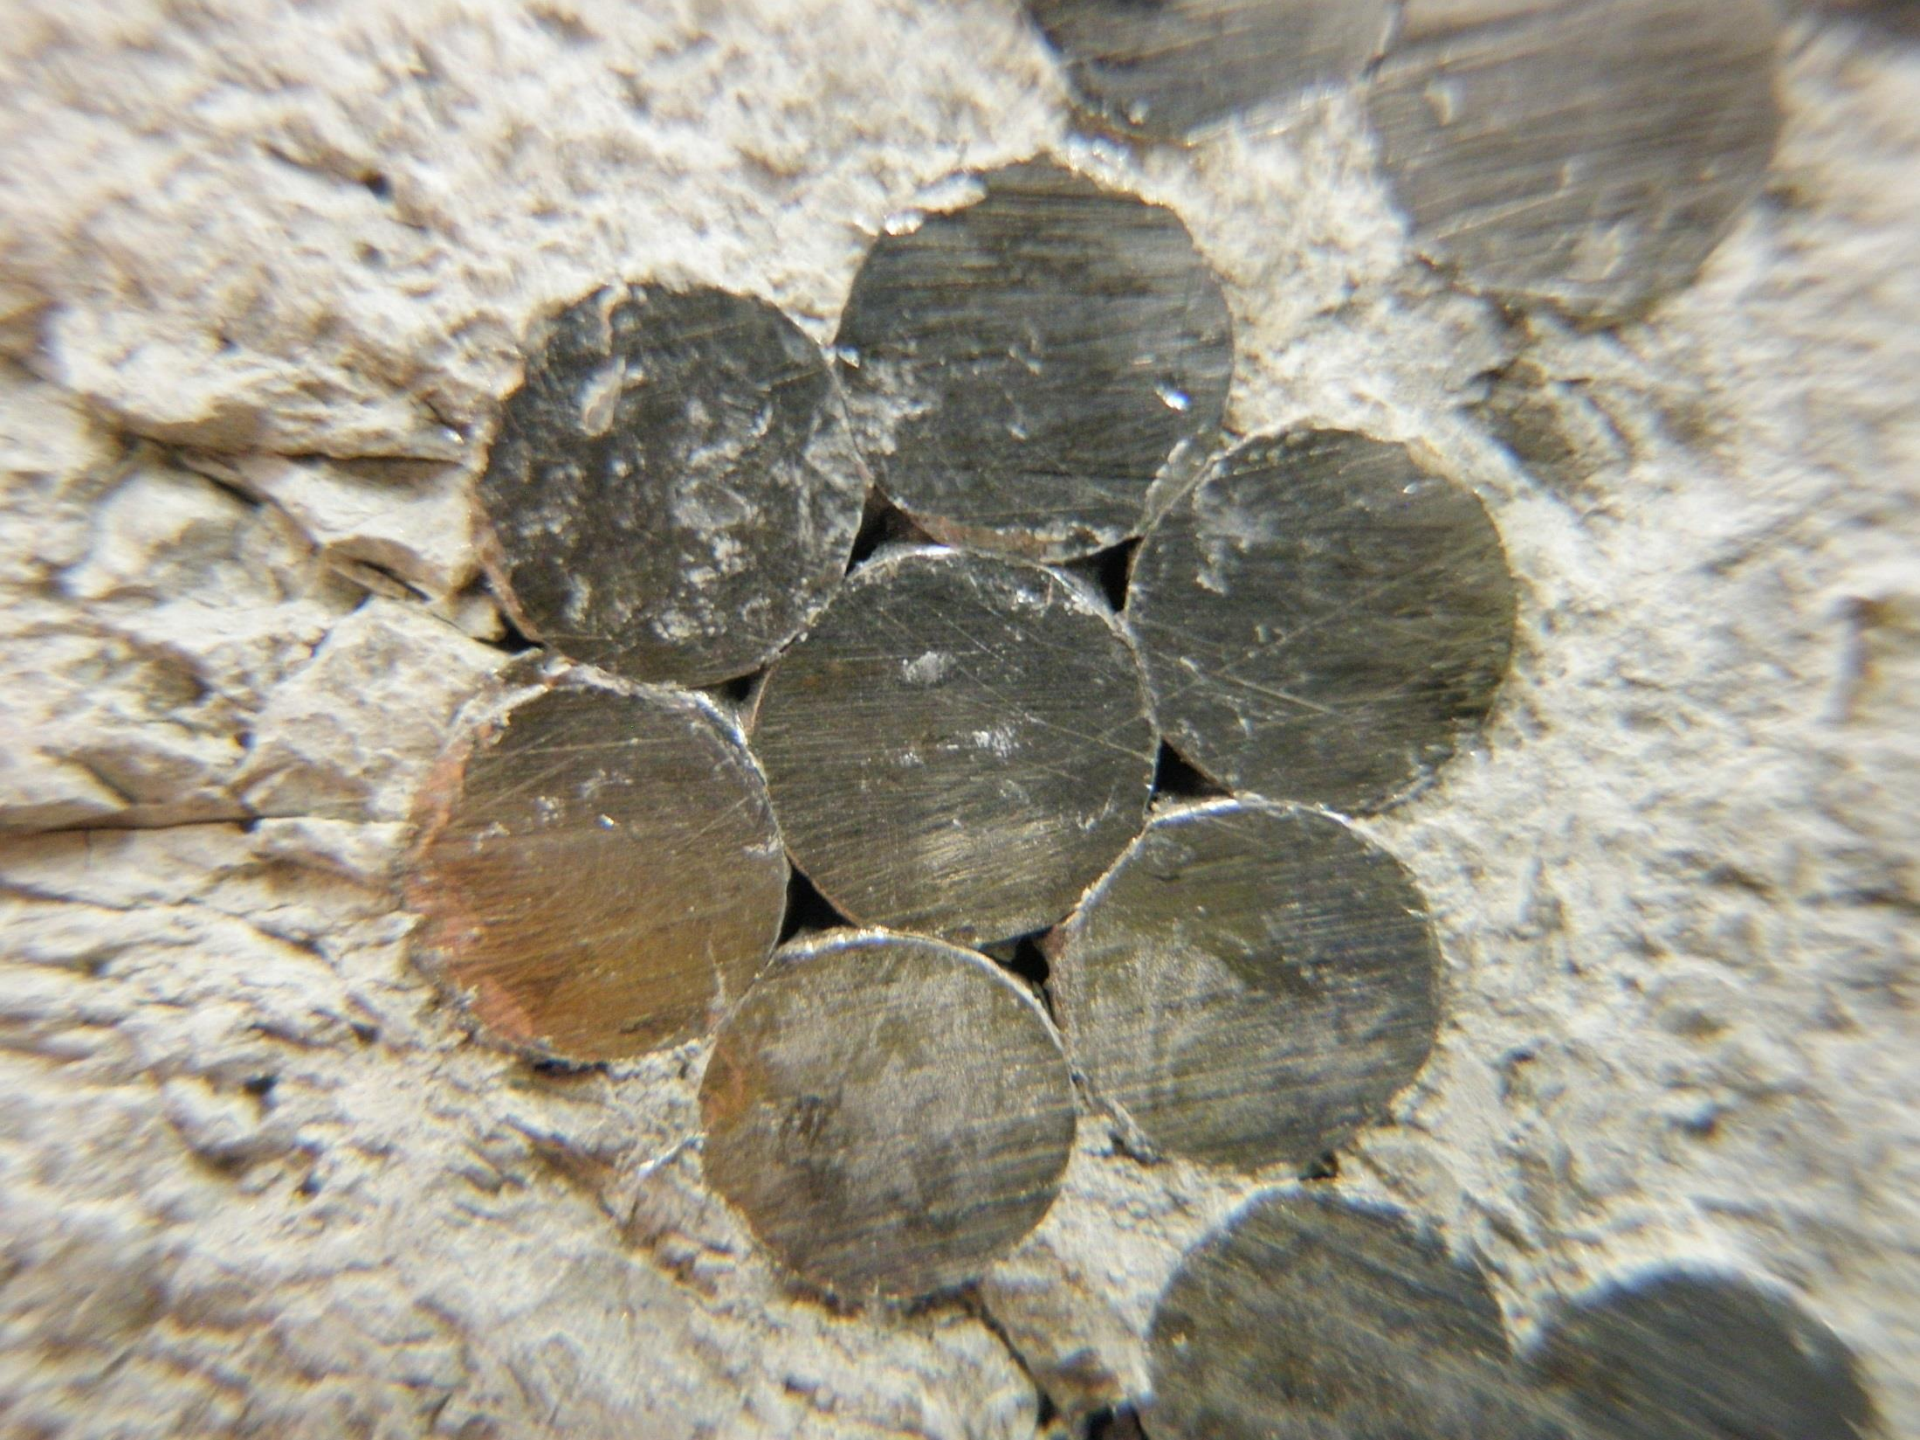
Post-Tension Cable Impregnation

- Corrosion protection for bonded post-tension and pre-stressed cables
- Uses corrosion inhibiting impregnation material
 - To make grout / concrete corrosion resistant
 - Coats exposed steel in voids to form a film and prevent corrosion

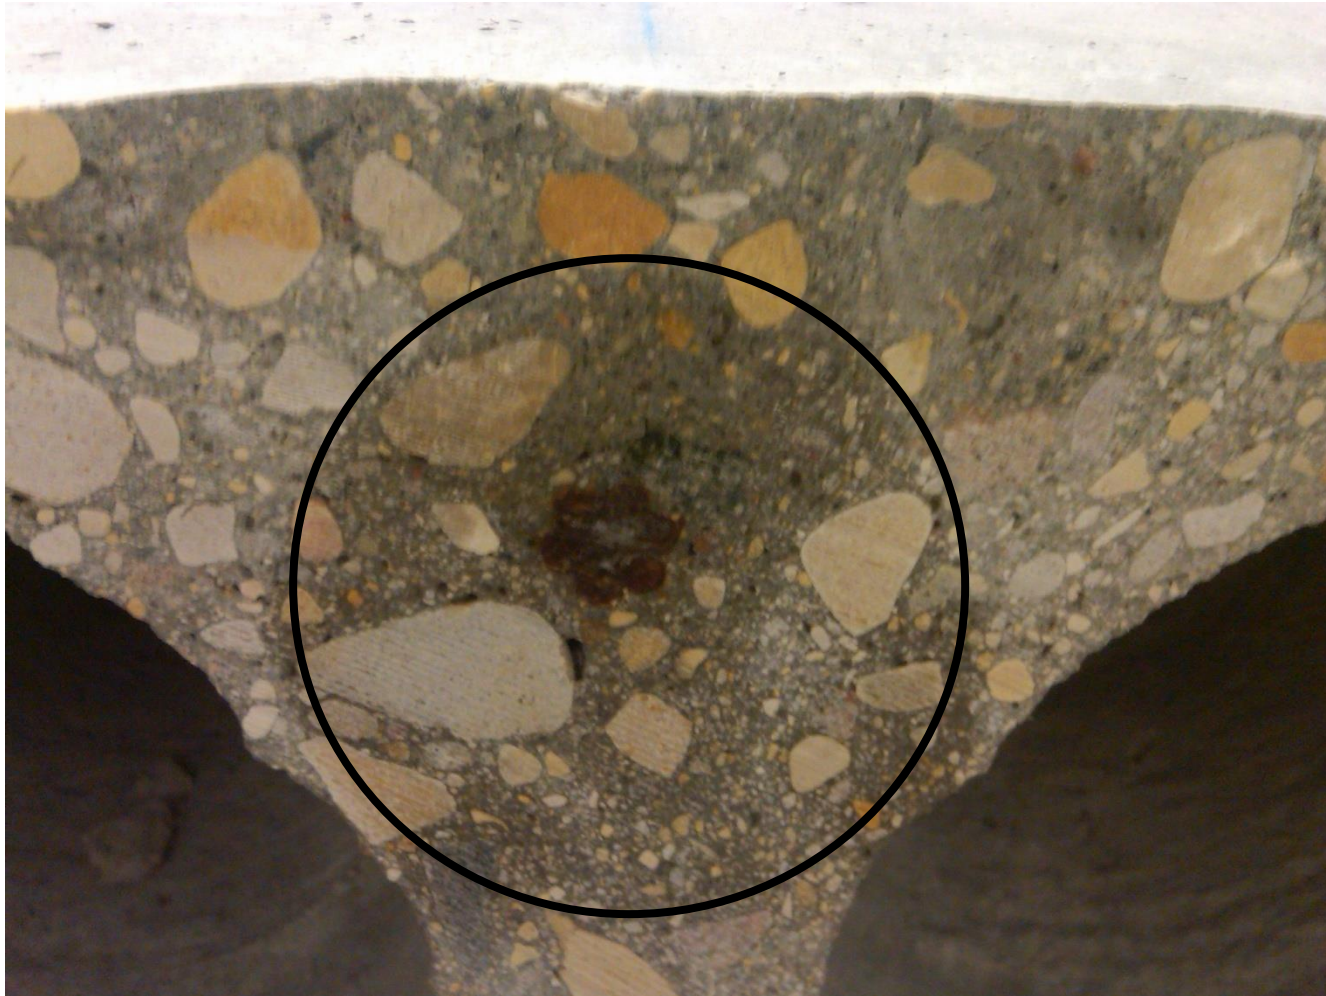
Impregnation Pattern

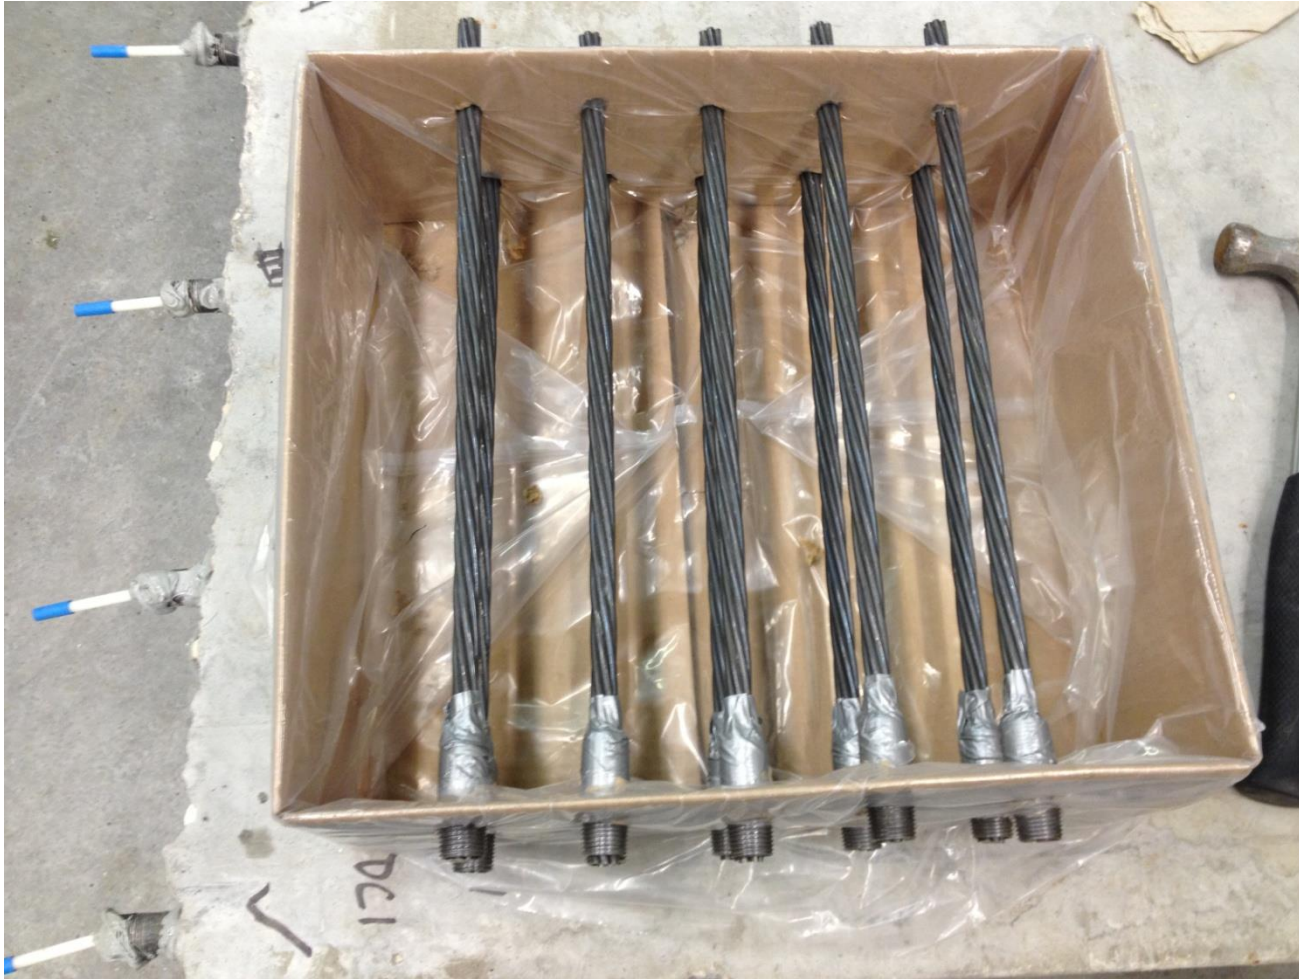
Corrosion Rate Test Specimen

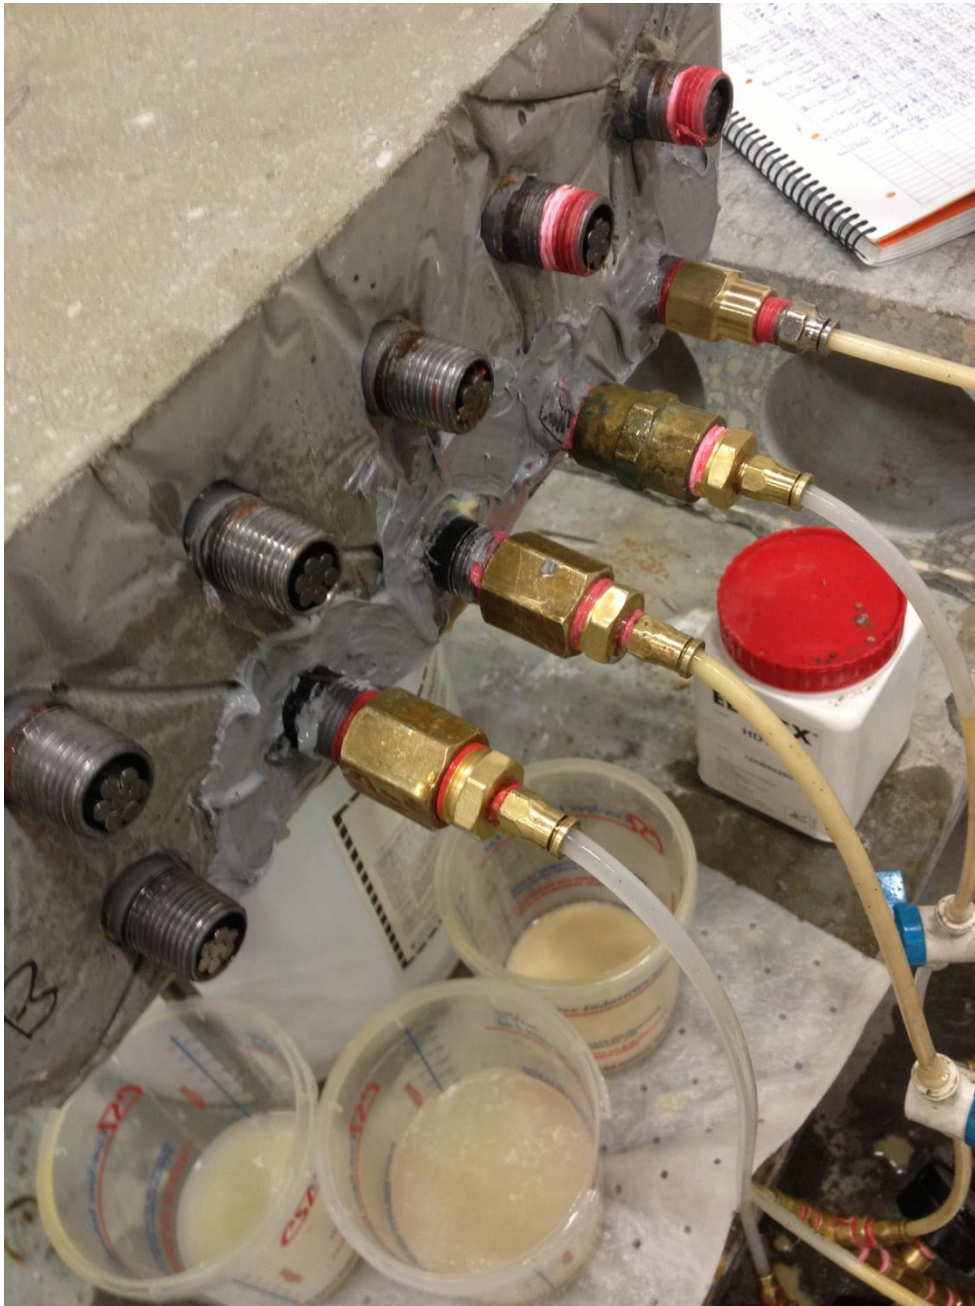
Test Specimen Impregnation

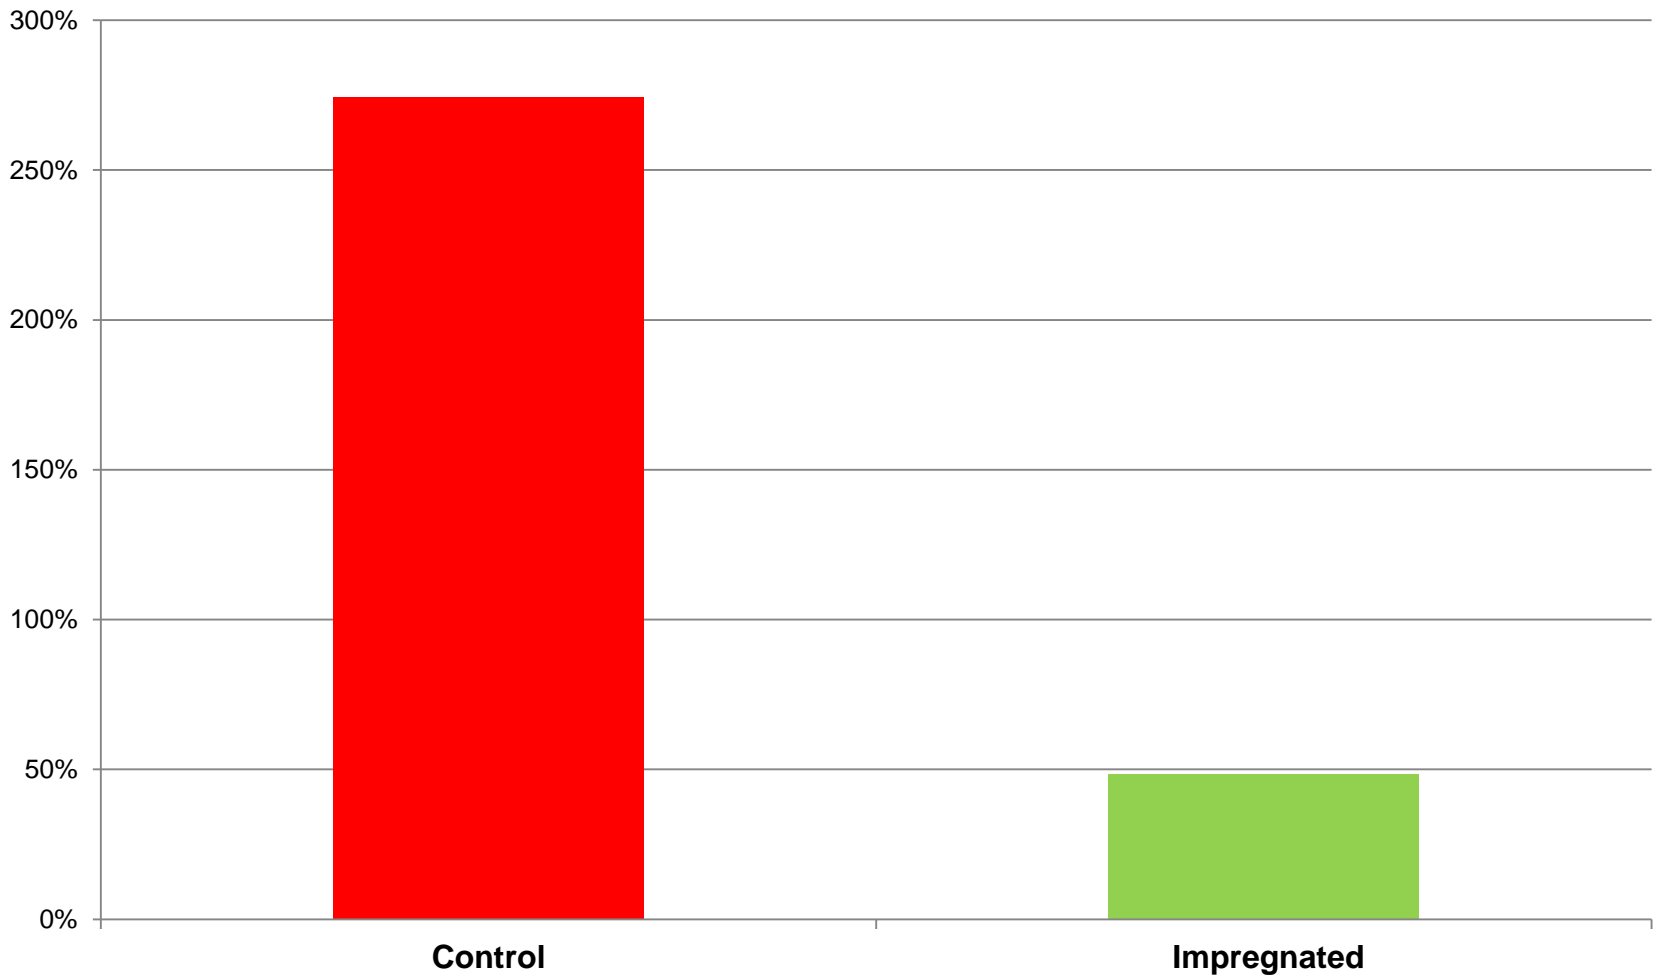
Average Percent Change in Corrosion Rate

4 Days After Wetting Test Specimen

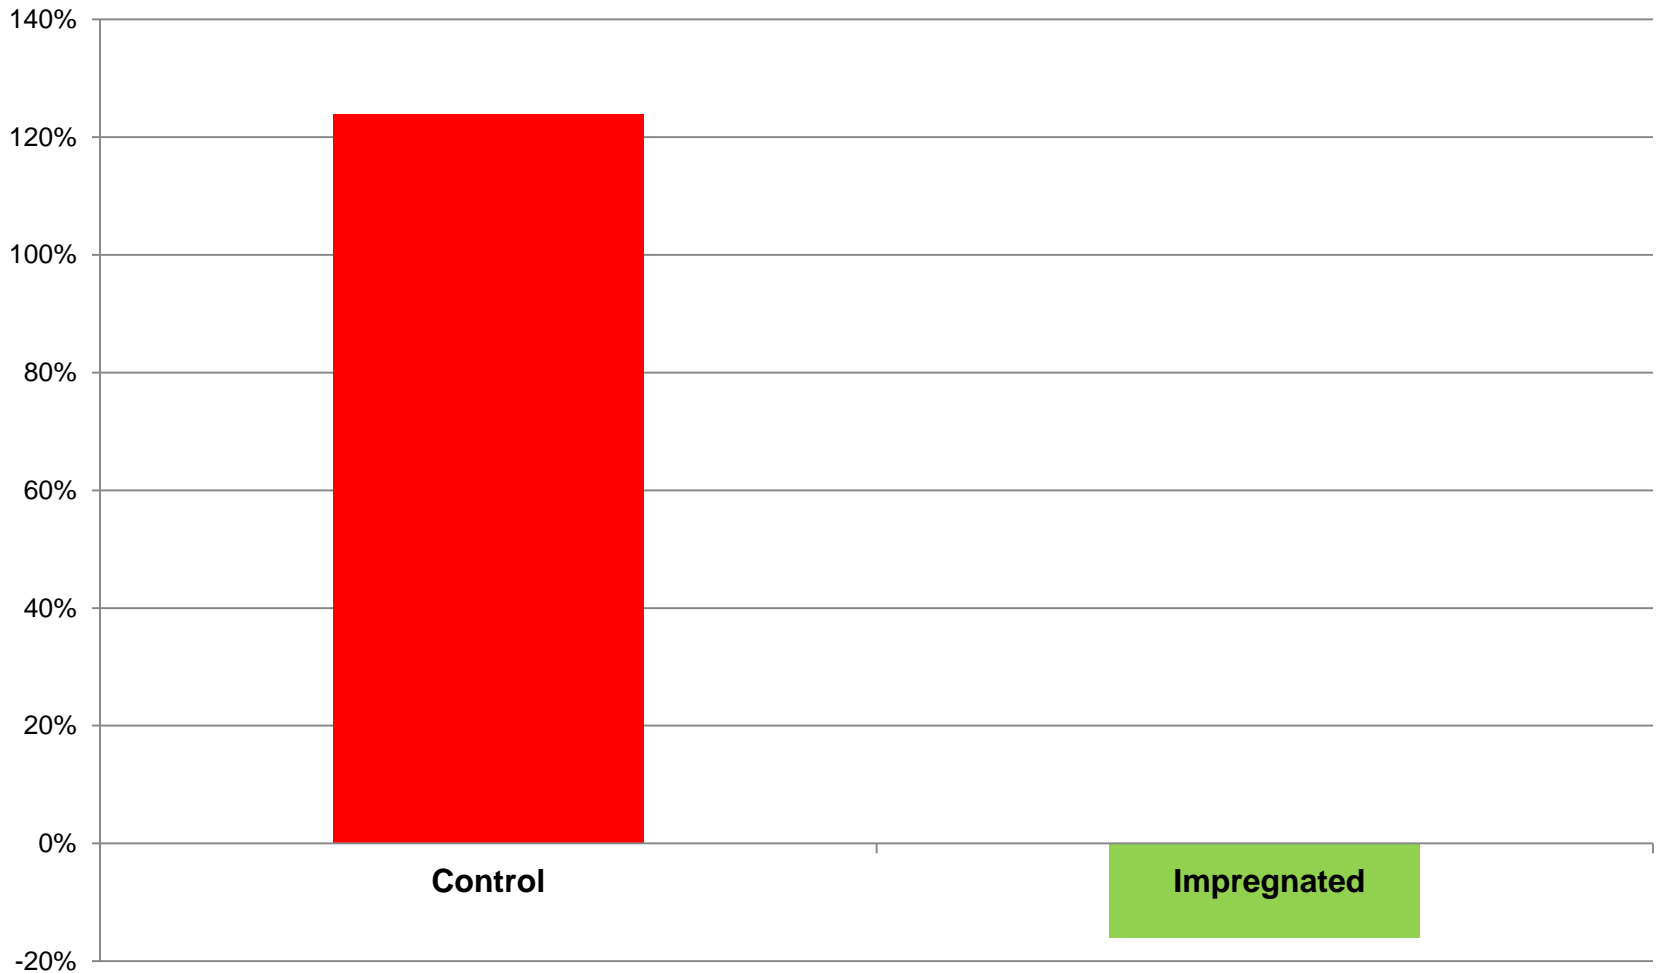
Average Percent Change in Corrosion Rate Over 40 Days After Wetting Test Specimen

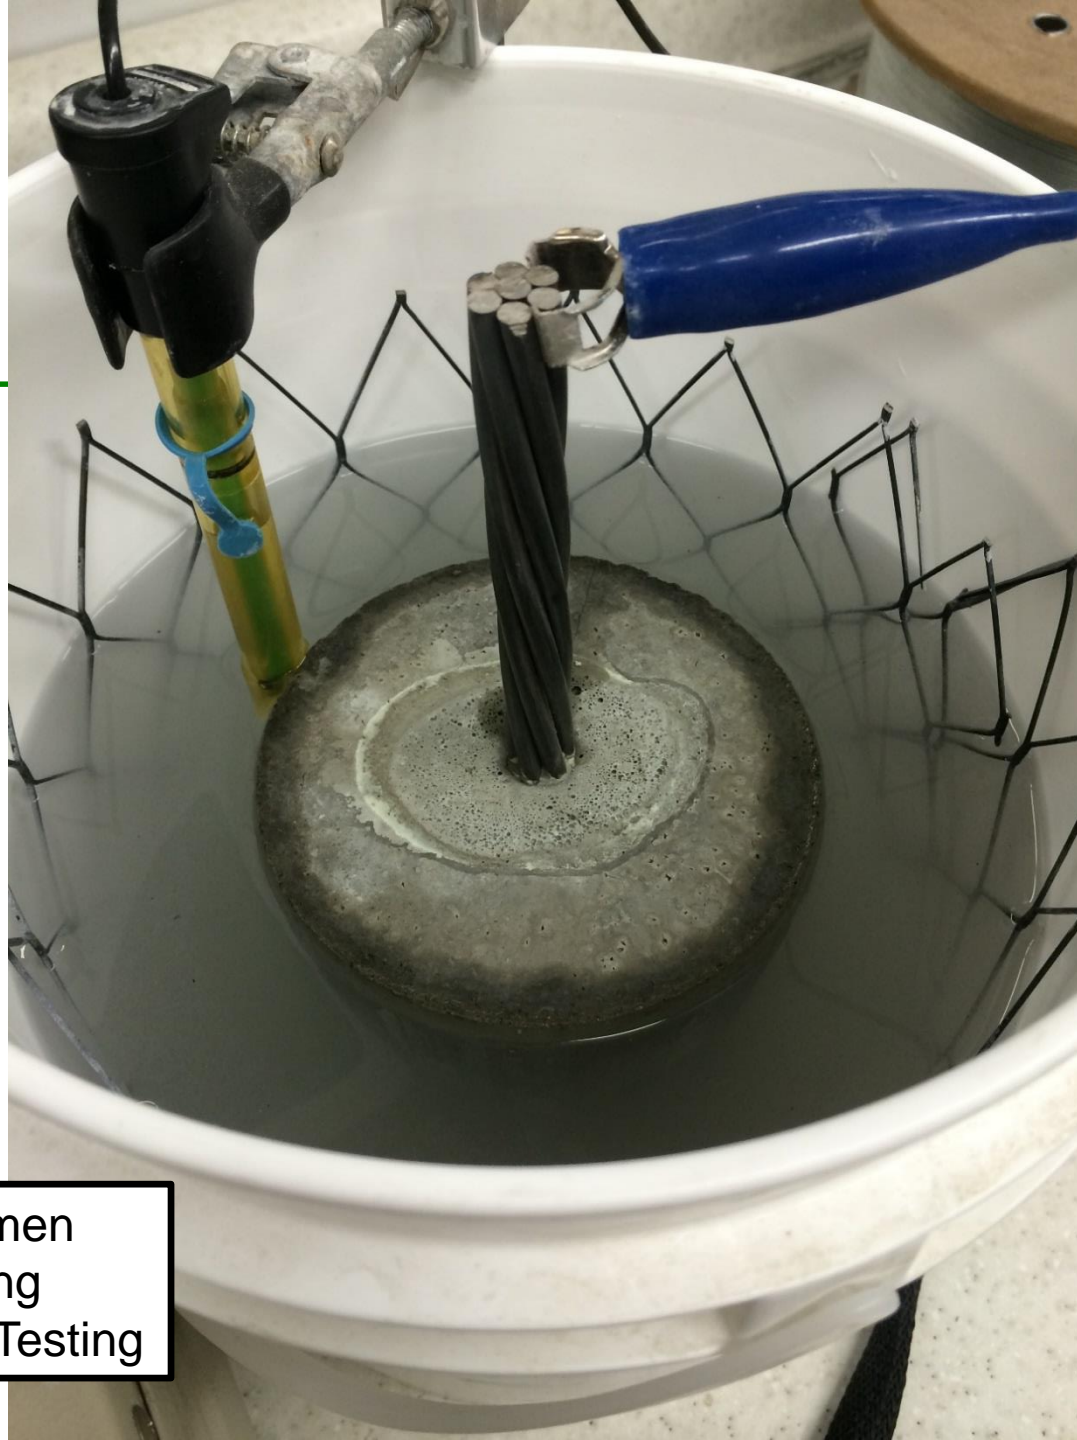
Test Specimen
Undergoing
Potentiostatic Testing

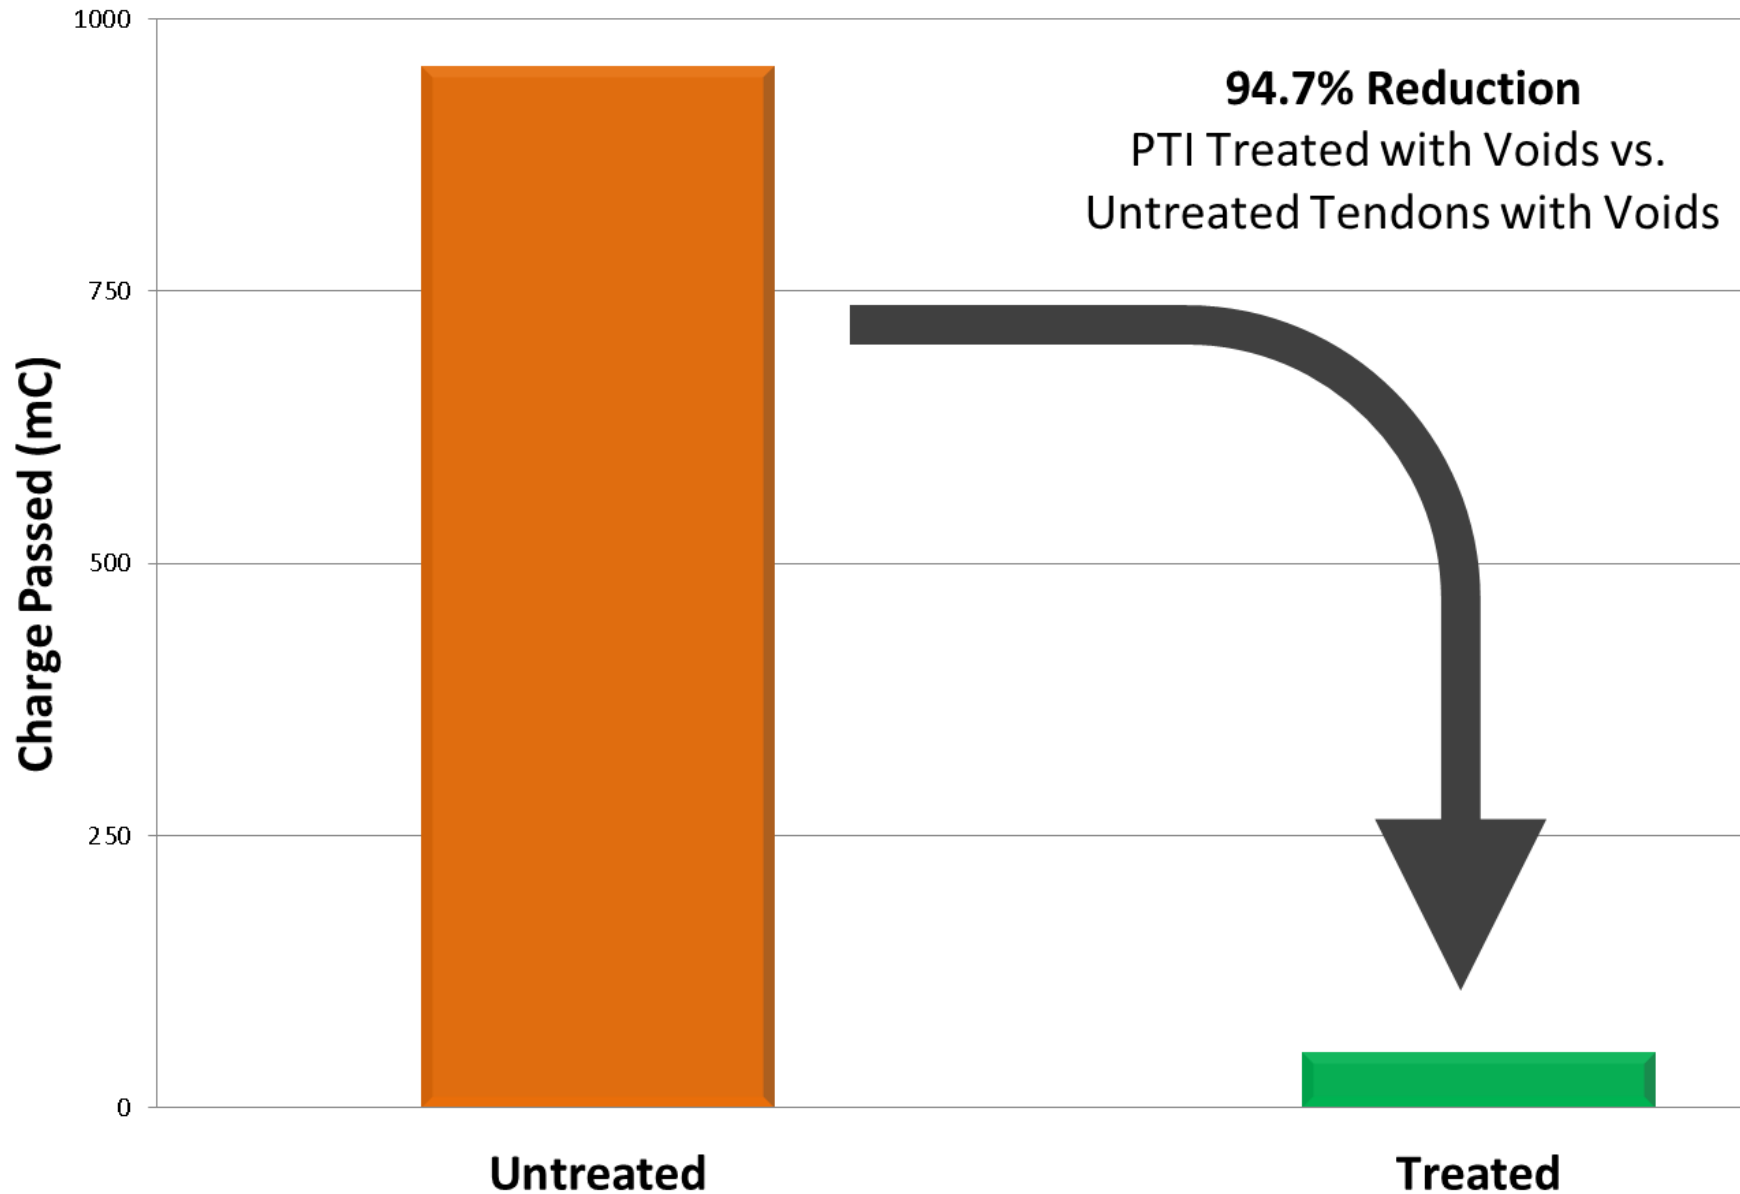
Potentiostatic Testing Tendons in Uncontaminated Grout with 4.5% Void

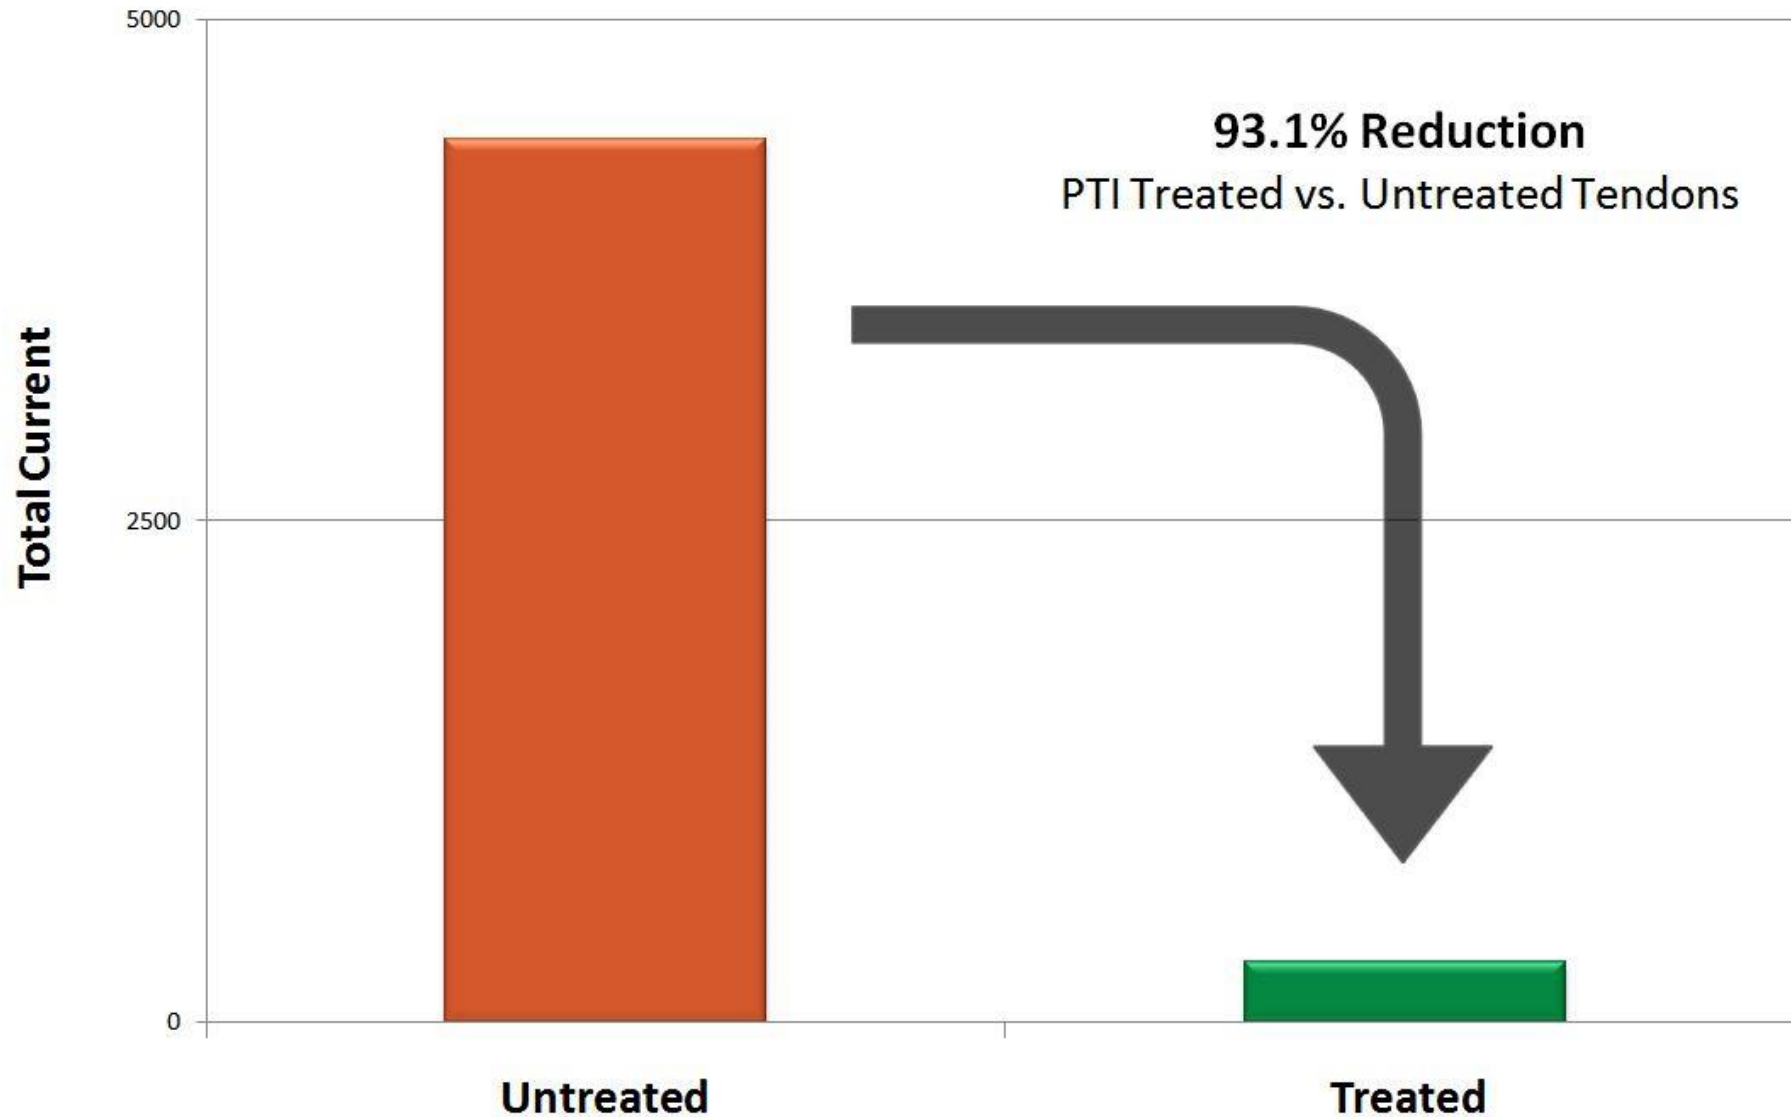
Potentiostatic Testing

Tendons in Chloride-Contaminated Grout (2% Cl⁻)

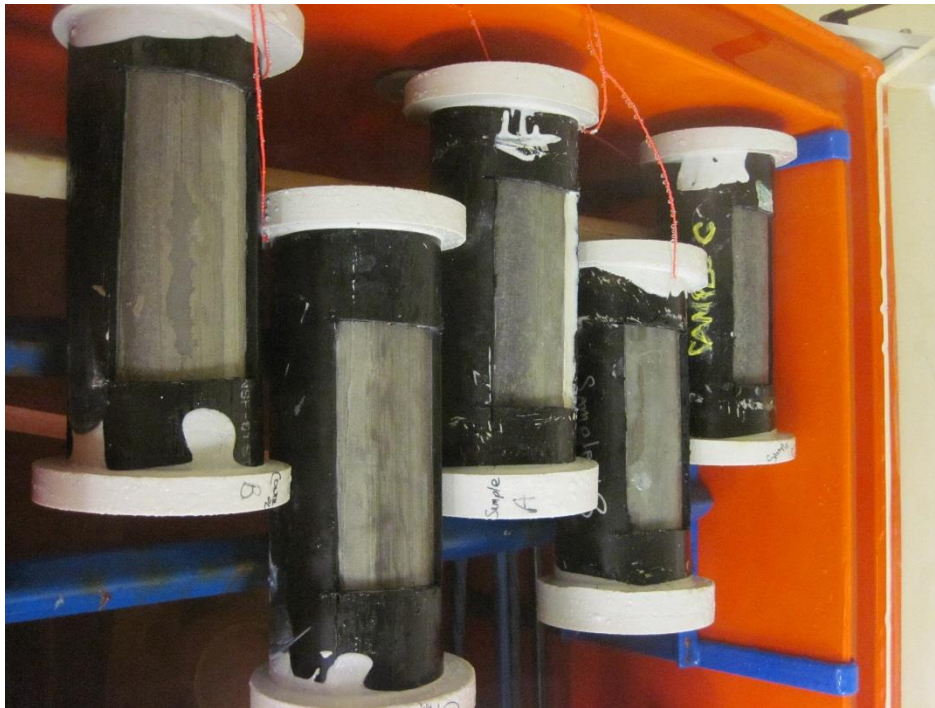
SALT-FOG CHAMBER EXPOSURE

Figure 1: Three impregnated and three control specimens were placed in a salt-fog chamber on mid February 2015. Voltage potentials (CSE) are obtained twice a week to identify time of corrosion initiation.

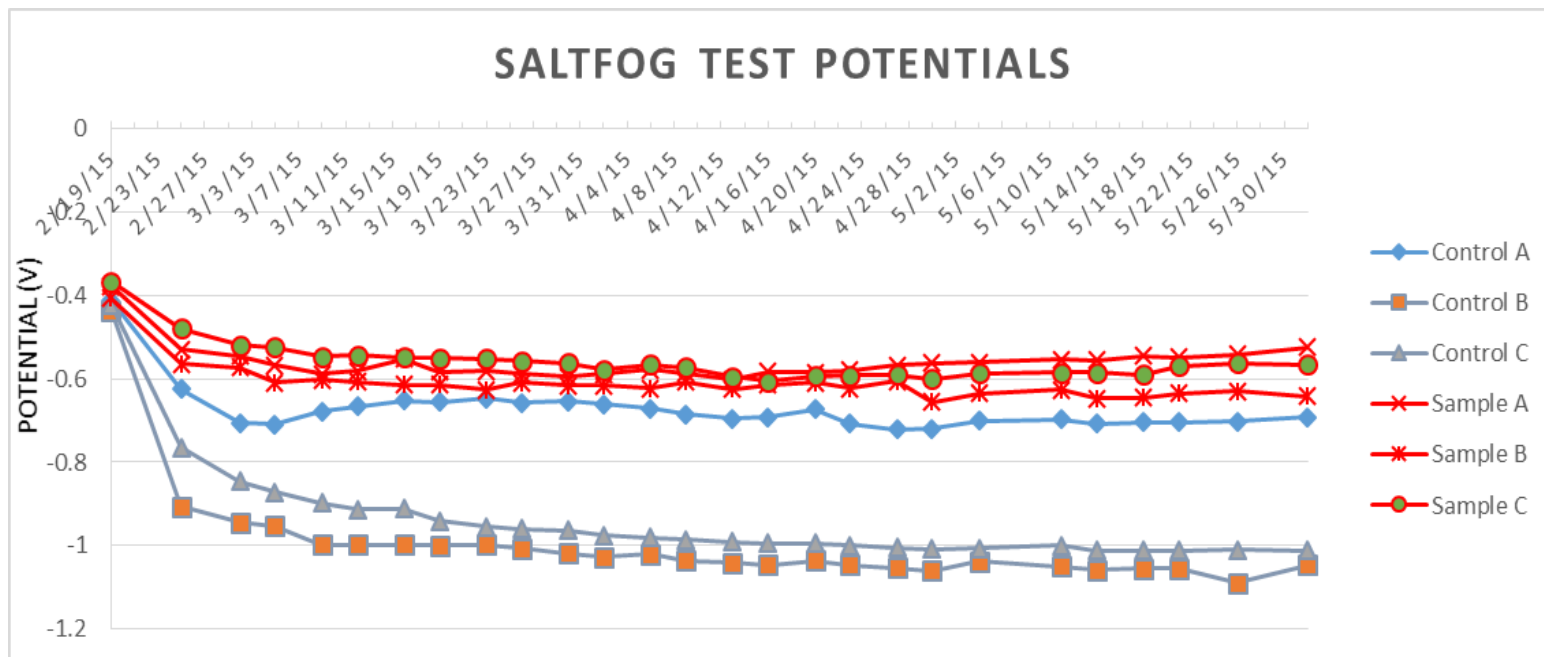
SALT-FOG CHAMBER RESULTS

Figure 2: Two of the control specimens exhibited corrosion initiation after around 15 days of exposure. After 90 days of exposure the impregnated tendons stabilized as a corrosion free state. The third control specimen has stabilized a voltage potential close to that of the impregnated specimens but it is uncertain if corrosion has initiated.

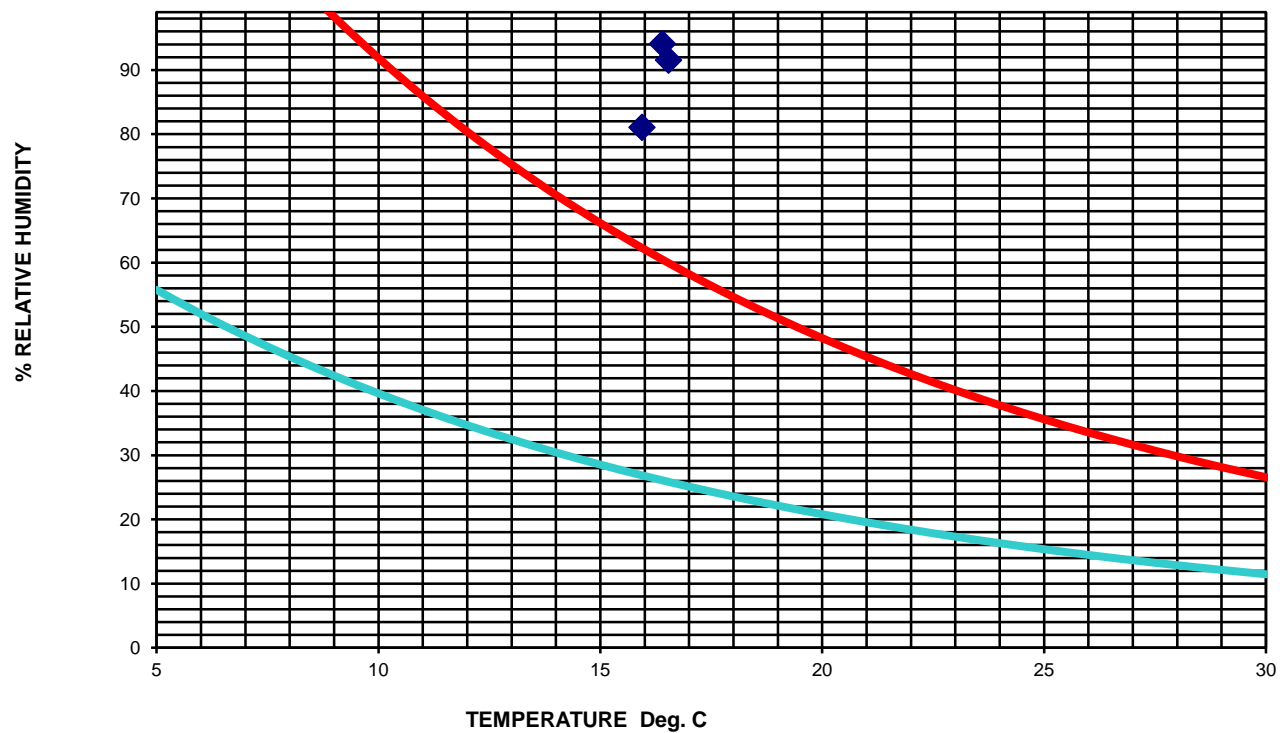
PT Corrosion Evaluation (Moisture Testing)

◆ PPL Data

— CE M.C.=0.003k

— CE M.C.=0.007k

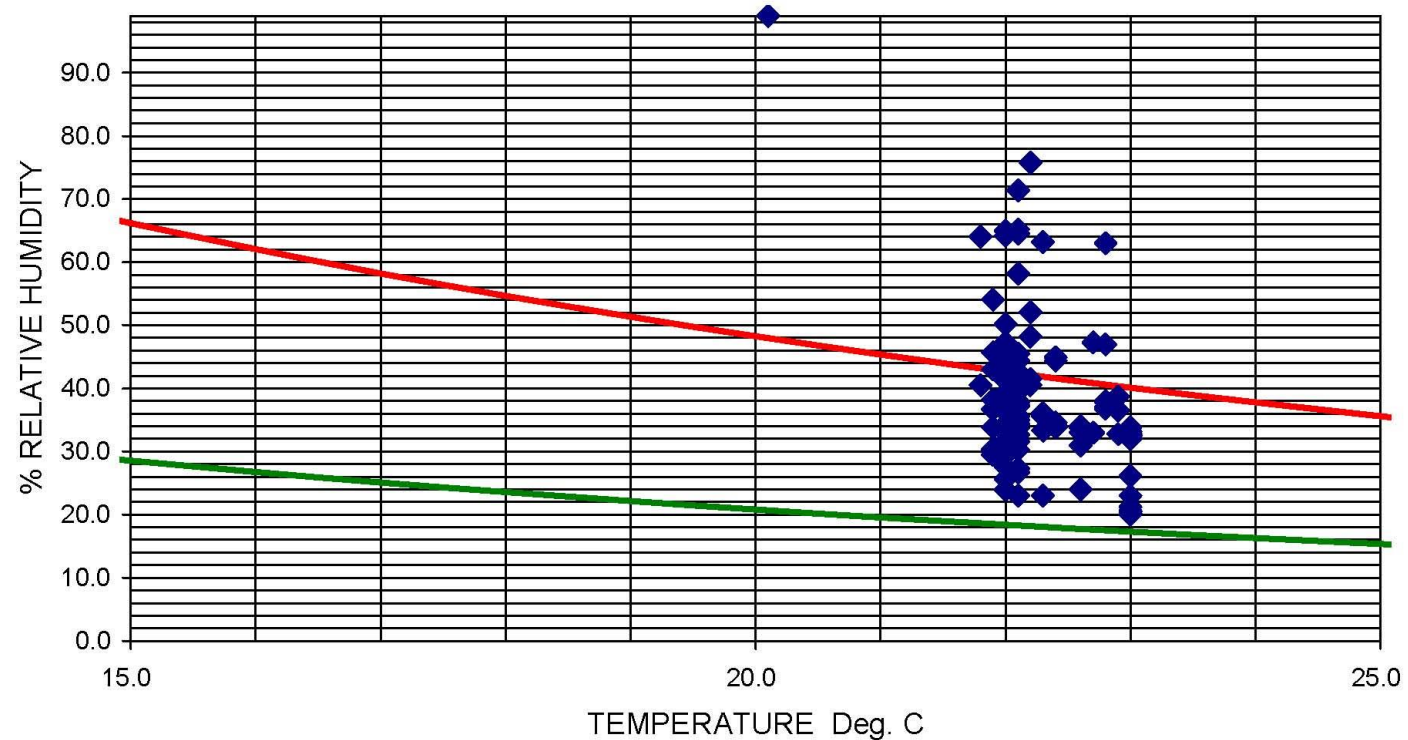
Standard Life Building Initial Measurements
Post-Tech CE* Test Results

◆ Data — CE M.C.=0.003k — CE M.C.=0.007k

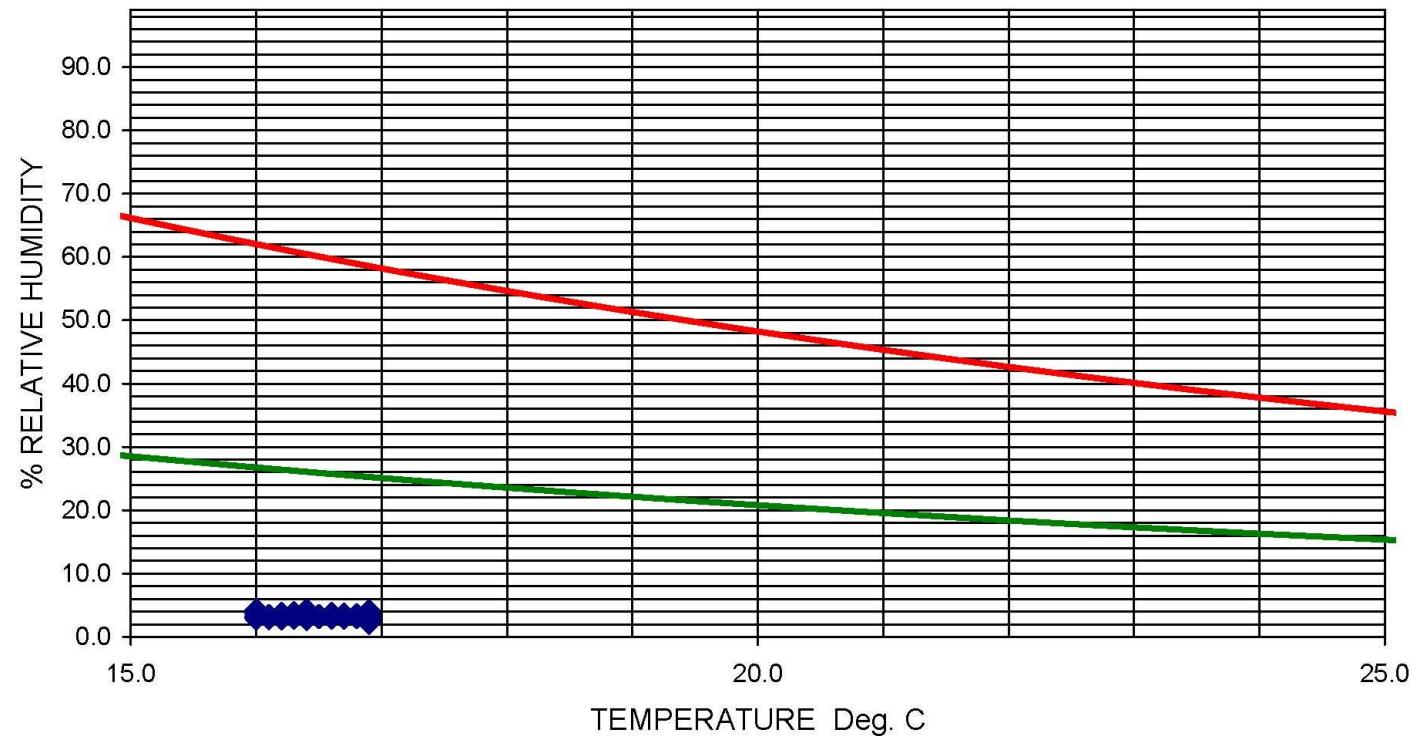
Standard Life Bldg. Final Measurements
Post-Tech CE* Test

◆ Data — CE M.C.=0.003k — CE M.C.=0.007k
