## **FIELD EVALUATION OF THE PRESTRESSING FORCE IN UNBONDED TENDONS**

Authorized reprint from: August 2003 issue of the PTI Journal

# Field Evaluation of the Prestressing Force in Unbonded Tendons

By Pawan R. Gupta<sup>1</sup>

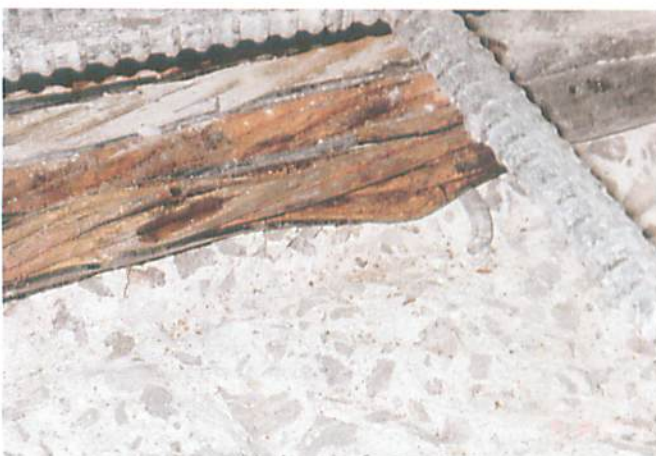
Fig. 1 - Corroded strands exposed for visual inspection

Following the visual survey, engineers select locations where exploratory openings are made by chipping the concrete cover and exposing the strands. Strands are often exposed in areas where corrosion is likely to have occurred. Typically, sufficient concrete and sheathing is removed to expose a tendon length of approximately 8 in. (200 mm), see Fig. 1. The exposed strand is then visually examined for the following:

- Presence of rust and pitting
- Loss of cross-sectional area
- Presence of moisture and condition of the protective grease
- Type and condition of sheathing

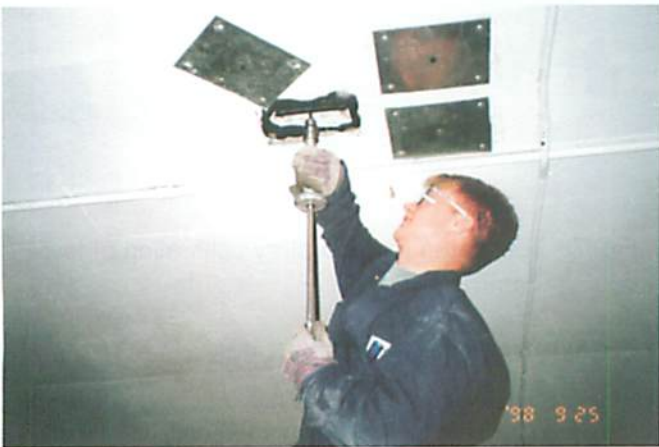
The screwdriver test is widely used to detect wire breaks in a strand. A short section of the strand, usually 8 in. (200 mm), is exposed by chipping out the concrete cover from the underside of the slab. A flat head of a screwdriver is driven by a hammer to wedge between the individual wires that make up a tendon (see Fig. 2). If penetration is achieved the strand likely has broken wires or the strand is not fully stressed. The test is non-destructive and relatively easy to conduct.

Fig. 2 - Wire penetration (screwdriver) test

However, it only gives limited information about the force in the strand that can be used in the structural evaluation of capacity. The test results are very sensitive to the skill of the operator and the condition of the screwdriver tip. The test is suitable as a preliminary tool in post-tensioning assessments.

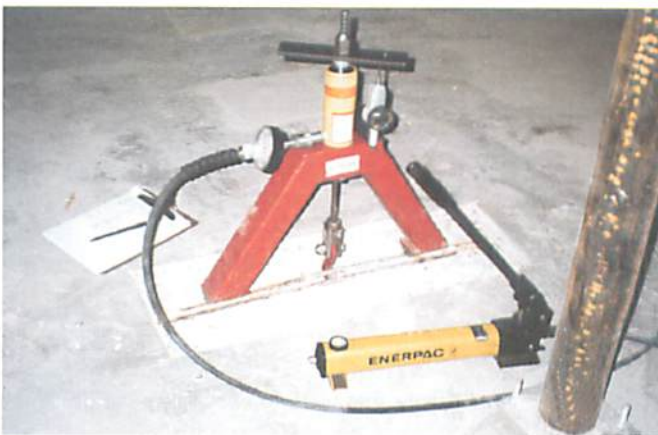
Fig. 6 - In-situ tension test set-up in field

in the jack is 500 psi and 1000 psi. Based on the calibration of the jack this translates into a lateral force of 0.965 kips and 2.29 kips respectively. Table 1 gives the expected deflections for the tendons when these forces are applied to the strand. Fig. 6 shows the test set-up in the field. A special attachment is used to hook single strands when the cables are closely spaced. It is noted that for a normally stressed 0.5 in. (12 mm) $\phi$  strand the expected deflection is usually less than 3/8 in. (10 mm). Since the tendon is unbonded and relatively long this represents a negligible increase in axial force during testing.

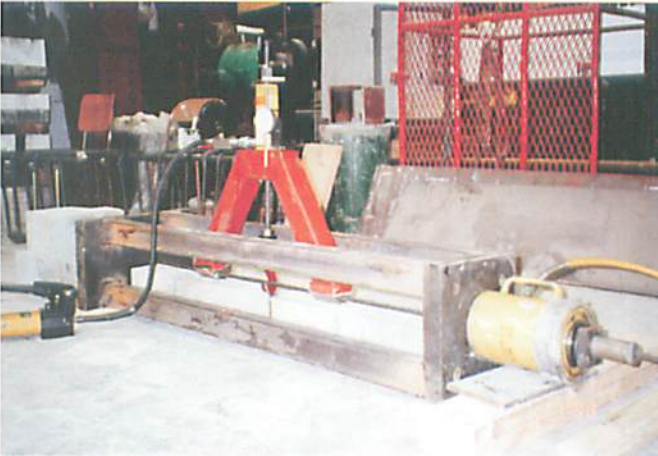
Fig. 7 - Test setup for laboratory calibration of test frame

The test frame was calibrated in the structural engineering testing laboratory at the University of Toronto, Fig. 7 shows the test set-up for calibration. A known axial force was applied to the 0.5 in. (12 mm) $\phi$  and 0.6 in. (15 mm) $\phi$  strands. Initial deflection was measured when the pressure in the hydraulic jack was 500 psi (Jack force = 0.965 kips). A second deflection reading was taken when the pressure in the hydraulic jack was 1000 psi (2.29 kips). The increase in transverse deflection between the two loads was used to determine the tension in the tendon.

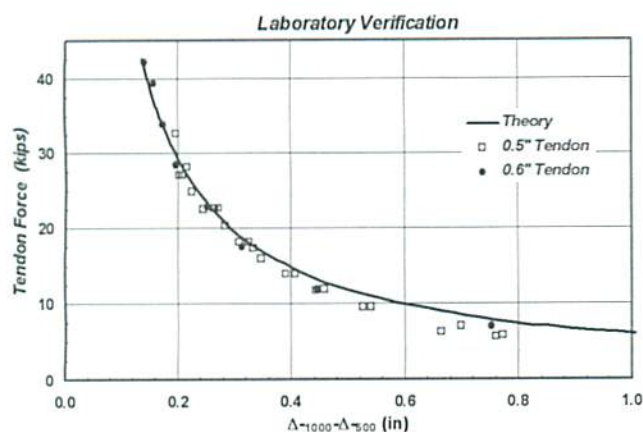
Fig. 8 - Calibration of test frame

Fig. 8 compares the results obtained from the calibration test and theoretical prediction using Eq. (1). It is noted that in the second order effects are neglected in the derivation of Eq. (1). This causes the predicted load to be higher when the axial tension in the tendons is less than 15 kips. Considering that practical range of forces for 0.5 in.  $\phi$  and 0.6 in.  $\phi$  strands is usually more than 25 kips, it was felt that the accuracy of the system was adequate for field applications. If needed accuracy can be improved in the lower range by considering the second order effects.

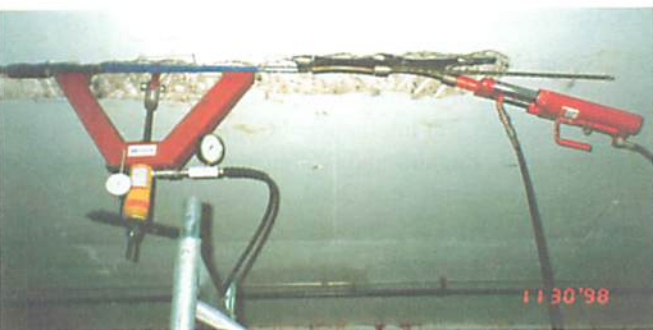
Fig. 9 - Field calibration of the test frame

The results of the test were also verified under field conditions. Two strands were exposed in the slab of a parking garage in Toronto. The test frame was attached to each tendon and the load/deflection readings were taken. Fig. 9 shows the frame during field-testing. The strands were then cut to release the prestress. The total elastic shortening of the tendon was measured. Based on the total length of the tendon, the tension in the tendon was calculated. The total elongation was also measured during re-stressing.

The results were compared to the effective force in the cable calculated using the in-situ tension tester. Table 2 shows a summary of the observations during field-testing. As expected the accuracy is somewhat lower when the force in the strand is 15 kips. However, in the normal working range of 25-35 kips the accuracy of the test is about 3%. The test frame has also been calibrated against lift-off test in the field with good results.
