**WATERPROOFING WITHOUT MEMBRANE:  
FORTY YEARS AFTER COMPLETION, A POST-  
TENSIONED SHRINKAGE-COMPENSATING  
MAT FOUNDATION IS STILL SOLID AND  
WATERTIGHT**

Authorized reprint from: August 2009 issue of the PTI Journal

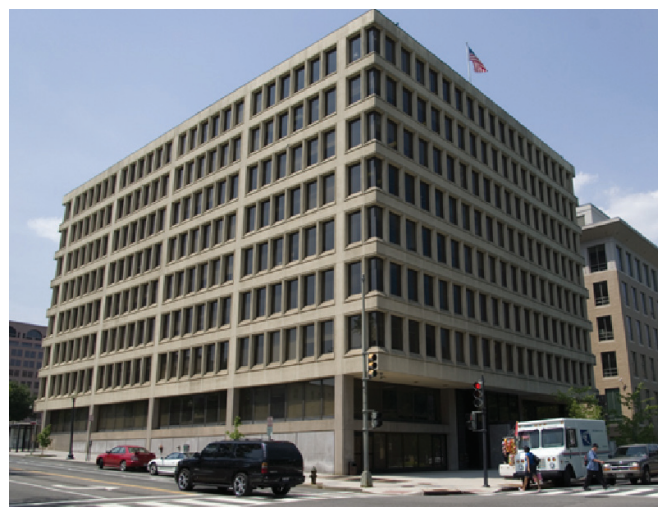
Fig. 1—500 First Street, NW is an eight-story building with two basement levels. Like many sites in the Washington, DC, area, there were significant groundwater issues to contend with in constructing the foundation. Erected in 1967, it was the first building in the city constructed with post-tensioning. (Photo by Steven H. Miller, courtesy of CTS Cement Manufacturing.)

The office building at 500 First Street, NW was the first post-tensioned building constructed in Washington, DC. It was designed by Weihe Black & Kerr Architects, Washington, DC. Structural engineering was done by Keith Thornton, then Vice President of T.Y. Lin and Associates and Manager of the firm's New York office. The Lin firm pioneered post-tensioned structural concrete in the U.S. Design documents date from February 1966, and the building was completed in April 1967 (Fig. 1).

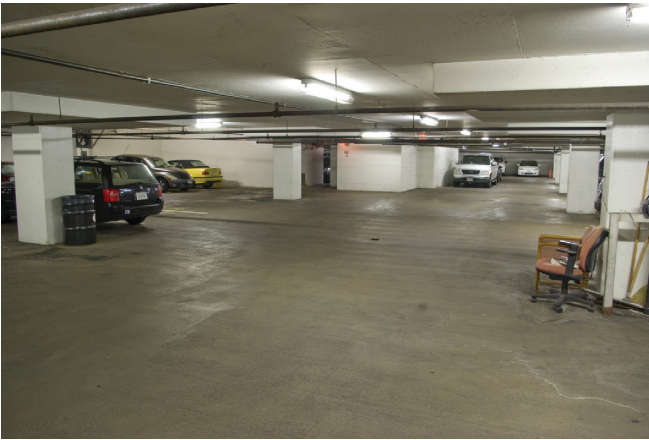
Fig. 3—The floor of the second basement is actually the top surface of the foundation. Forty years after construction, it is crack-free, watertight, and completely dry. The 10 in. (250 mm) thick drop panels of the first basement deck are clearly visible in the ceiling of this photo: they resemble broad soffits surrounding the load-bearing pillars. (Photo by Steven H. Miller, courtesy of CTS Cement Manufacturing.)

Forty years later, 500 First Street is stable, occupied, and functioning well. The second basement—the floor of which is the foundation slab—is crack free and does not leak (Fig. 3). The below-grade walls also remain watertight (Fig. 4). The only sign of water damage in the

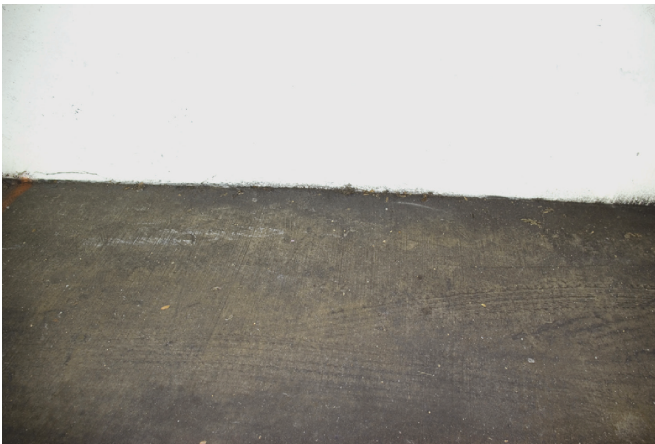
Fig. 4—Even at the meeting point of foundation and basement wall, there is no evidence of cracking or leakage. (Photo by Steven H. Miller, courtesy of CTS Cement Manufacturing.)

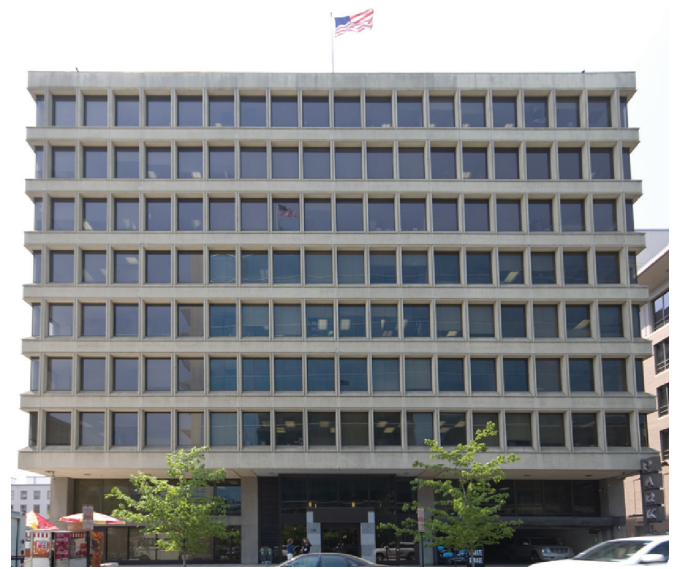
Fig. 5—Forty years later, the building is stable and in excellent condition. The thin deck-slabs made possible by post-tensioning allowed the designers to get an extra story into the structure and still stay under the city's absolute height limit. The building is currently occupied by offices of the Federal Bureau of Prisons. (Photo by Steven H. Miller, courtesy of CTS Cement Manufacturing.)

cured. They can create stress points that compromise the concrete and cause leaks. There is no evidence, however, of any such leakage at 500 First Street, possibly due to the effective combination of shrinkage-compensating concrete and post-tensioning (Fig. 5).
