THE ROYAL CLUB CONDOMINIUMS—POST-TENSIONED CABLE RESTORATION

by Scott A. O'Connor

The Royal Club Condominiums
2457 Collins Avenue, Miami Beach, FL

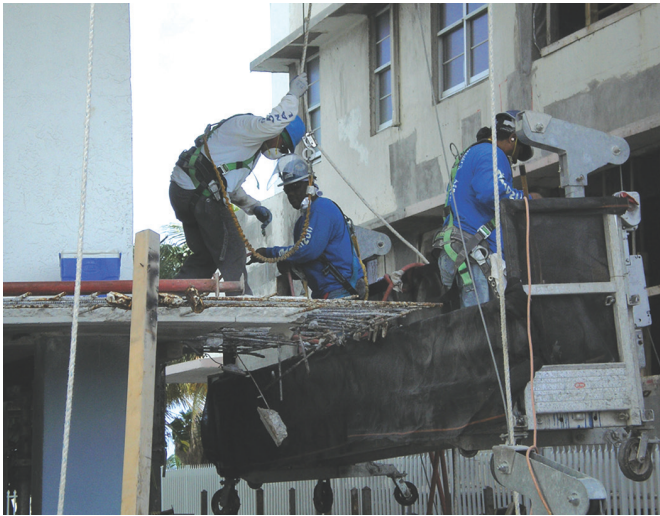
Shoring in place.

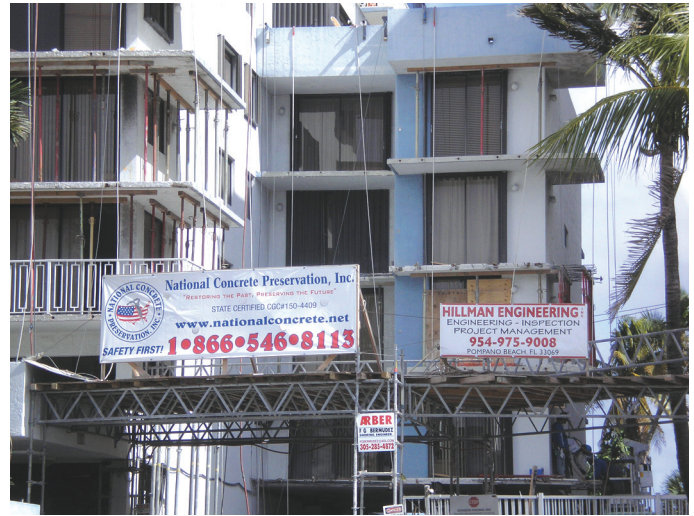
Removal of deteriorated concrete from balcony.

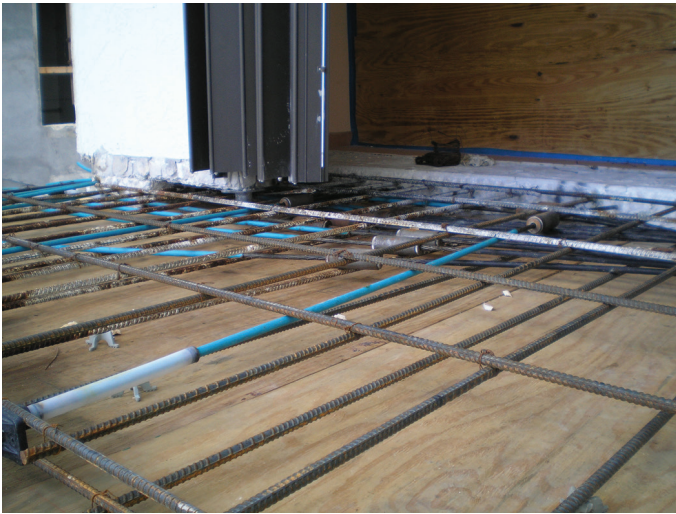
PTC splices in place.

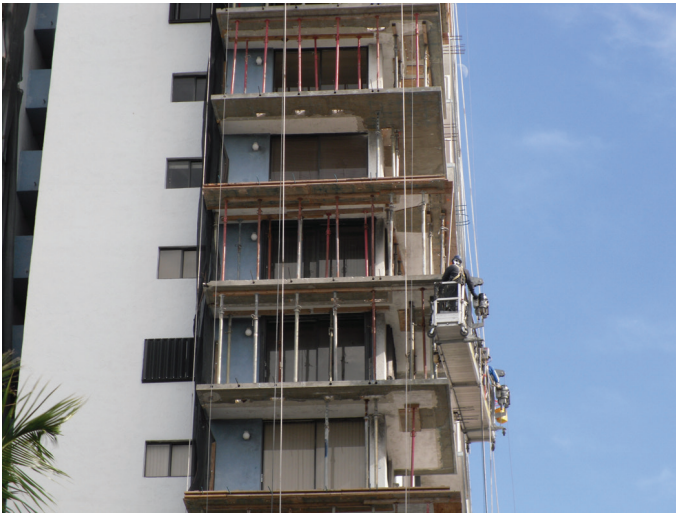
Formwork in place.

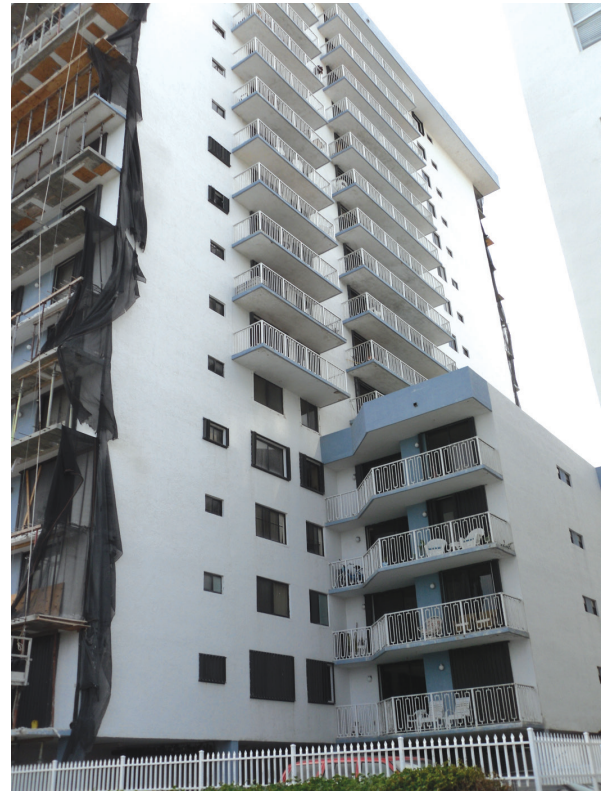
North face of building: ready for restoration.

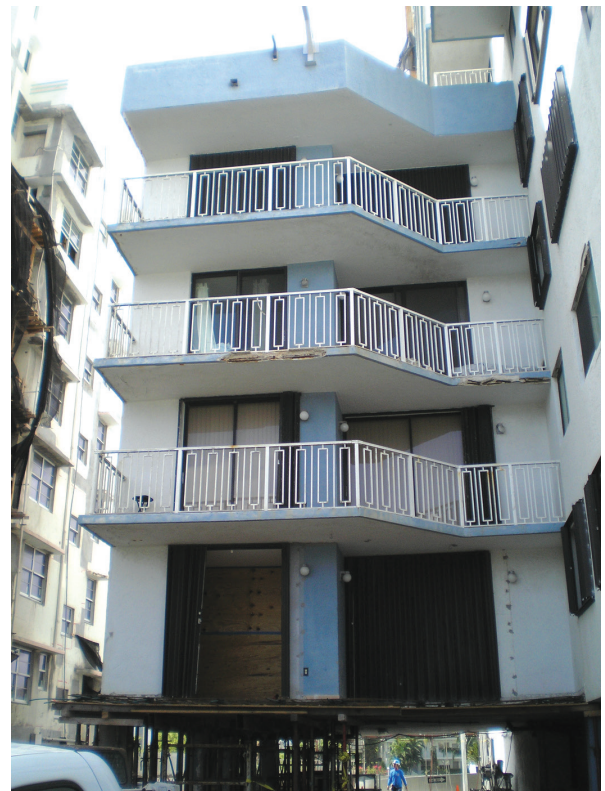
East face (note spalls evident on balcony edge).

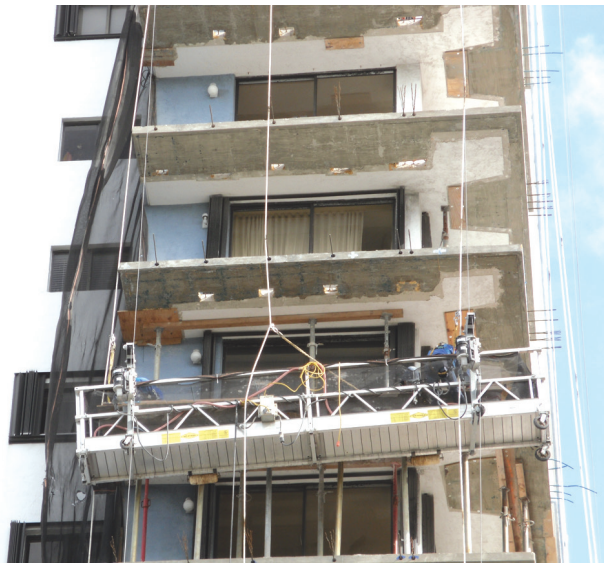
East face formwork removed, concrete placed.
