**CONCRETE SLAB EDGE REPAIRS WITH  
POST-TENSIONING ANCHORS**

BY DONALD CHALAIRE

Authorized reprint from: December 2016 issue of the *PTI JOURNAL*

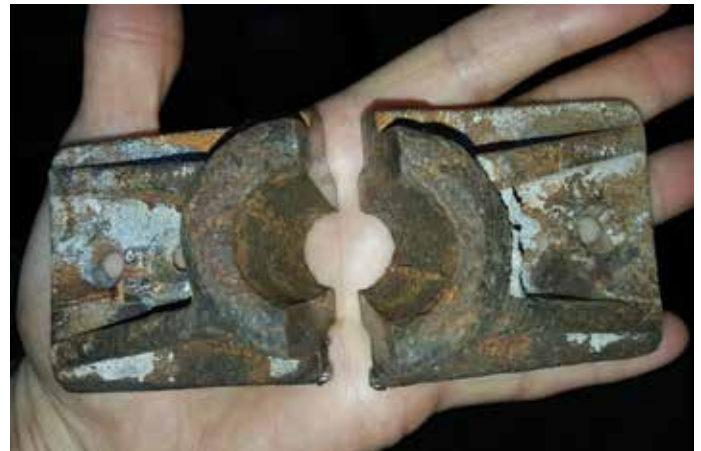
Fig. 1—Specimen No. 1: anchor, nonbearing front side.

Specimen No.	1	2	3	4	5	6	7
<b>General</b>	The anchor, wedge, and strand were saw-cut in half (Fig. 1)	The wedges and strand were machine pressed out of the anchor (Fig. 9 and 10). The wedges stayed attached to the strand (Fig. 11, and 12)	The anchor, wedge, and strand were left intact	The anchor, wedge, and strand were left intact	The anchor, wedge, and strand were left intact	The anchor, wedge, and strand were left intact	The anchor, wedge, and strand were left intact <sup>2</sup>
<b>Strand in tendon</b>		Lightly oxidized with no loss of cross-sectional area	No loss of cross-sectional area	No loss of cross-sectional area	No signs of rust or deterioration	No signs of rust or deterioration	
<b>Bearing side of anchor</b>	Minor pitting approximately 0.005 in. deep (Fig. 3)	Very minor pitting approximately 0.005 in. deep	Surface rust and outer edges with pitted areas approximately 0.06 in. deep (Fig. 15)	Surface rust at the edges only and pitted areas of 0.06 in. in some areas (Fig. 17)	Surface rust at the edges only (Fig. 19)	Surface rust with minor pitting around the edges only approximately 0.005 in. deep (Fig. 21)

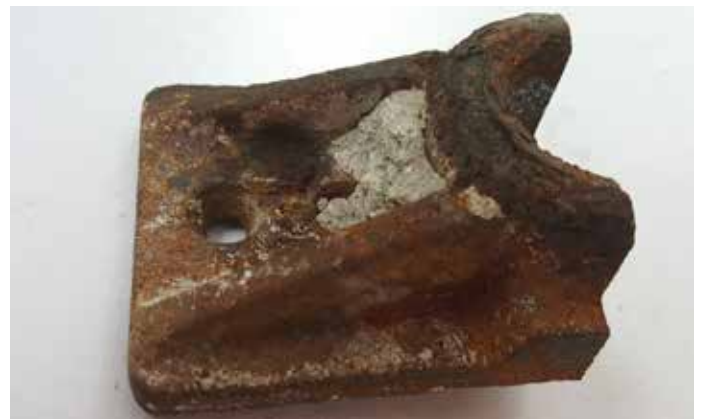
Fig. 2—Specimen No. 1: anchor, nonbearing front side.

<b>Wedge cavity</b>	Minor pitting <0.005 in. deep (Fig. 4)	Very minor pitting <0.005 in. deep (Fig. 13)					
<b>Nonbearing front side of anchor</b>	Minor pitting approximately 0.005 in. deep (Fig. 2)	Minor pitting approximately 0.005 in. deep	Rust scale mostly at the outermost surface at the barrel	Minor pitting and scaling, mostly at the outer edges with pitting approximately 0.005 in. deep	Minor pitting and scaling; the pitting is approximately 0.005 in. deep	Minor pitting approximately 0.005 in. deep	
<b>Wedge outside surface</b>	Minor pitting <0.005 in. deep	Very minor pitting <0.005 in. deep					
<b>Wedge inside surface</b>	Clean serrated teeth intact along the cut (Fig. 5-7) <sup>1</sup>						
<b>Strand tail in front of anchor</b>	Significantly deteriorated	No loss of cross-sectional area	Significantly deteriorated (Fig. 14)	No loss of cross-sectional area (Fig. 16)	Deteriorated with approximately 30% loss of cross-sectional area (Fig. 18).	No loss of cross-sectional area (Fig. 20)

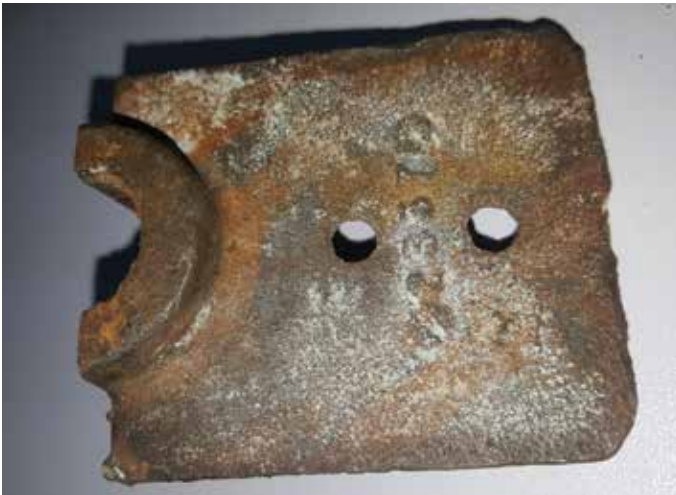
Fig. 3—Specimen No. 1: anchor, bearing side.

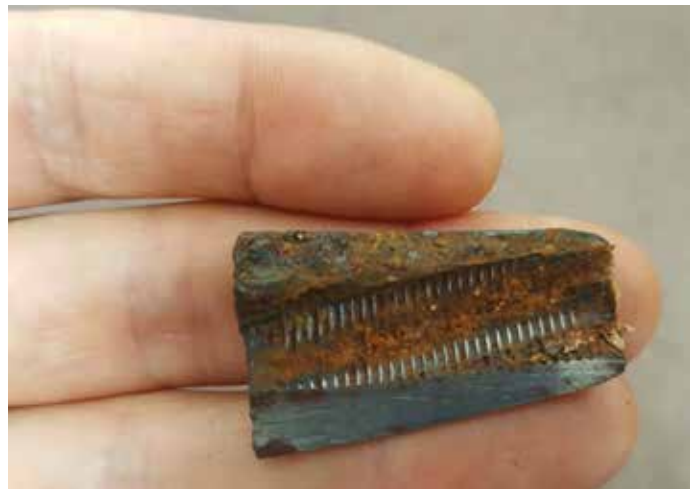
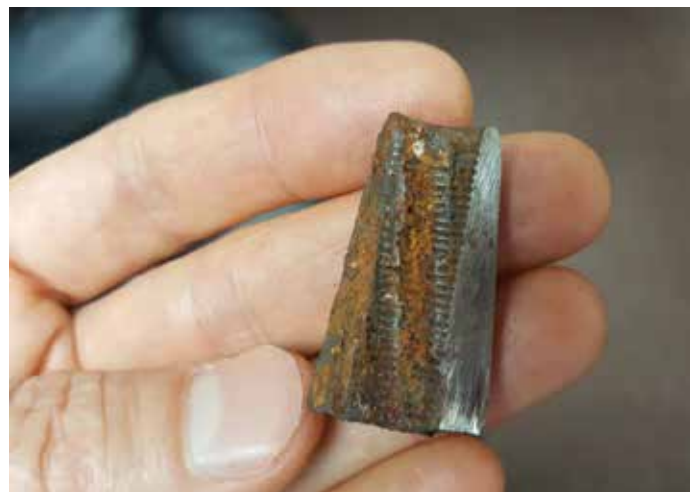
Fig. 6—Specimen No. 1: wedge serrated teeth.

Fig. 7—Specimen No. 1: wedge serrated teeth

1. The serrated teeth that did not contact the stranded are covered in scale the same height as the teeth. The cable strands on the load side of the anchor show clean bite marks from the wedge teeth with no rust and no loss of cross-sectional area. (Fig. 8)

5. Steel surfaces loaded in high compression against other steel surfaces will not rust. The steel loaded in compression in the wedges serrated teeth showed no rust. The rust on the PT parts only propagated between void spaces between cable strands or wedge spaces. If the void spaces were reduced or eliminated, the rust would be eliminated.

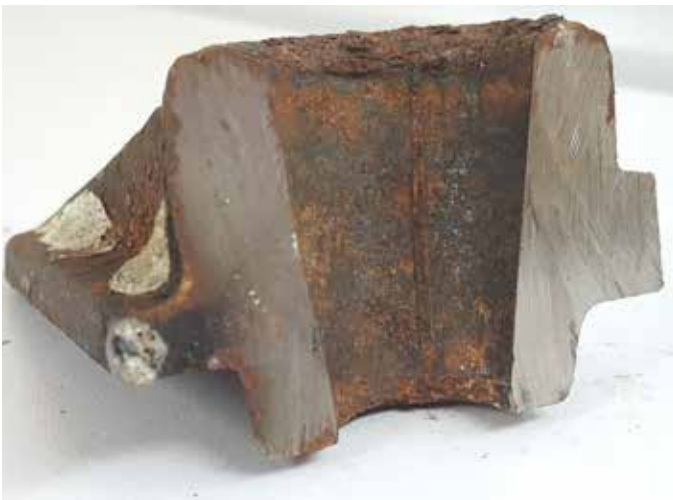
Fig. 4—Specimen No. 1: anchor cross section.

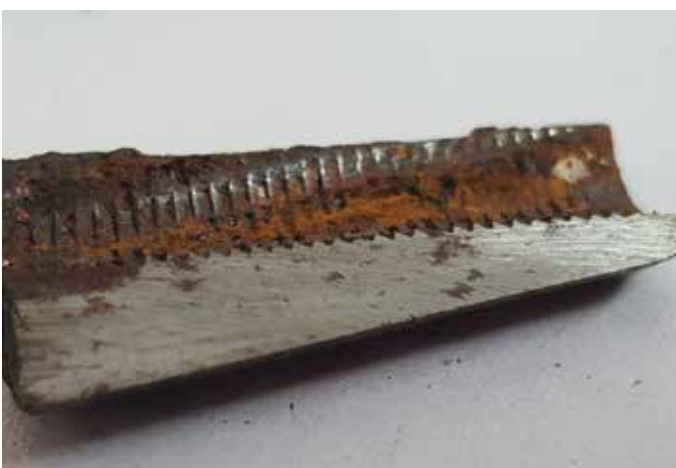
Fig. 5—Specimen No. 1: wedge cross section.

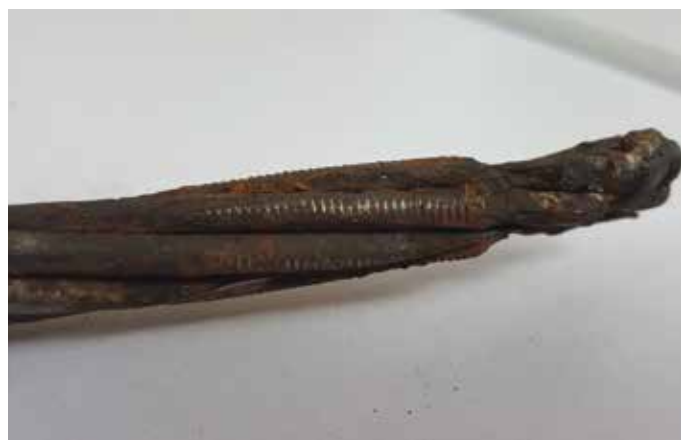
Fig. 8—Specimen No. 1: strand bite marks from wedge.

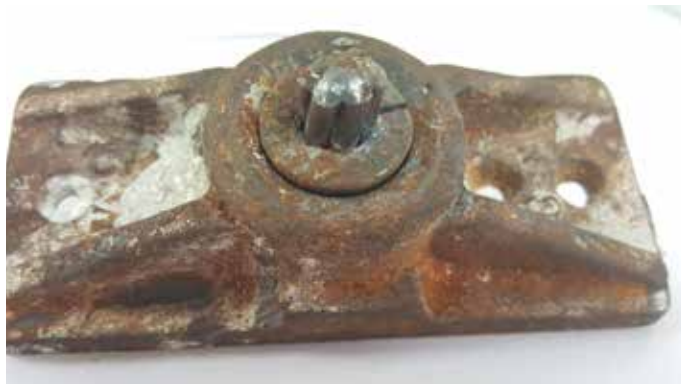
Fig. 9—Specimen No. 2: anchor, nonbearing side.

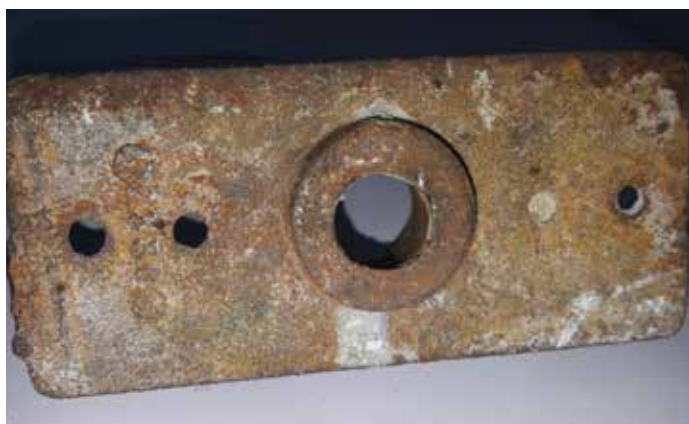
Fig. 10—Specimen No. 2: anchor, bearing side.

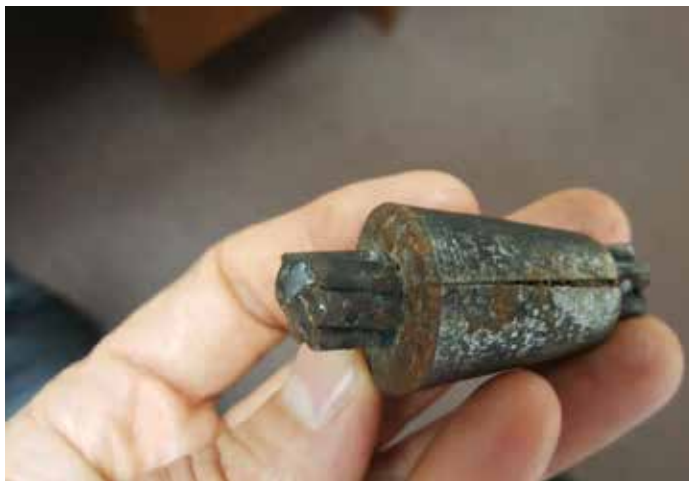
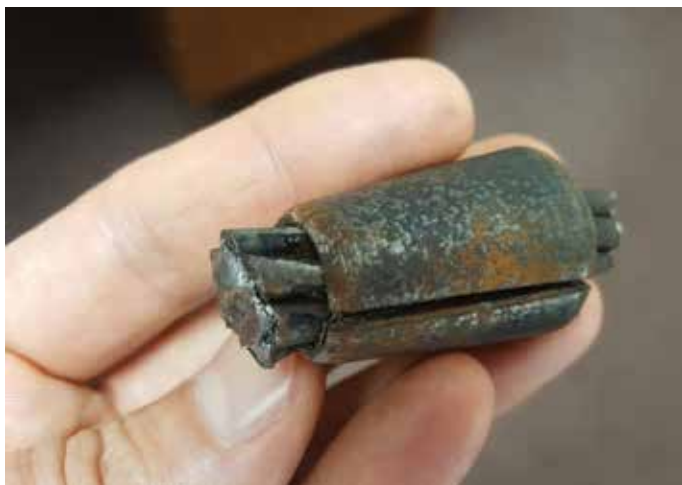
Fig. 12—Specimen No. 2: wedge and strand.

Fig. 11—Specimen No. 2: wedge and strand.

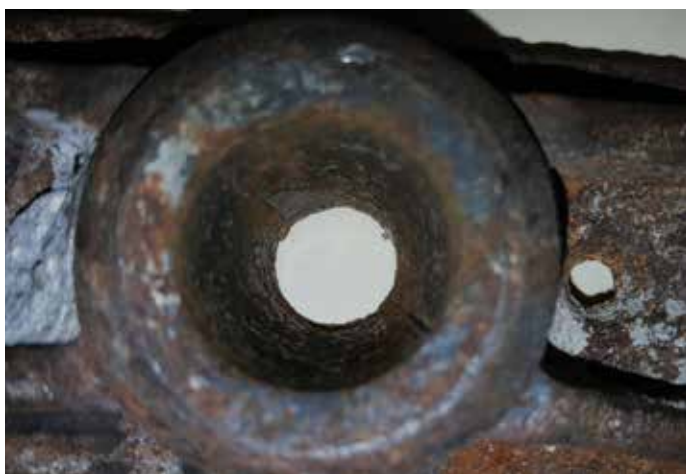
Fig. 13—Specimen No. 2: anchor, inside surface of wedge cavity.

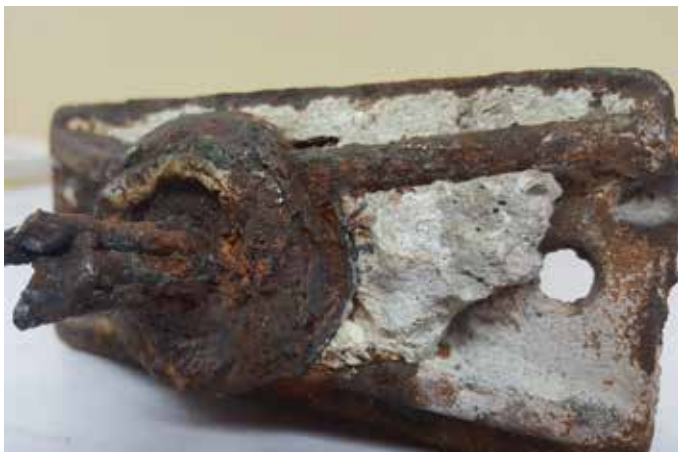
Fig. 14—Specimen No. 3: anchor, nonbearing side.

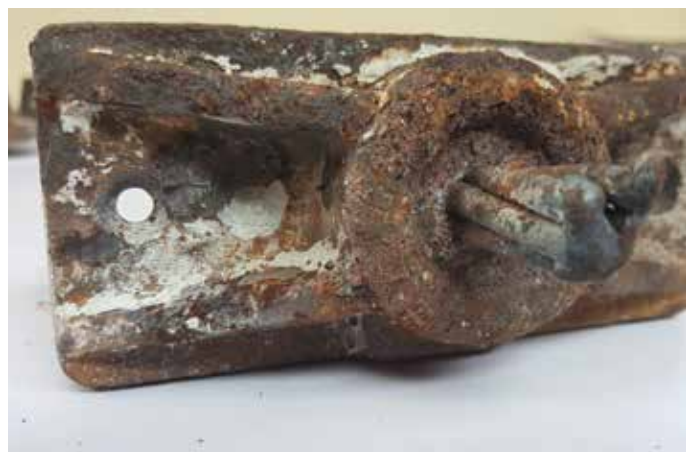
Fig. 16—Specimen No. 4: anchor, nonbearing side.

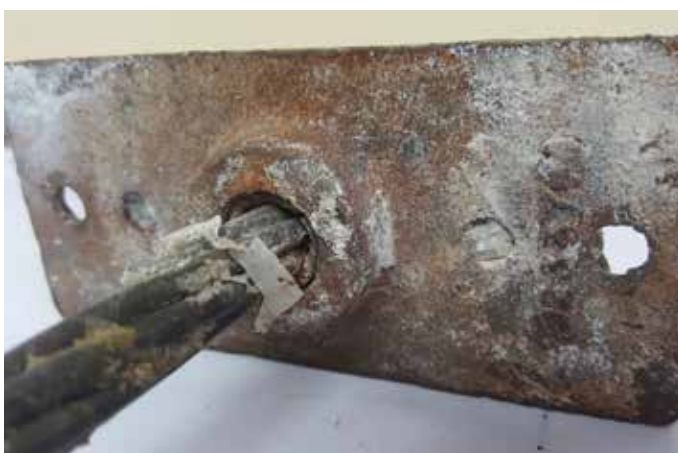
Fig. 15—Specimen No. 3: anchor, bearing side.

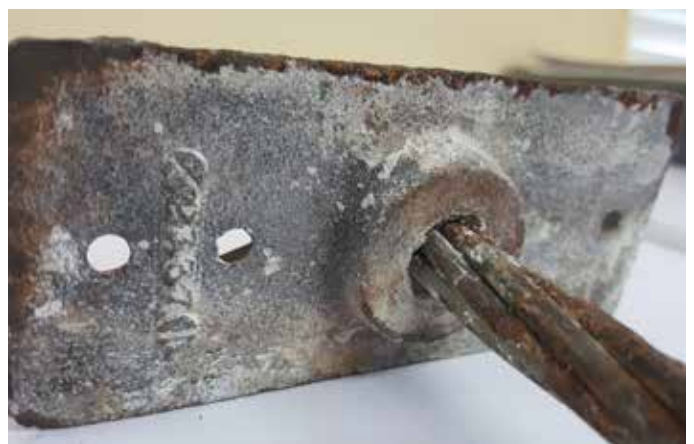
Fig. 17—Specimen No. 4: anchor, bearing side.

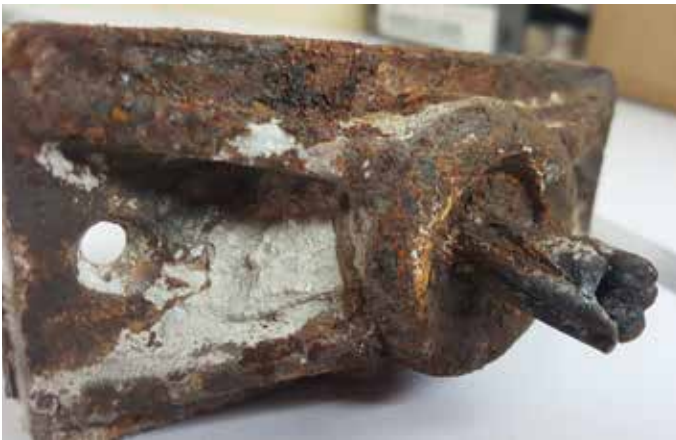
Fig. 18—Specimen No. 5: anchor, nonbearing front side.

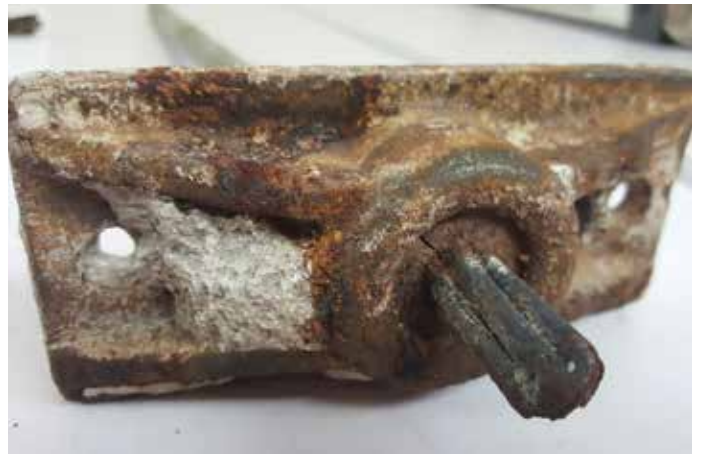
Fig. 20—Specimen No. 6: anchor, nonbearing front side.

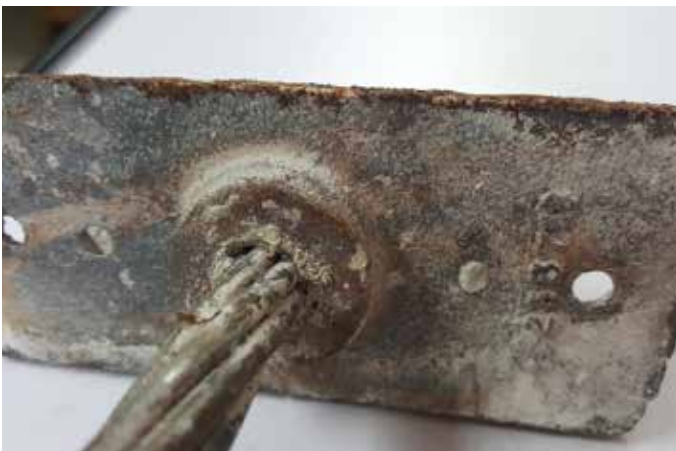
Fig. 19—Specimen No. 5: anchor, bearing side.

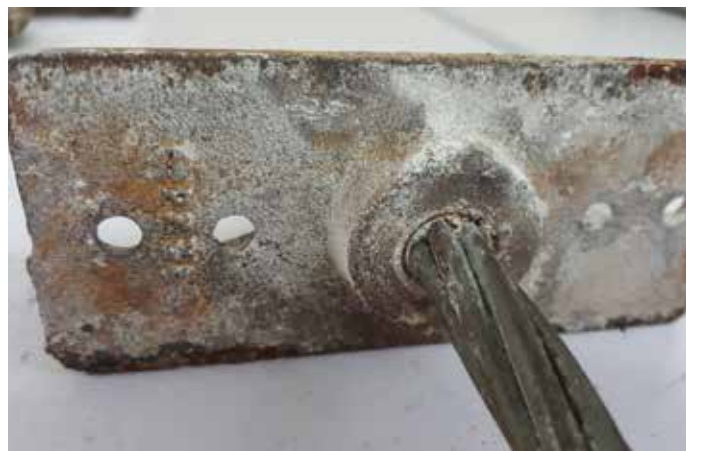
Fig. 21—Specimen No. 6: anchor, bearing side.
