**ALTERNATIVE SOLUTION USING POST-TENSIONING FOR
CHANGE-IN-USE OF EXISTING BUILDING**

SIVAKUMAR MUNUSWAMY AND ERIC SEARCH

Authorized reprint from: December 2017 issue of the PTI Journal

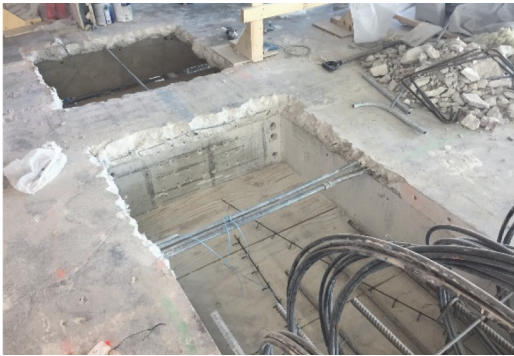
Fig. 10—Concrete cross beam drilled at west-end to allow PT tendons (12th level).

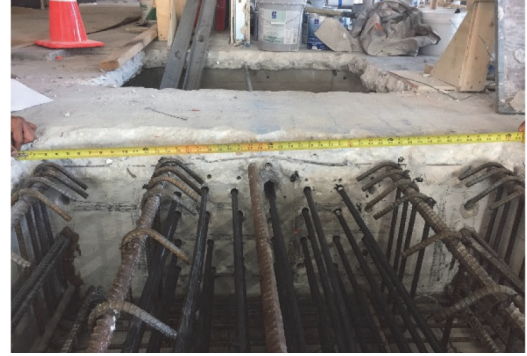
Fig. 11—PT tendons installed (12th level).

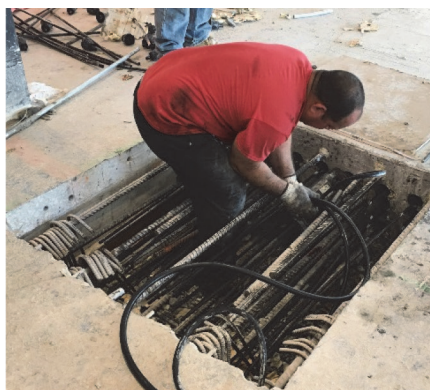
Fig. 16—Stressing of PT girder (13th level).

The transverse beams supporting the joists were poured together with the PT girders (Fig. 14). Access holes were core drilled into the floor slab to enable concrete placement (Fig. 15) into the transverse concrete beams. Initial condition stresses dictated that concrete strength required at the time of tendon stressing was at least 4500 psi (31 MPa) (Fig. 16). The formwork was removed after the second pour attained the designed compressive strength of 6000 psi (40 MPa). The slab openings were successfully made and the stairs installed (Fig. 17).

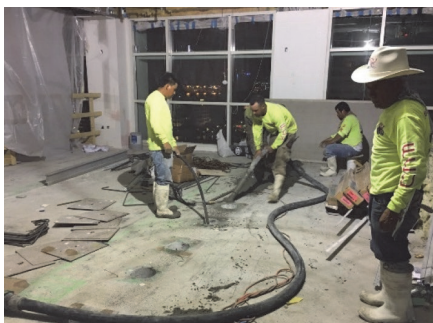
Fig. 15—Pouring of concrete through access holes for concrete transverse beam.

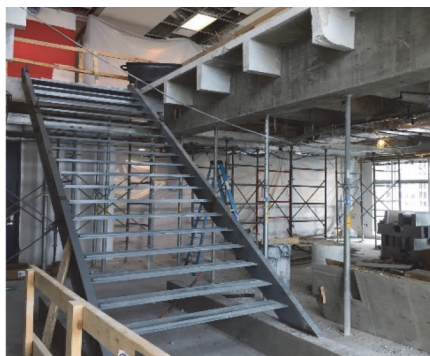
Fig. 17—Slab opening and stair.
