Authorized reprint from: July 2019 issue of the *PTI JOURNAL*

# NONDESTRUCTIVE TESTING FOR VOIDED AND SOFT GROUT IN INTERNAL POST-TENSIONING DUCTS

BY PAUL FISK AND BENSON ARMITAGE

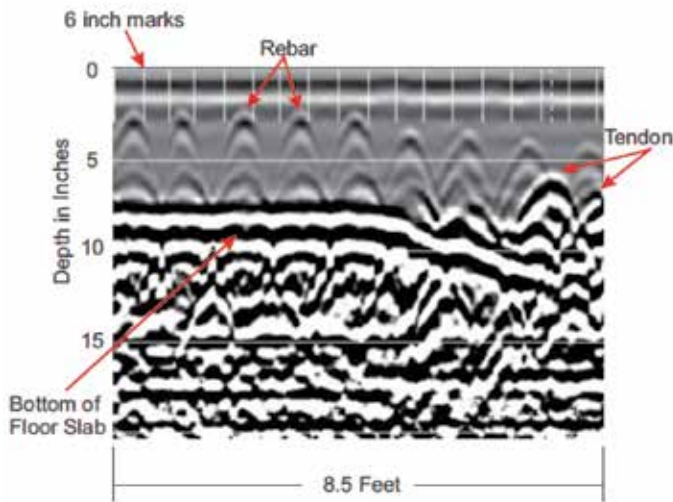
Fig. 1—Annotated GPR record to locate PT ducts.

Placement of sonic/ultrasonic sensors and the energy generation for impact echo testing needs to be highly accurate, within 1/2 in. (13 mm) of the projected plane of the internal PT duct. High-resolution GPR is used to accurately locate the centerline of the duct. Shop and/or as-built drawings are not usually accurate enough to locate the centerline. GPR data (Fig. 1) are acquired using a 1600 MHz or higher-frequency antenna to locate metal and PVC ducts with the required accuracy. Figure 1 shows GPR data being acquired on a vertical line of coverage on the web of a girder to locate PT ducts. The approxi-

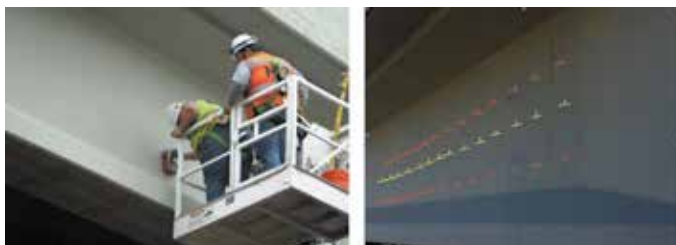
Fig. 2—(a) GPR to locate web tendons; and (b) tendon locations marked on girder web.

mate center line of each tendon duct is marked on the concrete surface with different color keel at 1 ft (305 mm) test intervals for sonic/ultrasonic testing (Fig. 2).

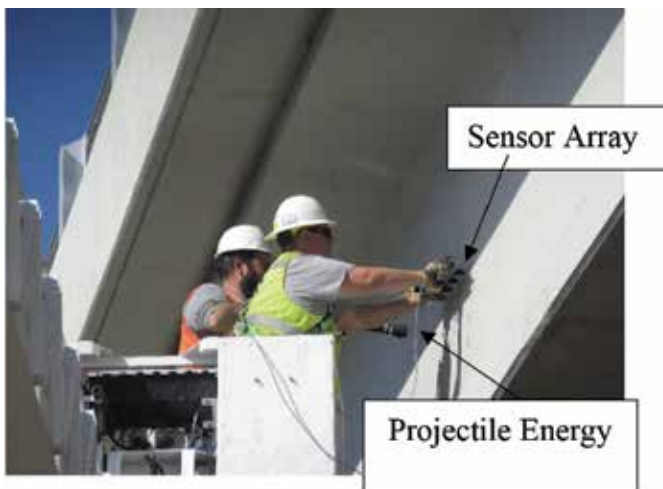
Fig. 3—Impact echo testing.

The projectile impact produces stress waves that are reflected from the back wall and detected by an array of sensors. Each sensor measures the amplitude of the stress wave in time (time-domain plot). The sensor array is placed at the marked 1 ft (305 mm) intervals along the top quarter point of the duct (Fig. 3). Time domain data are used to measure the compressional and shear wave velocity values (strength of girder concrete), and the frequency domain data is a Fourier analysis of the time domain data to determine the resonant frequency (thickness) of the concrete elements being tested.

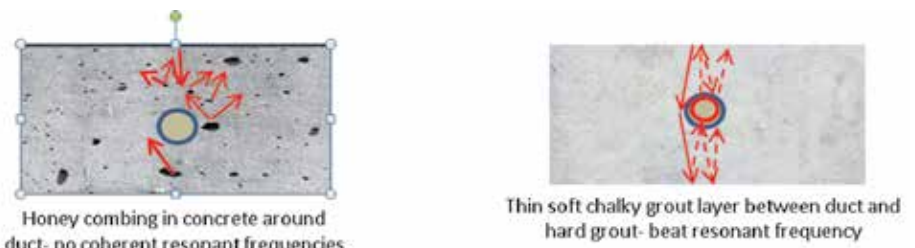
Fig. 6—Diffracted sonic wave paths.

The resonant frequency for a fully grouted duct typically is slightly lower than the thickness of the concrete in which the tendon is located. If the duct is voided or has soft grout, the wave will effectively travel (diffract) around the void/soft grout along a longer time path (Fig. 5)/lower frequency than that for a fully grouted duct. When duct voids, soft grout, grout delaminations, or honeycombing in the concrete around the duct exist, the arrival of the diffracted wave may destructively interfere with the normally reflected (direct wave), preventing identification of the normal thickness resonant frequency and in some cases introducing spurious beat frequencies or no coherent frequencies. (Fig. 6).

Condition 2 is considered to be an anomalous condition that is due to a layer of soft, chalky, or brittle grout inside the duct, duct tape, or corrosion on the duct or high air entrapment in the web concrete. Spurious frequencies are due to destructive interference due to the conditions listed in Fig. 6.

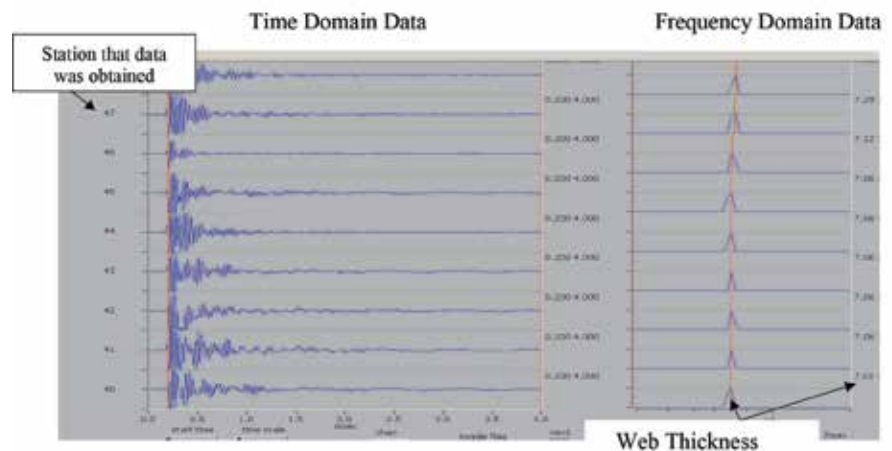
Fig. 7—Samples of sonic/ultrasonic data associated with ducts filled with hard grout.

Examples of the sonic/ultrasonic data for Condition 1 and 3 are provided herein. Figure 7 is an example of Condition 1. Sonic/ultrasonic impact echo thickness resonant frequencies are in the range of 6.5 to 7.4 kHz and drilling verified ducts filled with hard grout.

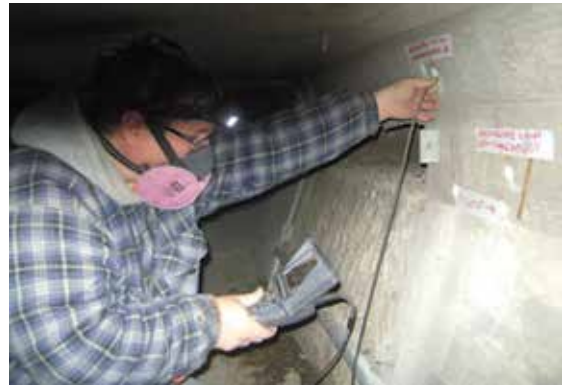
Fig. 9—Borescope inspection.

made to open metal ducts for visual observation of grout condition. Grout conditions inside the duct and the drill hole side wall conditions are documented using a video borescope (Fig. 9 and 10).
