**EVALUATION OF DRYING TECHNIQUE FOR  
REMEDIATING SOFT GROUT IN  
POST-TENSIONING TENDONS**

BY SATYAJEET PATIL, EDUARDO TORRES, CHRISTINA  
FREEMAN, AND H. R. (TREY) HAMILTON

Authorized reprint from: July 2019 issue of the PTI *JOURNAL*

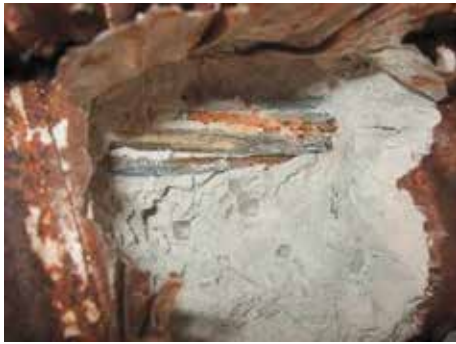
Fig. 1—Deficient grout in PT tendon in Sicily, Italy (Anania et al. 2018).

Corrosion has been found during inspection of several grouted post-tensioned (PT) bridges in Florida (Azizinamini and Gull 2012) as well as in PT bridges outside of Florida (Sprinkel and Balakumaran 2017; Anania et al. 2018). Generally, corrosion occurs when the PT grout is deficient or due to incorrect grouting practices. One grout deficiency is when all or a portion of the injected grout does not harden (Fig. 1), resulting in soft, unhardened grout. This “soft grout” has been found to form due to higher-than-recommended water dosage, use of large proportion of filler materials, or prehydration of the prepackaged cementitious material (Randall et al. 2015).

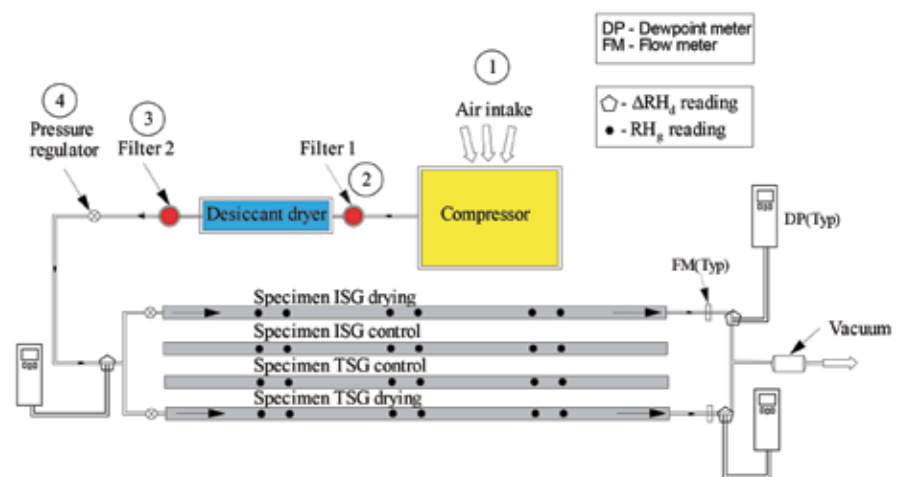
Fig. 2—Drying test setup.

Four tubular specimens with dimensions of 31 ft (9.4 m) long and 4 in. (100 mm) diameter were constructed to evaluate the effectiveness of the proposed drying technique (Fig. 2). These specimens were filled with layers of soft grout mixtures with different moisture contents, which were prepared by mixing cement and ground dolomite limestone mixtures in various proportions based on previous studies (Randell et al. 2015). Two of the four specimens did not undergo the air drying process to serve as control and allow for comparison with the drying specimens. The drying system consisting of a compressor and desiccant dryer that was set up to produce dehumidified air for removing moisture from air. Each specimen had an inlet and outlet to allow for the flow of the dehumidified air. Relative humidity (RH) of air discharged at the outlet was measured at regular intervals to monitor the drying process. Once the RH of the outlet air was reduced to that of the inlet air, drying was terminated, and specimens were dissected. For comparison, non-drying control specimens, which were replicates of drying specimens, dissected at the same time as drying specimens. The moisture content of grout samples collected from control and drying specimens were used to determine the effectiveness of the drying technique. RH readings collected during drying were further analyzed to determine the criteria for drying termination.

A drying system was set up to dry mockup specimens filled with grout, which injected pressurized dried air into one end of the mockup specimens; this air flowed through the specimen and was discharged at the opposite end (Fig. 2). The drying system was designed to generate dry air with relative humidity (RH) less than 10%. Compressor, desiccant dryer, and filters in the drying system produced dry air and the pressure

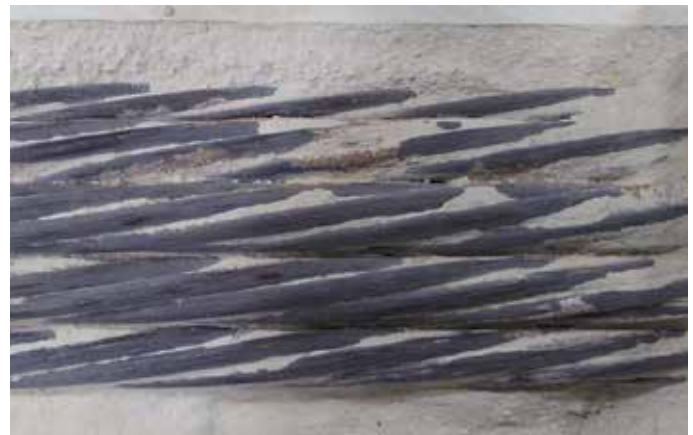
Fig. 9—In-place corroded strands near Port C drying TSG specimen.

the presence of corrosion. During visual evaluation, corroded strands were found predominantly in drying specimens (Fig. 9). However, corrosion was preferential on the peripheral strands of the tendon. The location of corrosion found on the specimen is shown in Fig. 10.

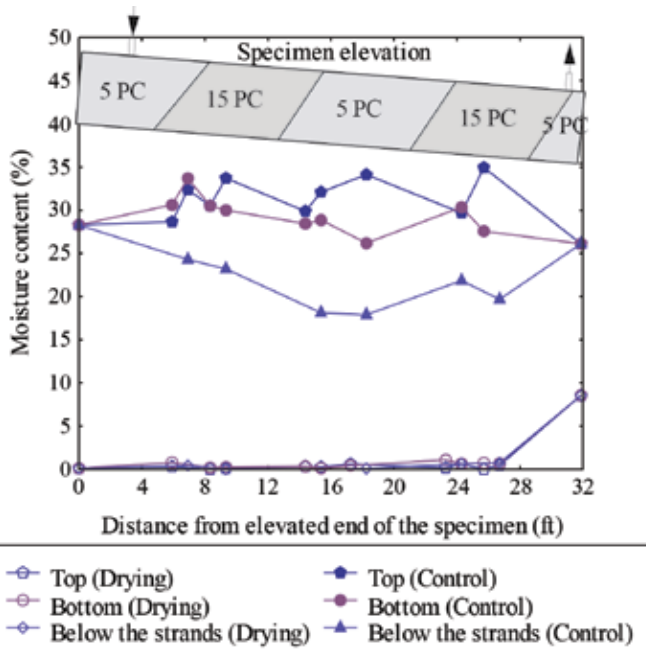
Fig. 14—Comparison of moisture content for drying and control ISG specimens.

Figure 14 shows a graphical representation of the MC measurements plotted as a function of their location in the ISG specimen for both the control (solid markers) and drying specimens (hollow markers). Moisture content in the drying specimen was negligible (<1% by mass) compared to that measured in the control specimens, with the exception of the measurement taken at the lower end of the slope. Thus, it can be concluded that the drying technique was effective in removing almost all moisture from soft grout present in the drying specimen between the air inlet and outlet.

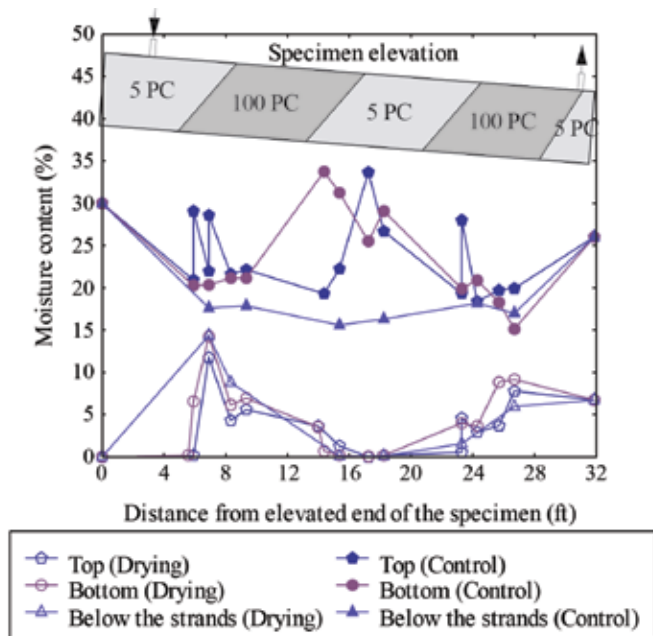
Fig. 15—Comparison of moisture content for drying and control TSG specimens.

Figure 15 shows moisture content measurements plotted as a function of their location in Specimen TSG for both the control (hollow markers) and drying specimens (solid markers). Figure 15 shows that in the undried control specimen, 100PC normal grout layer had lower moisture content than the adjacent 5PC soft grout layer even though the water to solids ratio was the same. This was because normal grout had more cement content, resulting in higher degree of hydration and higher consumption of water than soft grout. On the other hand, in a dried specimen, dried normal grout layer had higher moisture content than dried soft grout. This was probably due to the less porous nature of the 100PC, which restricted the removal of moisture compared to the relatively porous soft grout.

In general, moisture content of both 5PC and 100PC decreased considerably after drying. Moisture content in the central 5PC layer in drying specimen was negligible (<1%) compared to the control specimen. These results in Specimen TSG are similar to that of Specimen ISG, indicating that the airflow through the hardened normal grout layers was sufficient to dry the trapped layer of 5PC grout.

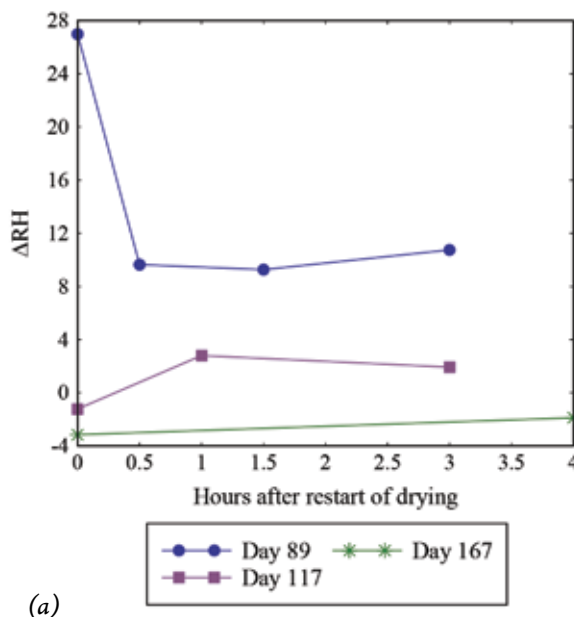
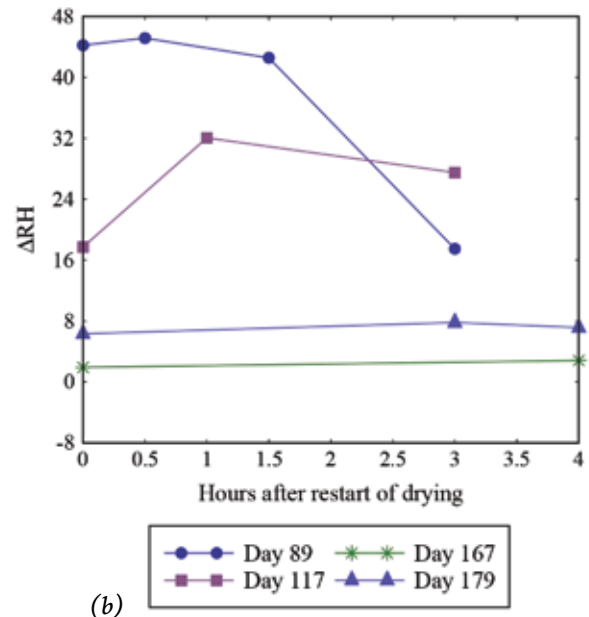
Fig. 18—Dryness checks for specimen: (a) ISG; and (b) TSG.

Dryness checks were performed using the procedure described in drying process chapter for  $\Delta RH_d$  readings to check if significant free moisture remained in the specimens. Dryness checks were performed several times after 89 days of drying. Table 3 shows interpretation of dryness check based on difference between the initial RH measured immediately after restarting the drying system ( $\Delta RH_{di}$ ) and RH measurement after 2 hours of restarting the drying system ( $\Delta RH_{df}$ ).
