**VANCOUVER HOUSE**  
**Vancouver, BC**

Authorized reprint from: Issue 2 2020 of the PTI *JOURNAL*

# VANCOUVER HOUSE

VANCOUVER, BC, CANADA

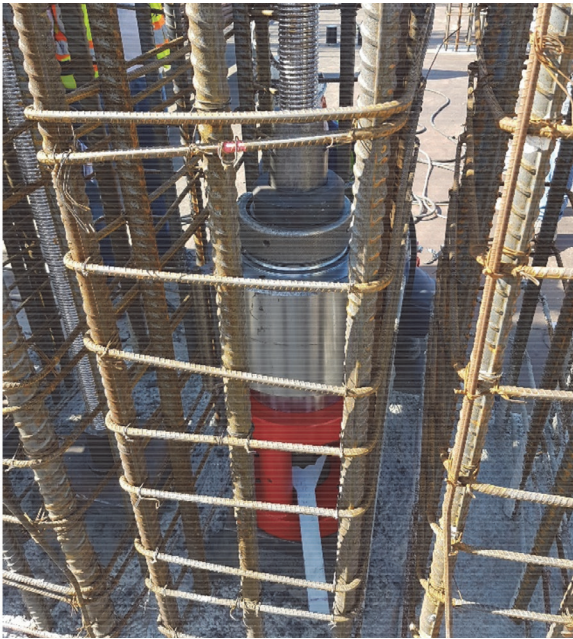
Fig. 4—Stressing of vertical threadbars.

Vertical post-tensioning is not used often and this structure required 11 prestressing threadbars (Fig. 4), each 2.6 in. (66 mm) nominal diameter, to be anchored in the foundation and extend up the core to the 36th level. The tendons are installed in a corrugated sheathing and coupled when required. There were two intermediate stressing locations to help overcome the overturning moments of the cantilevered floors above during construction. At level 26, four of the 2.6 in. (66 mm) threadbars were transitioned to 1.8 in. (46 mm) threadbars through the use of special machined transition couplers.

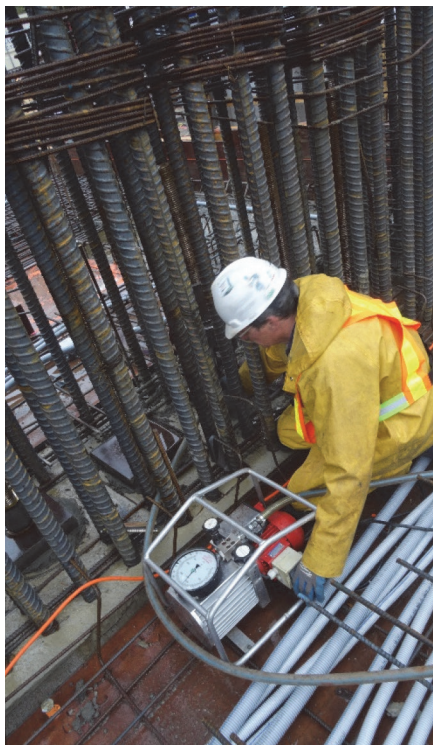
Fig. 5—Stressing of tendons at intermediate points.

The tendons at the intermediate points were stressed using a small-diameter, high-pressure ram (Fig. 5) to fit within the constrained space of the core reinforcing steel. This operation took a lot of coordination with trades and detailing in the area to make sure there were no bars impeding the insertion of the ram into the area.

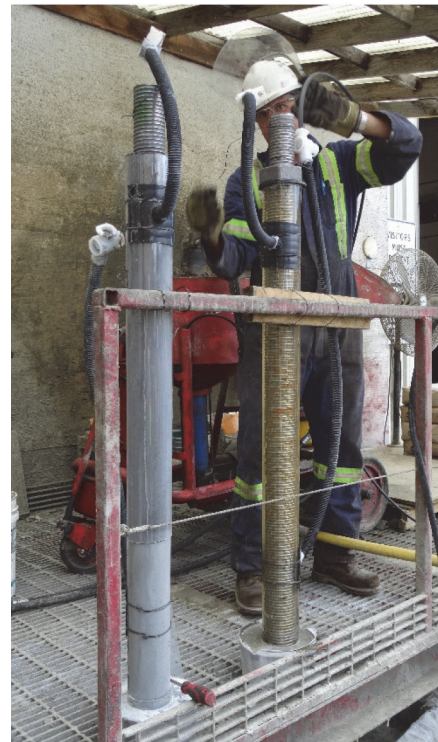
Fig. 6—Grout mockup testing.

Particular attention was paid to the grouting details to make sure the tendons would be completely grouted without voids and to ensure the grout could be injected and pumped to the top of the tendons. The bottom anchorage is located 11.5 ft (3.5 m) below the bottom parking slab, creating an area of concern for water collection. Prior to construction, various grout mockup tests (Fig. 6) were performed to select the appropriate mixture and prove the injection details and positioning of grout injection ports. After the mockup testing was completed, a method was determined to make sure any standing water was displaced from the bottom anchorage. The coupler locations were another area of concern to make sure the couplers had room to travel during stressing and to make sure the grout would not get constricted. Additional ports were installed above and below the couplers in case problems were encountered so that there were options to stop grouting

and continue later without having to drill into the core wall. During the grouting operation, none of the backup measures were required, as the mixture determined during the mockup test and equipment selected performed perfectly.
