PTI JOURNAL

Case Studies

POST-TENSIONING IN STAYED COLUMNS

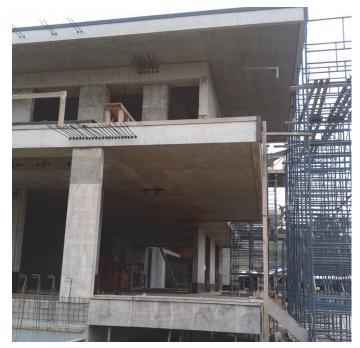
Fig. 5—Stayed column during construction.

The Structural Engineer designed two stayed columns that support the first floor from the roof (Fig. 4 to 6). The stayed columns would behave as tensile elements to support the first floor. It was possible to transfer and support the
