# Post-Tensioning Inspection and Rehabilitation of the I-526 Wando River Bridge

Nick Amico, PE

Senior Bridge Engineer

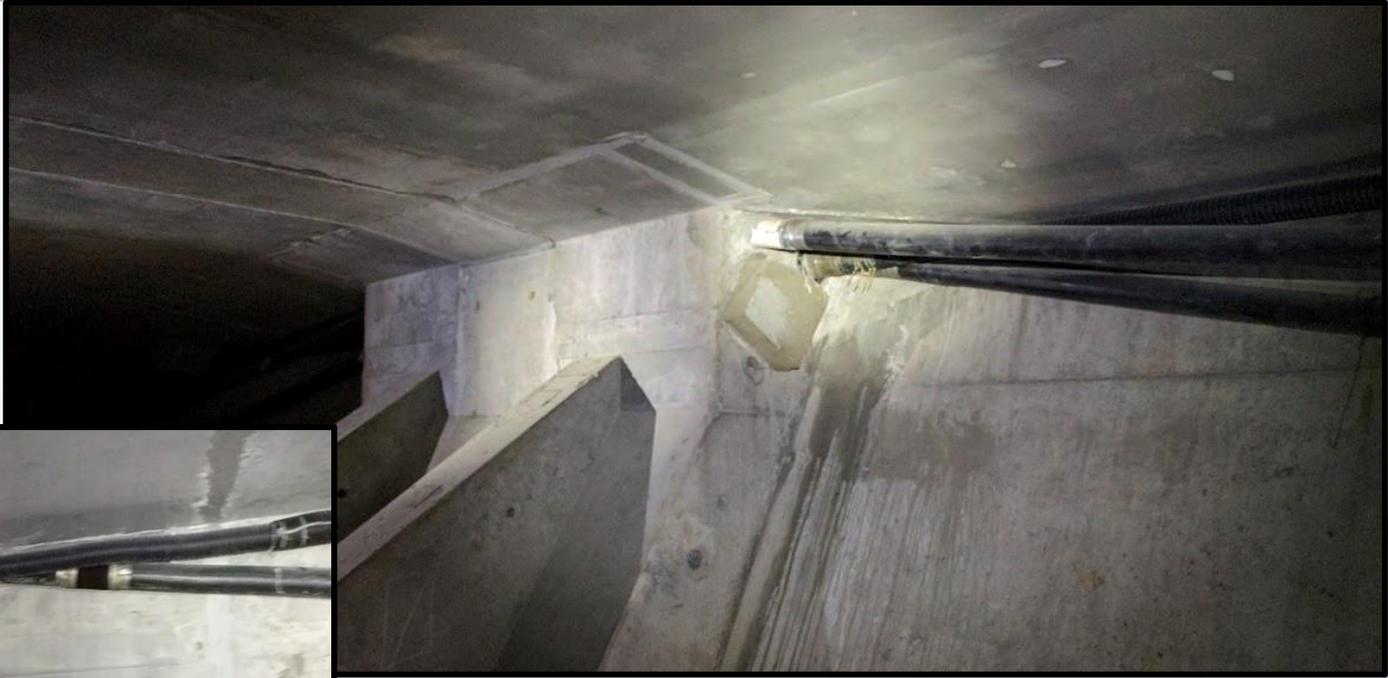
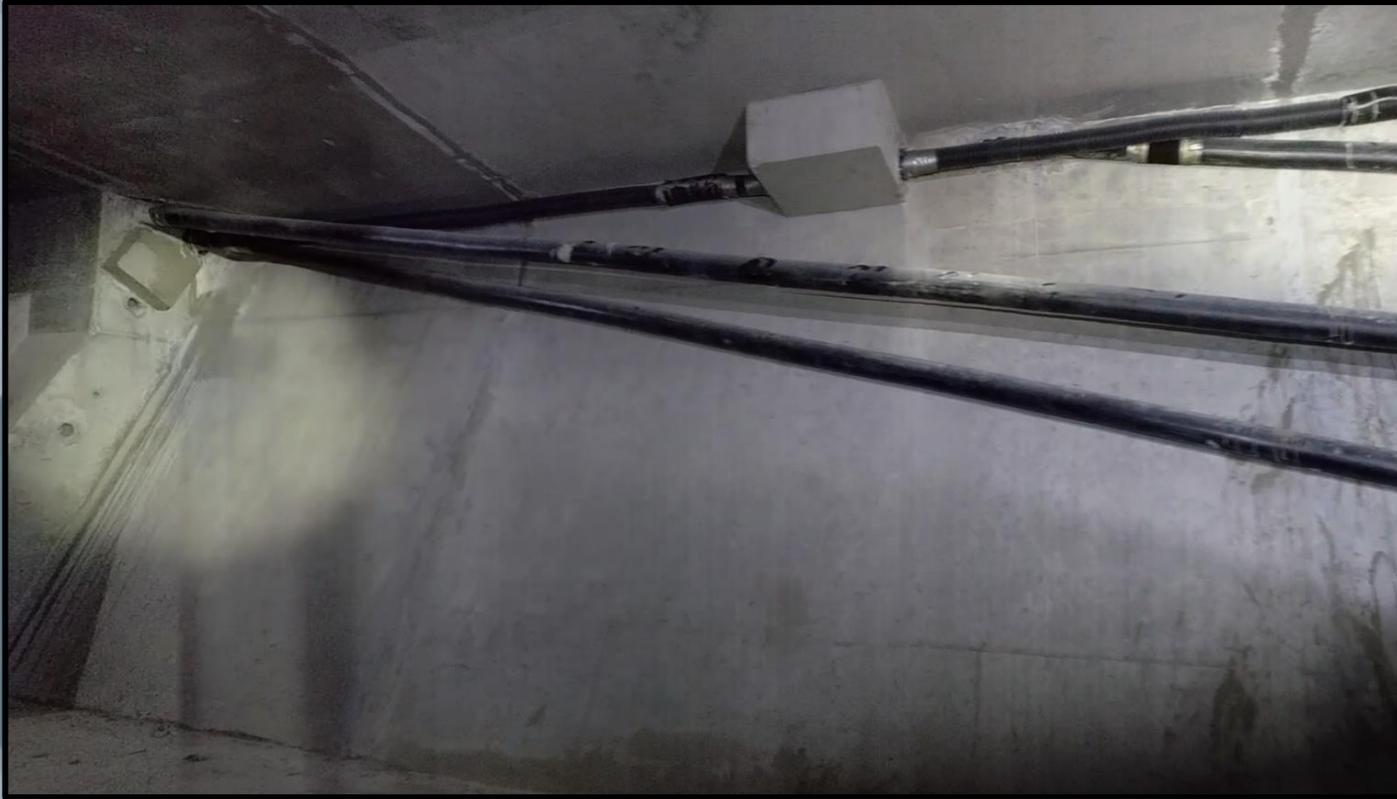
- All original anchors except one per web are uninspectable and unreplaceable.
- The tendon with the accessible anchor deviates into the top slab for multiple segments, including over the pier segment, preventing its replacement.
- No accommodation for future tendons

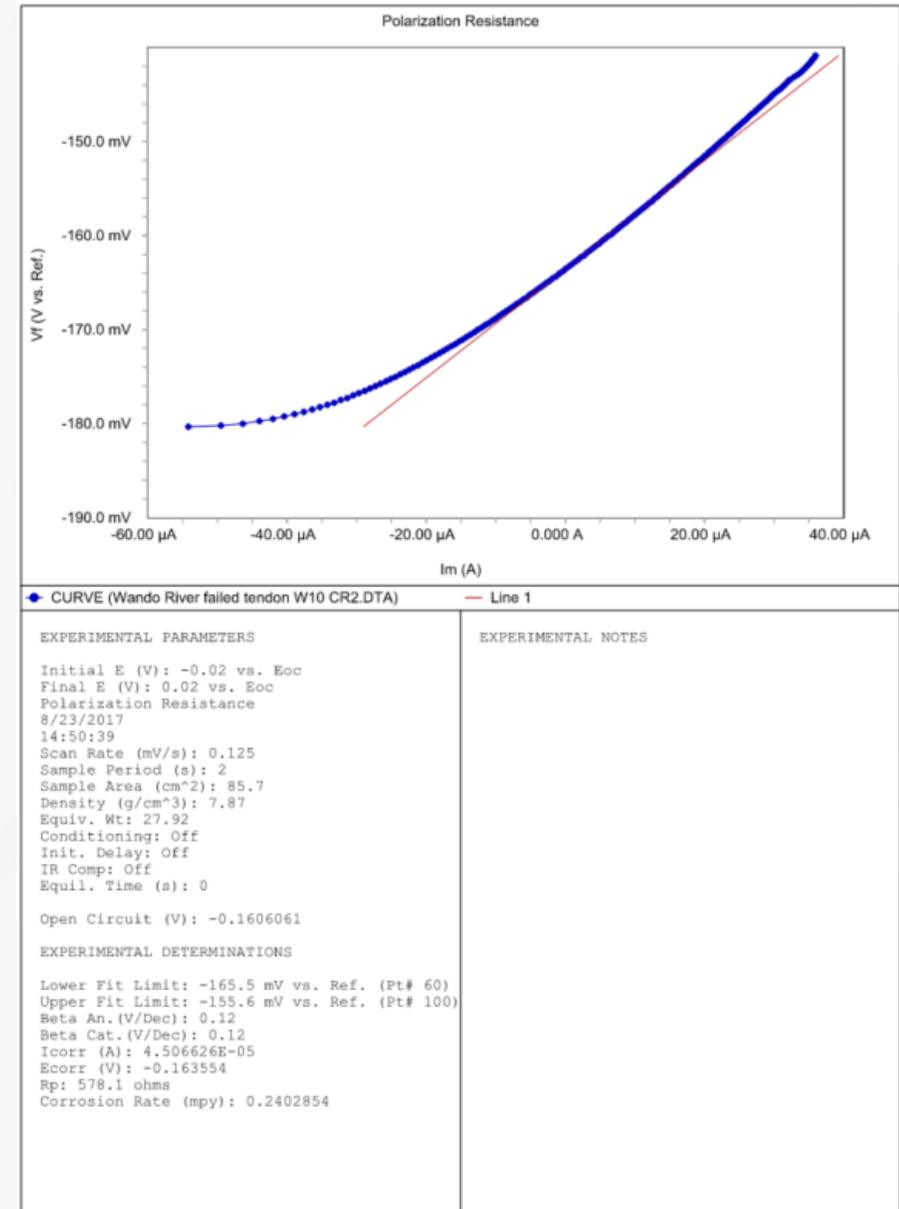
- Grout condition observations
- Corrosion potential
- Corrosion rate
  - Linear polarization resistance test
  - Results were very low  
0.04 mpy - 0.24 mpy

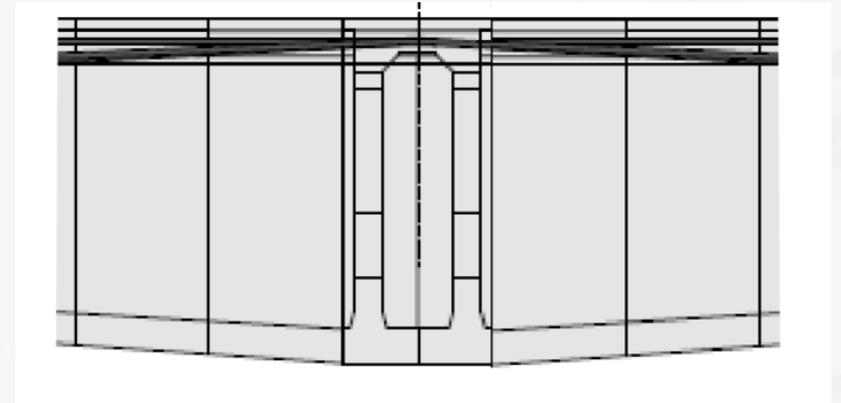
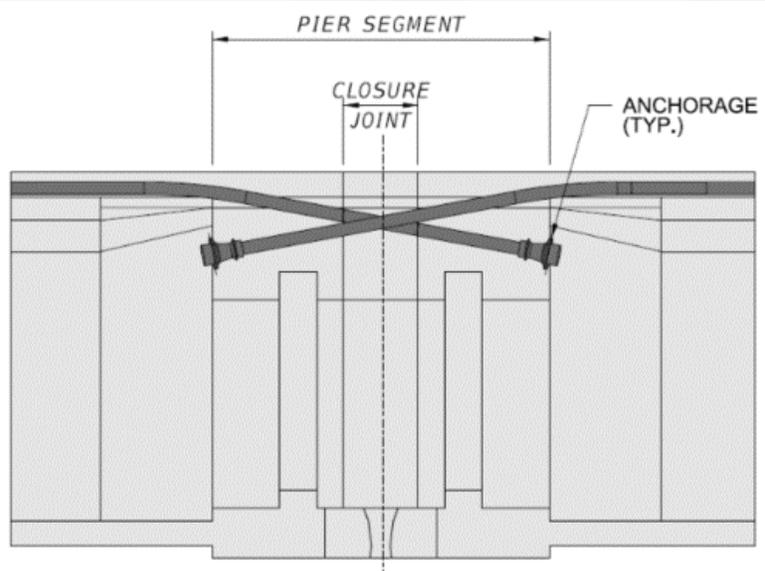
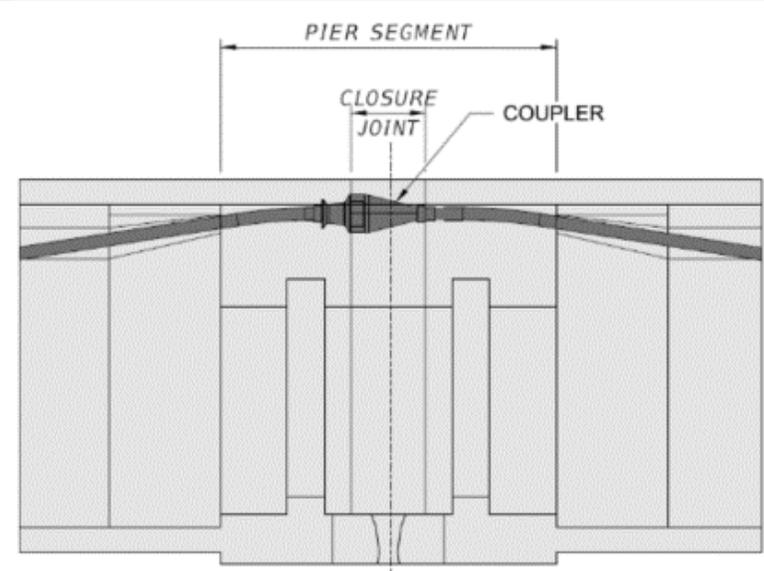
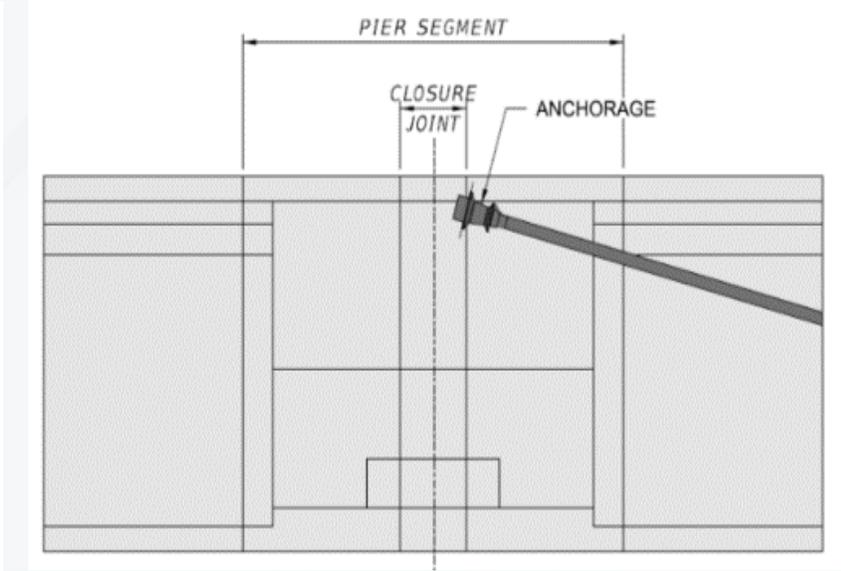
## Visual Tendon and Structure Inspections

- Walk-through inspection of both structures
- Borescope inspections of anchors and high points

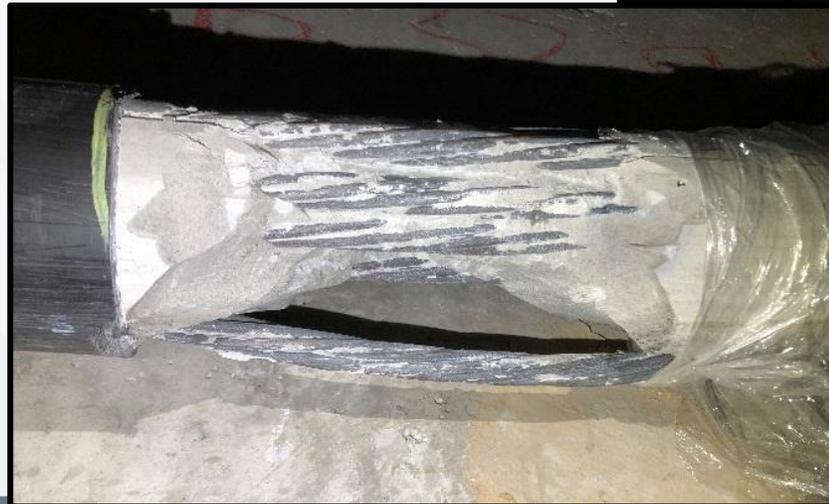
- Leaking segment joints
- Slack tendon (Span 16)
  - No evidence of water infiltration, corrosion, or poor grout
- Slack strands
  - Fully grouted in place, indicating occurrence during construction

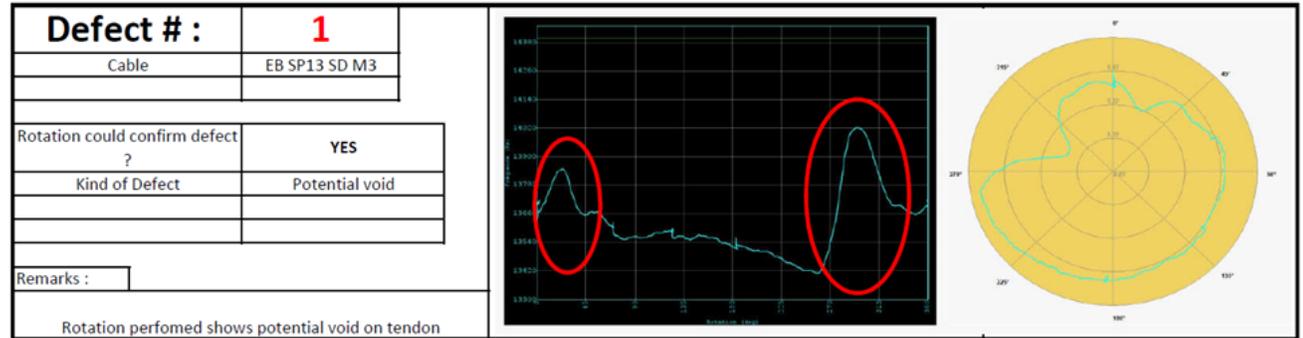
EB SP13 SD M3

- Locates defects including presence of voids, water, white paste, and soft grout
- Monitors the capacitance between two electrodes
- Contrast in permittivity between different materials and moisture content allows measurement of capacitance variation.
- Inspection depth of 30mm
- Moved along duct until a defect is located and rotated around duct to check full section at the point of interest
- Limitations:
  - Requires HDPE ducts with cementitious grout
  - Metallic surfaces within 30cm can interfere and alter the measured frequencies
  - Space required for rotations is 30cm; cannot inspect tendons close to the webs

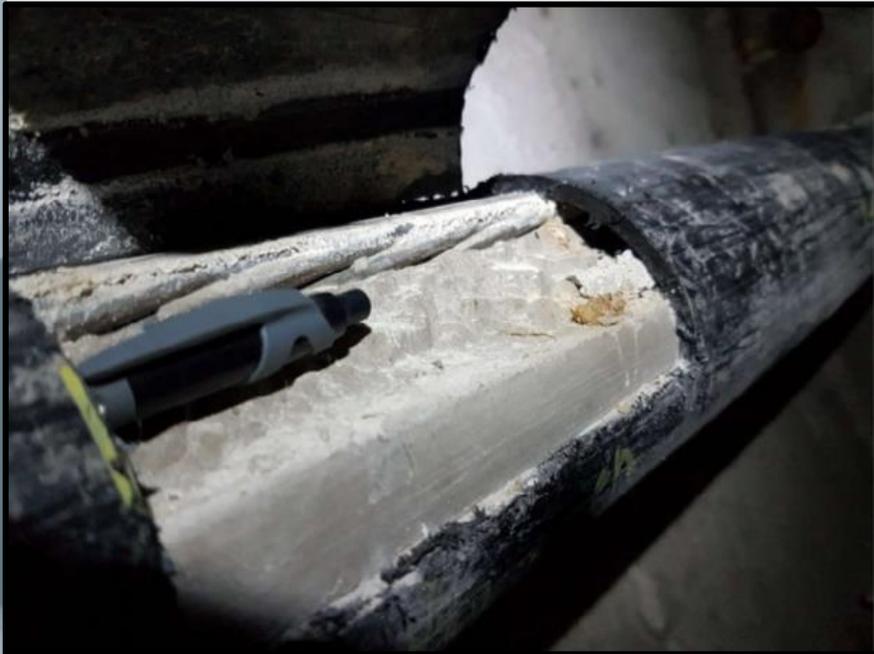
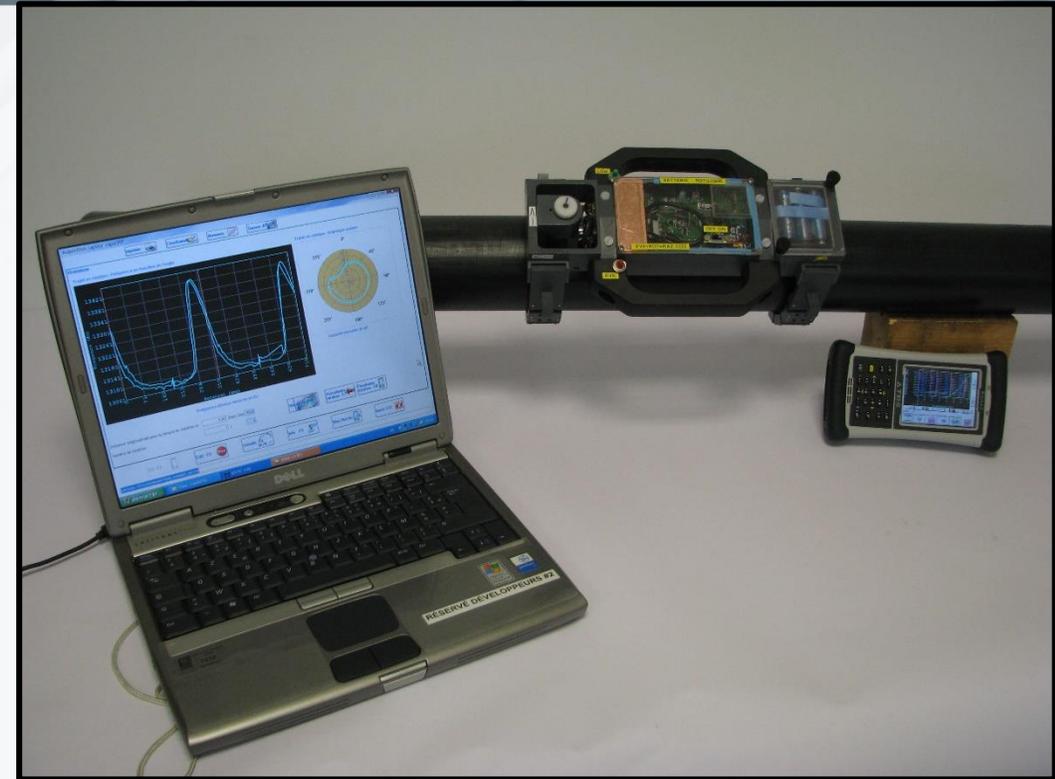
- Located voids of various size and severity
  - Some larger voids, similar to image
  - Some areas of heavily air-entrained grout
  - Small separations between the grout and to of duct
- No evidence of significant distress identified

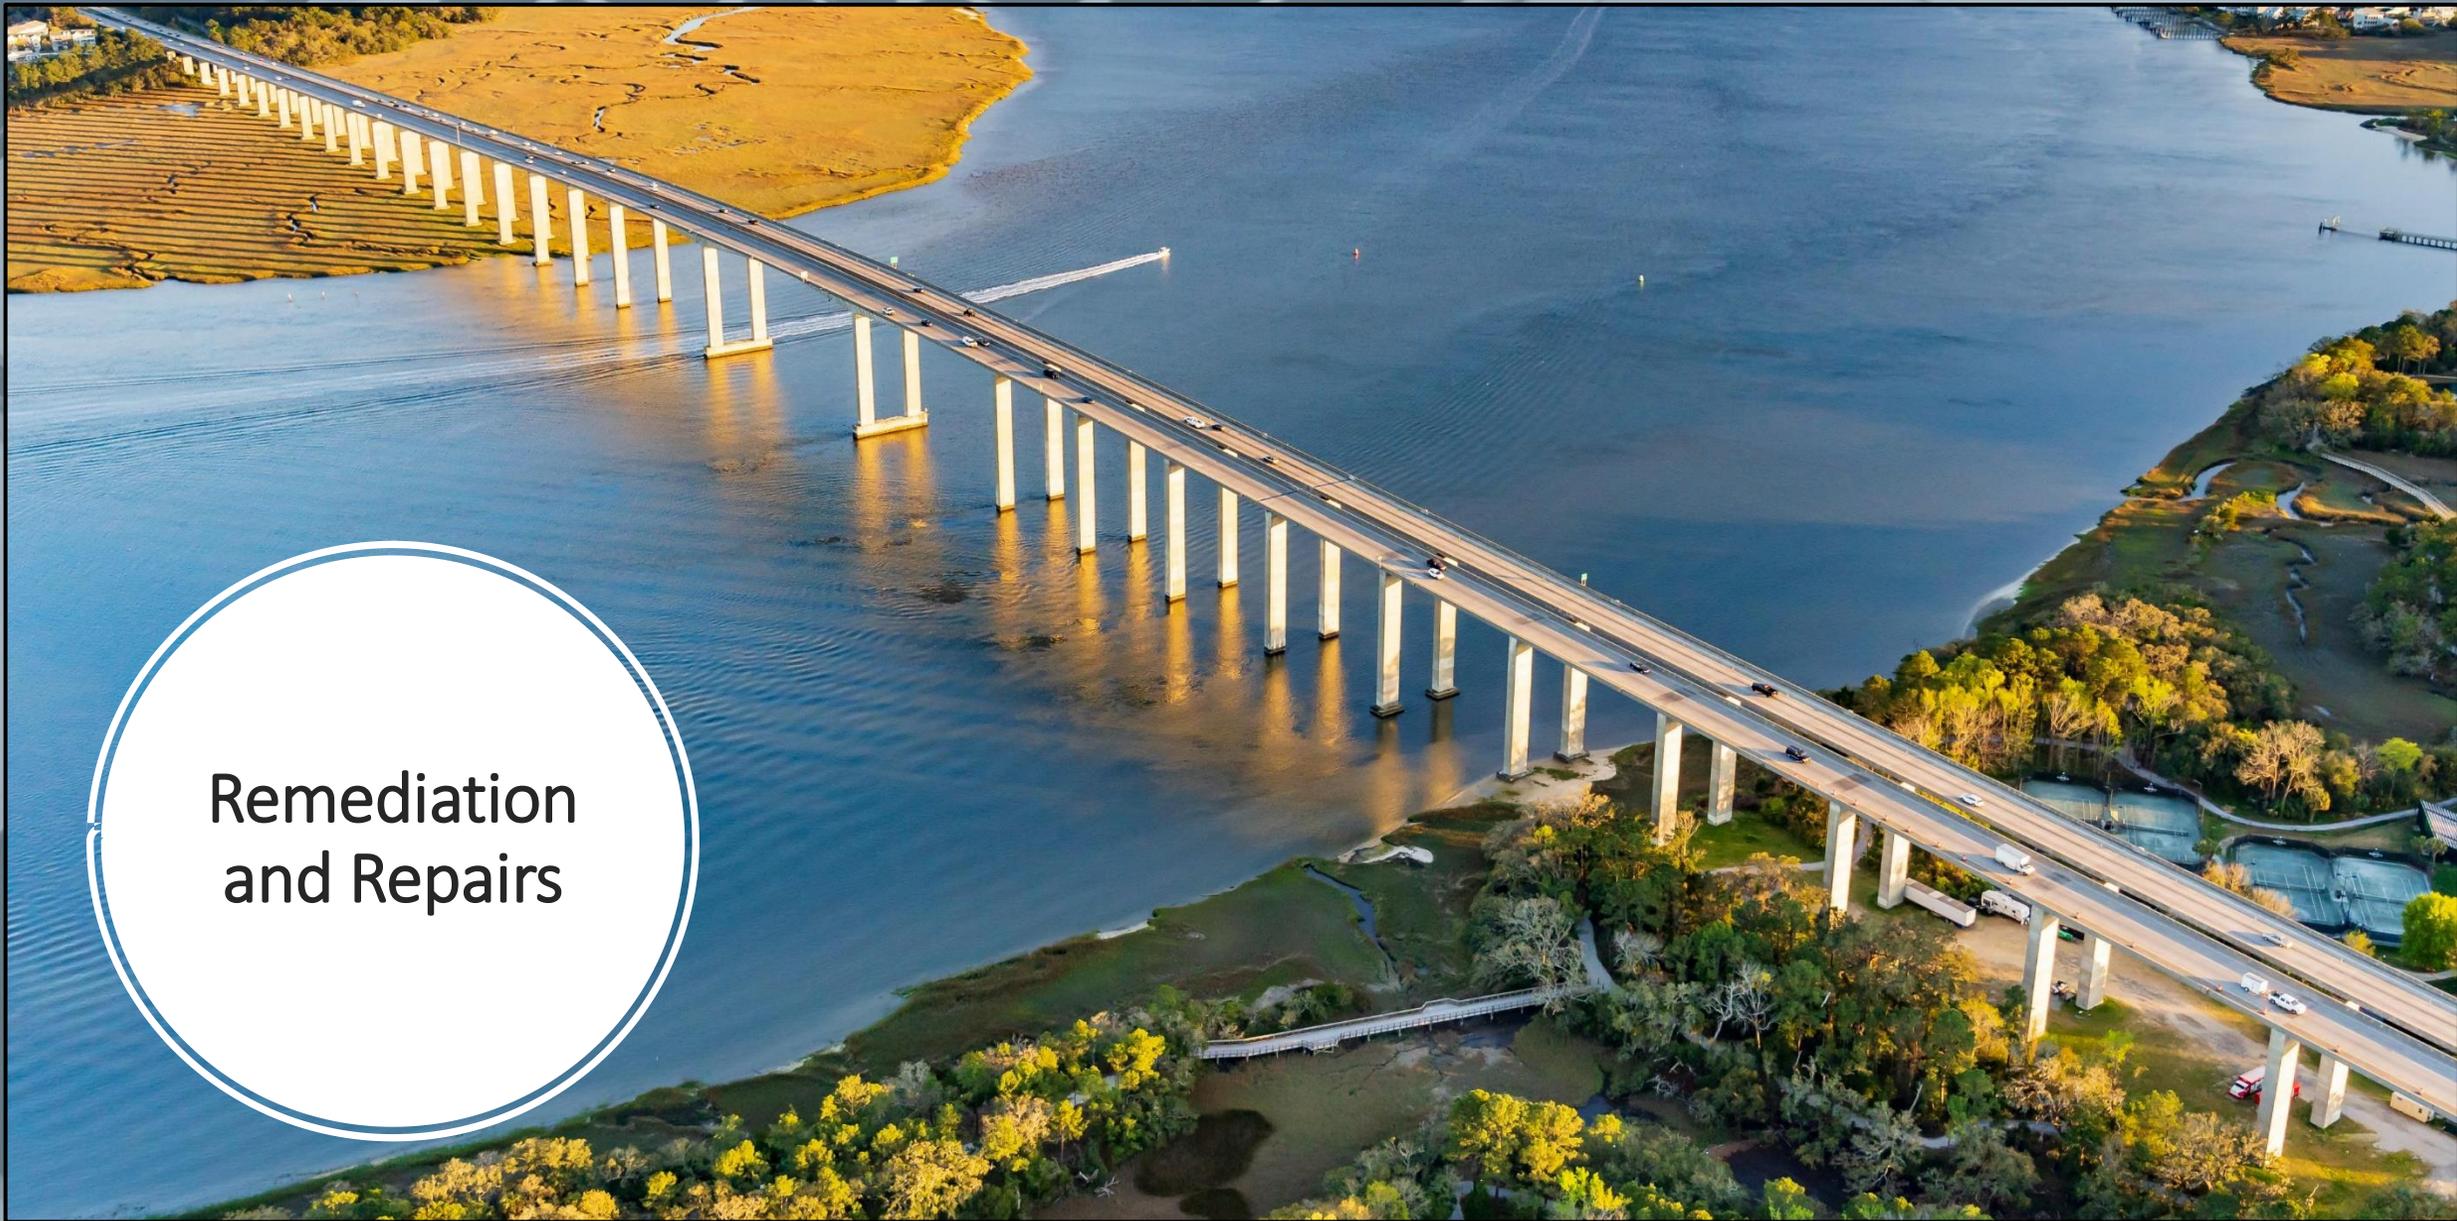
- M1 tendon failed due to the existence of a large grout void and water infiltration
- Grout throughout the structure was of reasonably good quality and would protect tendons as intended if fully encased
- Water infiltration was observed in several locations
- Several leaking segment joints
- One detensioned external tendon
- Use of couplers and embedding of anchors precludes direct replacement of most tendons

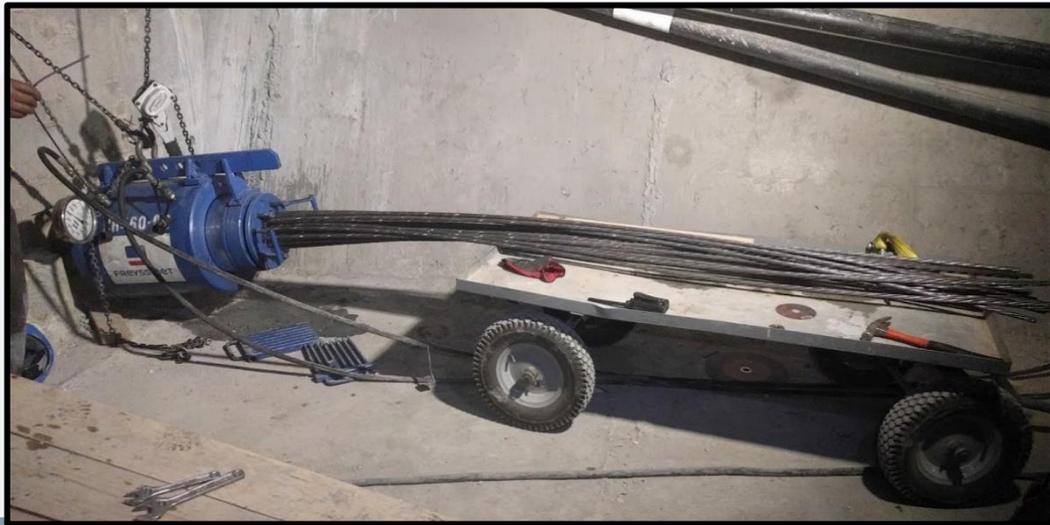
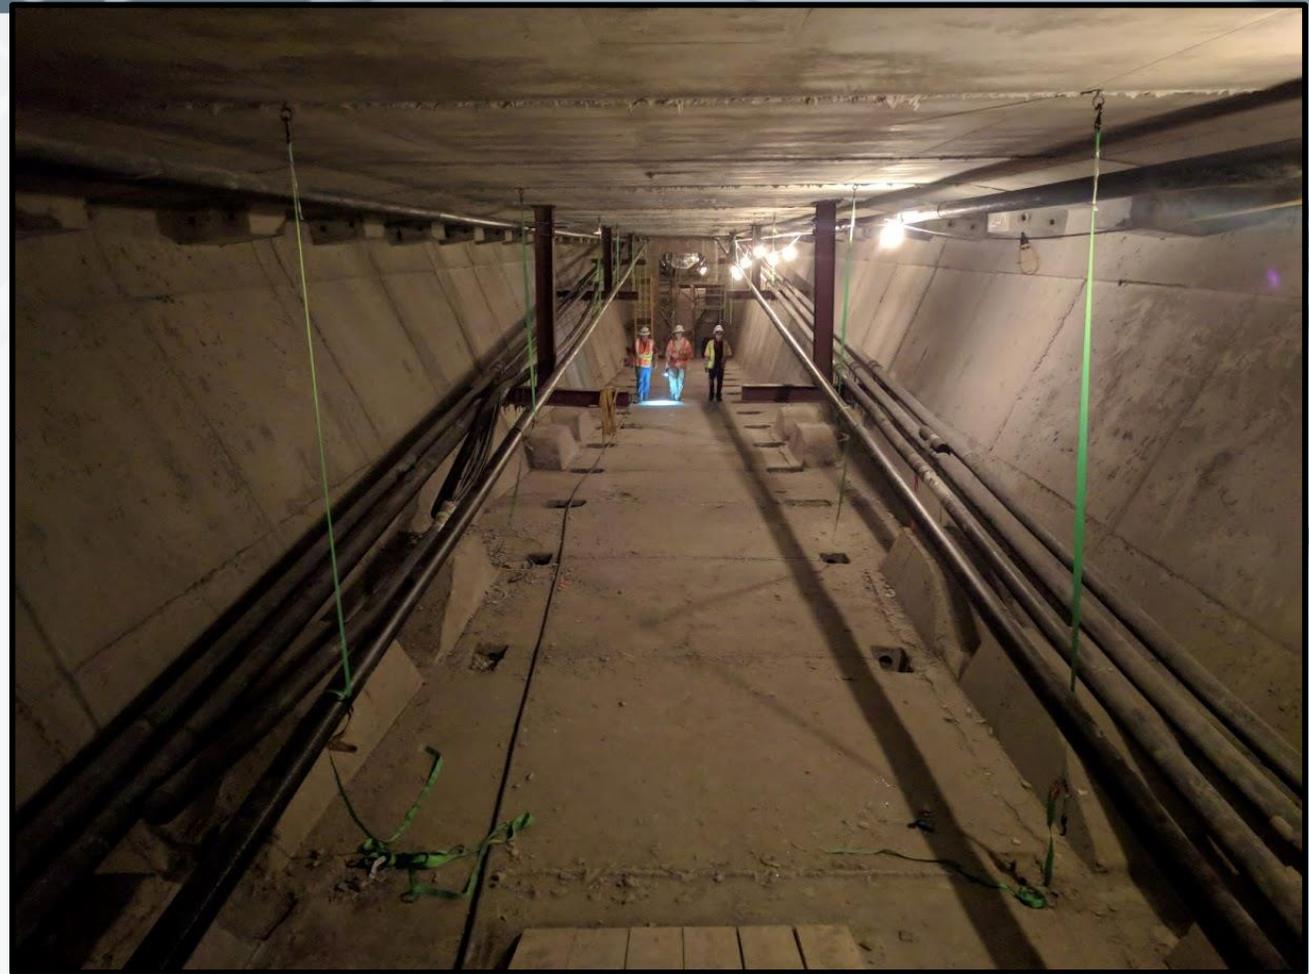
- Second WB tendon rupture, May 2018
- Rupture at same location as M1 tendon
- Closed WB structure; crossovers used to shift WB lanes to EB structure

- Two supplemental tendons permanently installed in both structures
- Deck repairs performed
- Metallurgical testing
- Bridge reopened after 19 days

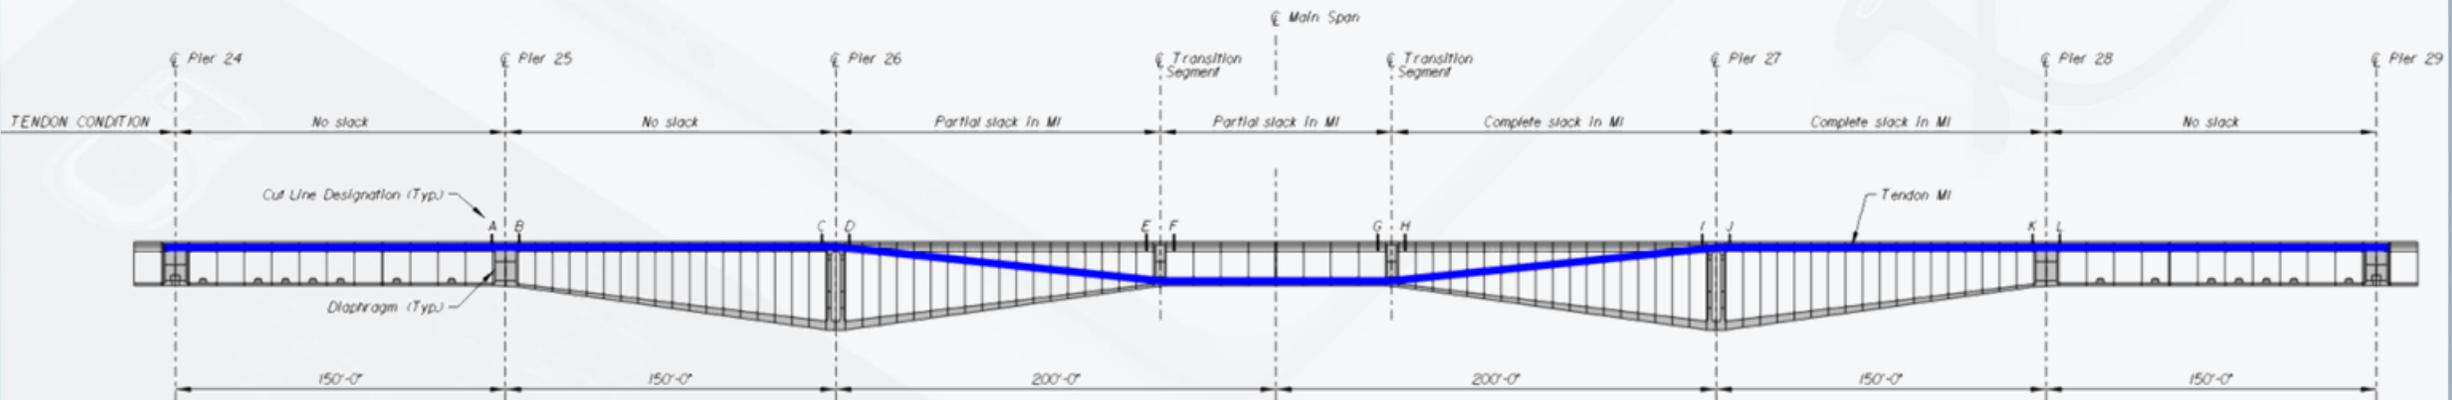
- Advanced corrosion was identified on two additional tendons in the WB structure
- Detensioning required prior to replacement
  - Method used for M2s differed from previous rupture replacements
  - M2s were completely intact, but had partially corroded

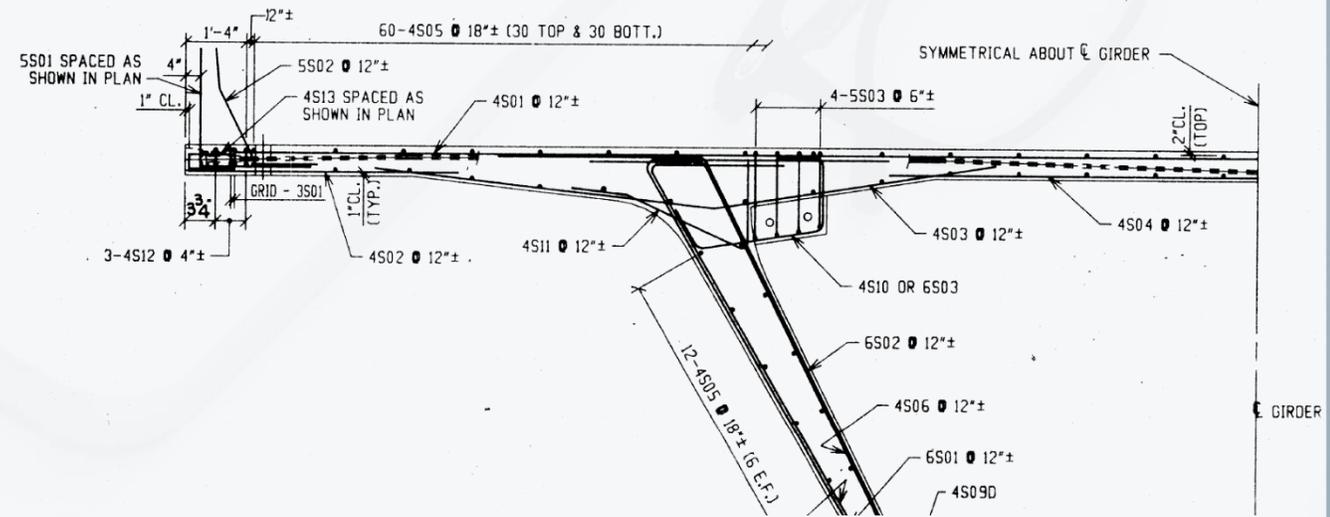
- Joint is between a pier segment and a typical segment
- Differential deck displacement at joint causing additional spalling and deterioration
- Needed to control the differential displacements, repair the deck, and seal the joint
- Deck is 8" thick (before milling) and very lightly reinforced, so limited shear capacity if a frame was added

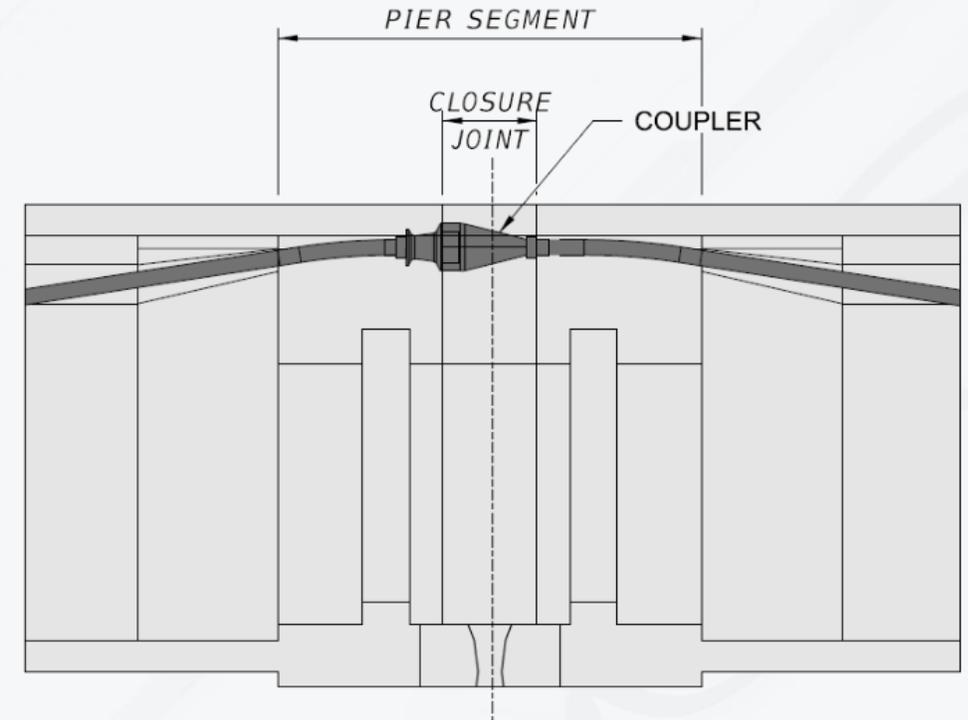
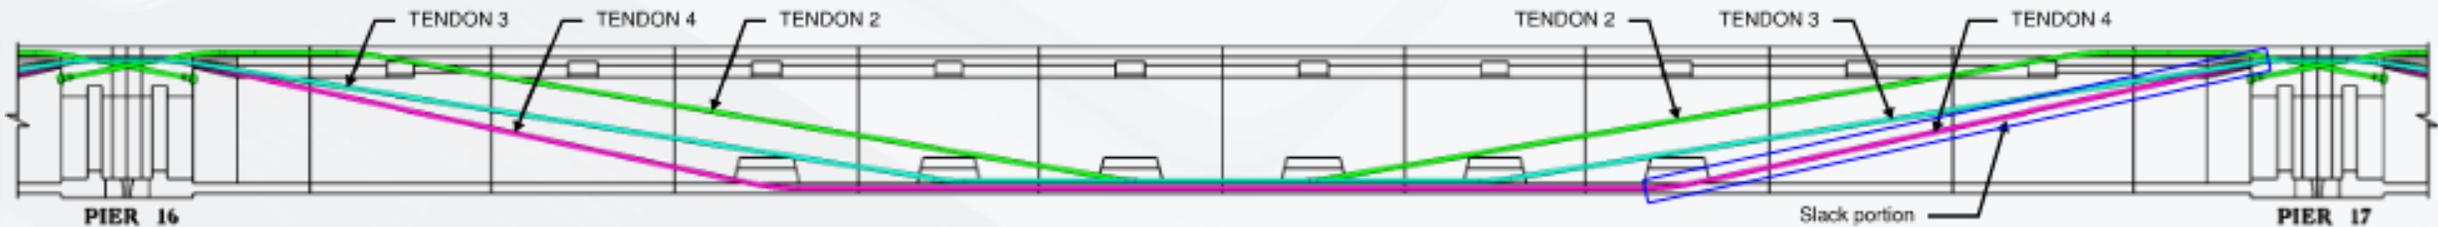
- Draped portion of Tendon 4S found to be during assessment phase
- Several bulges in the HDPE duct
- Opened in two locations to reveal fractured grout
- Downstation end of tendon still had tension
- No evidence of corrosion or water infiltration of the tendon or at the diaphragm

- Replacement challenges
  - Tendon is coupled to a tendon in the adjacent span
  - Tendon profile becomes internal to the bottom slab

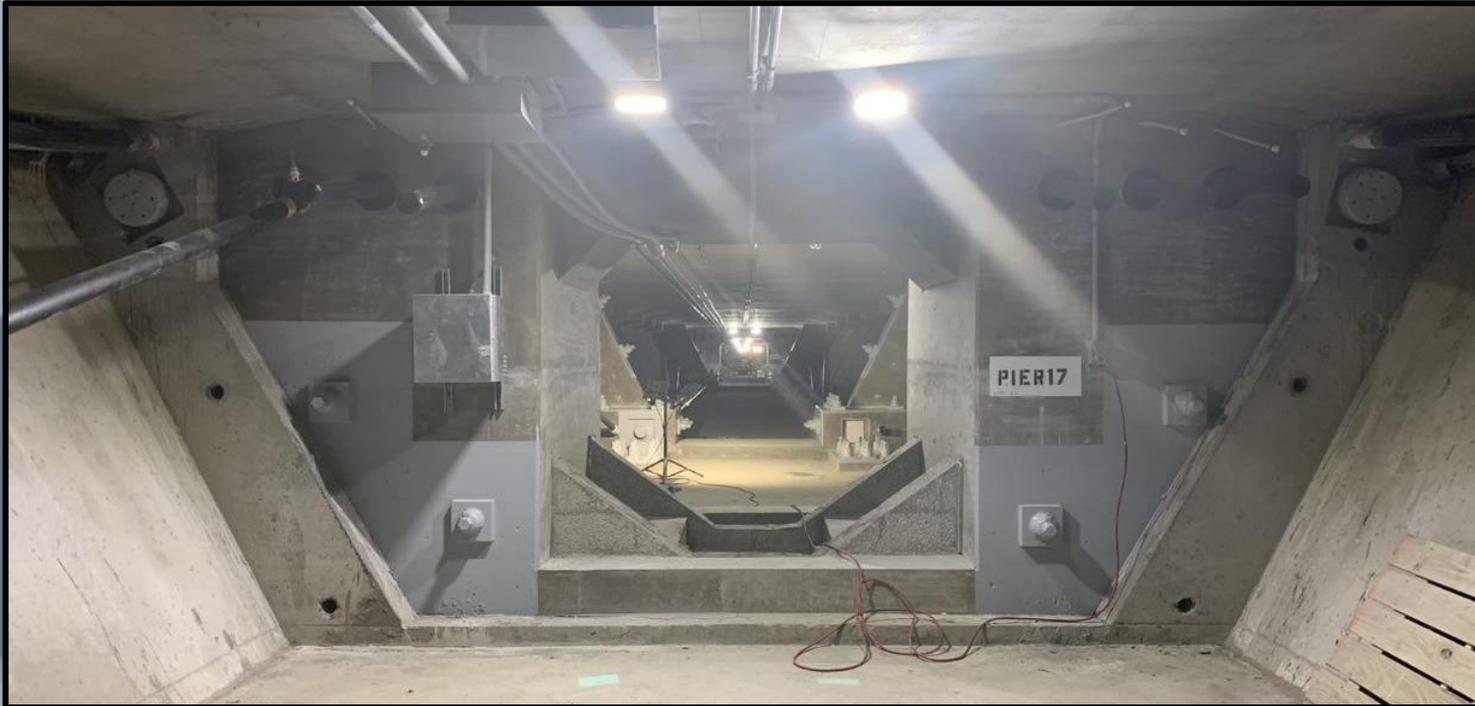
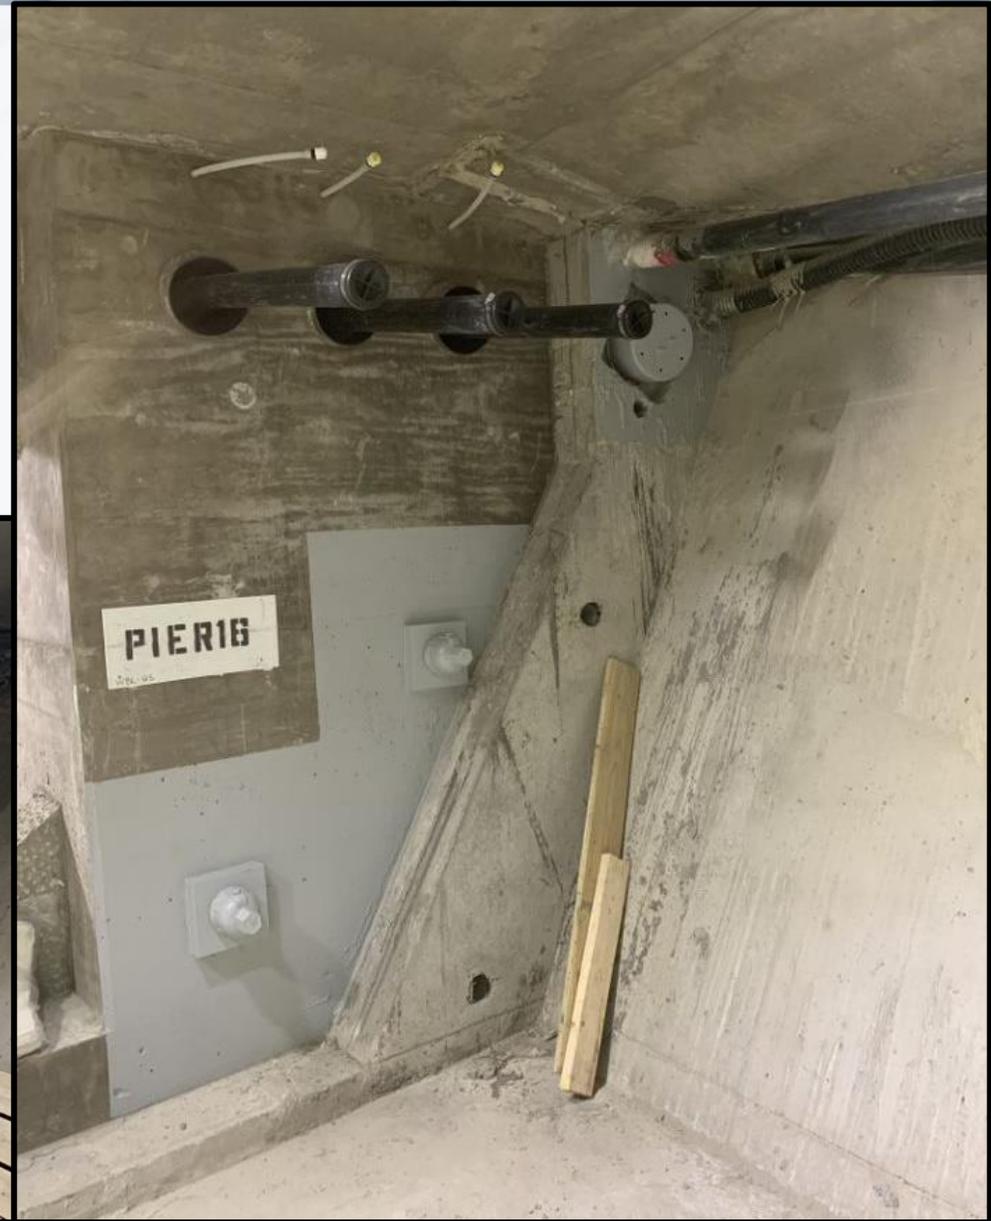
- Pier Segment Deviators

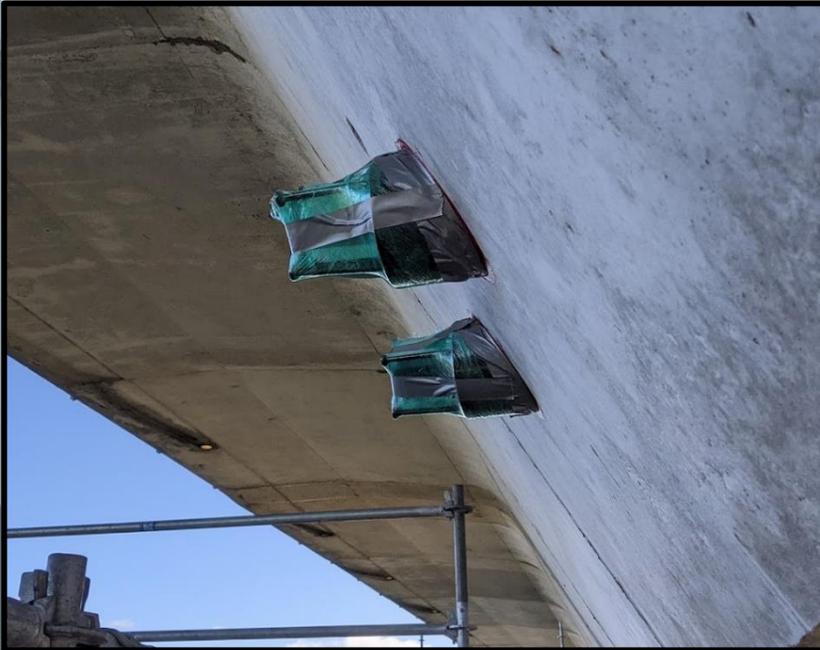
*PT bar anchors on exterior face of web*

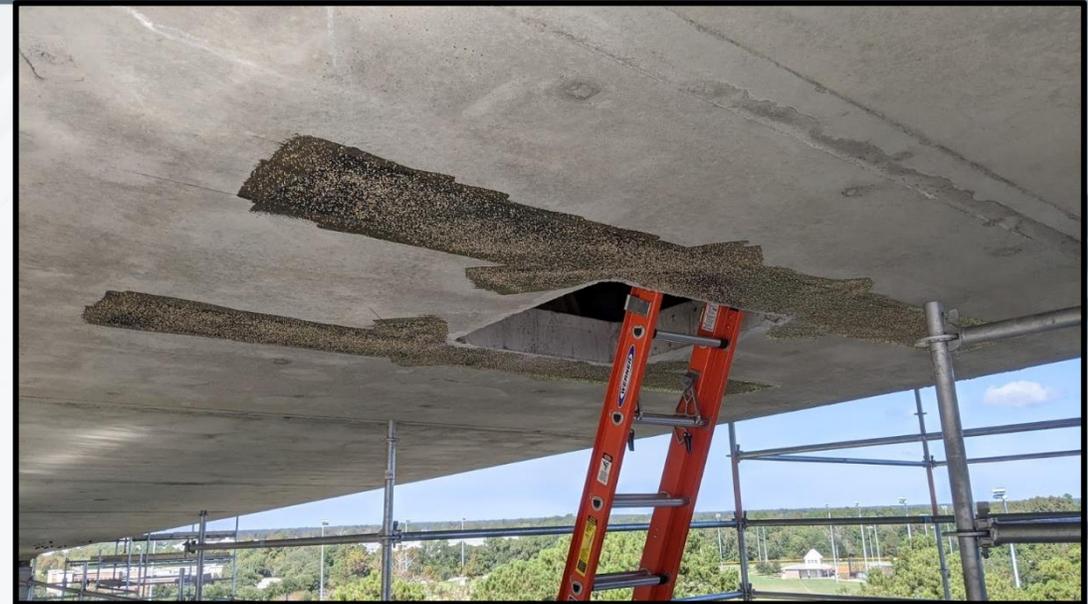
*CFRP reinforcing at new access opening*

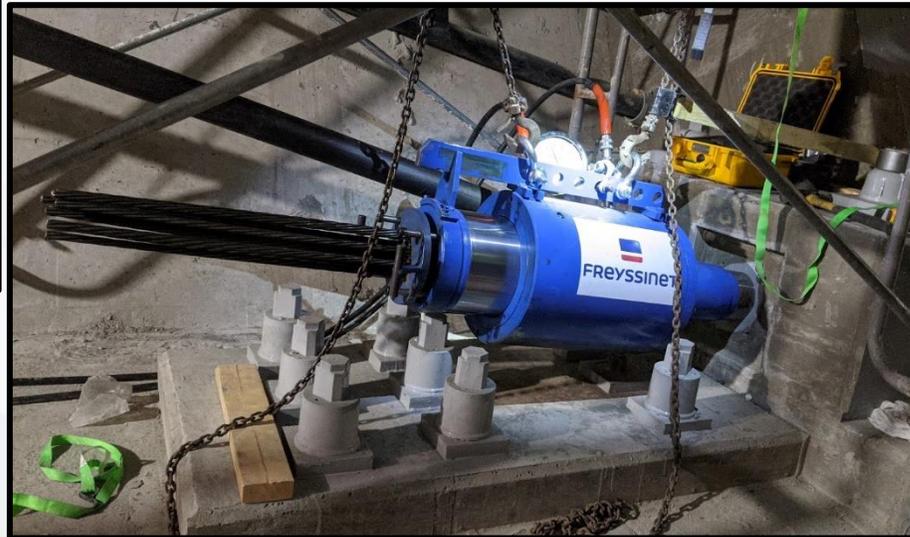
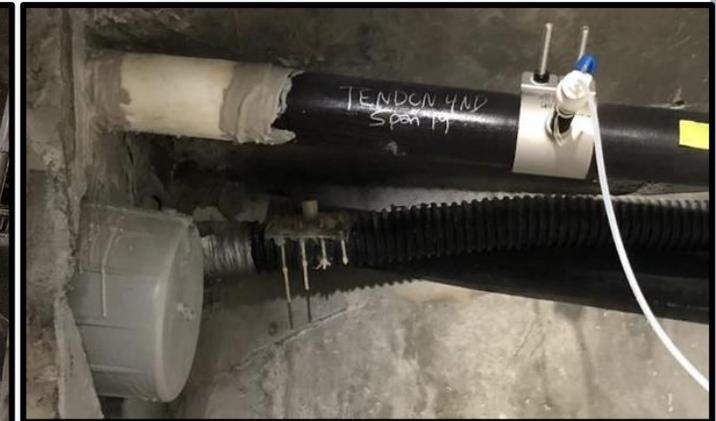
*Tendon impregnation*
