# **NON-DESTRUCTIVE TESTING OF UNBONDED POST-TENSIONED TENDONS**

J. MILLER AND A. SCOTT

Authorized reprint from: December 2006 issue of the PTI Journal

## ABSTRACT

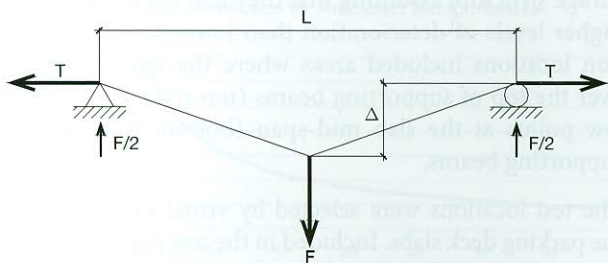
Fig. 2 – Free-Body Diagram

If we set  $\ell'$  equal to 0.19 in. and m equal to 100 ft the increase in tendon tension is theoretically 21 lb. If m is zero, as is assumed in this study (Fig.2), the increase in tendon tension is 1398 lb, or approximately 4% of the expected tendon tension of 35.7 kips. Thus it was deemed that the influence of the length of unbonded tendon away from the test location has a negligible affect on the results.

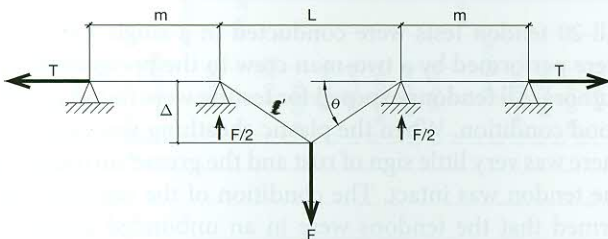
Fig. 3 – Free Body Diagram Including "Unbonded" Length

The influence of the length of unbonded tendon away from the test location was studied. See Fig. 3 for a free-body diagram of this system. The change in tension  $\Delta T$  in a tendon for a given displacement at the test hook can be calculated using Eq. 2.
