**PROGRESSIVE DETERIORATION CAUSED BY
POOR QUALITY CONTROL AND INADEQUATE
MAINTENANCE: THE SAD TALE OF A
DOOMED PARKING STRUCTURE**

by Gregory P. Chacos

This is a case study of a 2200-car, municipally-owned, cast-in-place, post-tensioned parking structure, opened in 1975 and demolished in 1994 because of severe deterioration. A review is made of significant features of the design, construction, and maintenance as they relate to the deterioration. The number and timing of broken strands (tendons) is given, as are descriptions of the incremental shoring that was installed and the demolition.

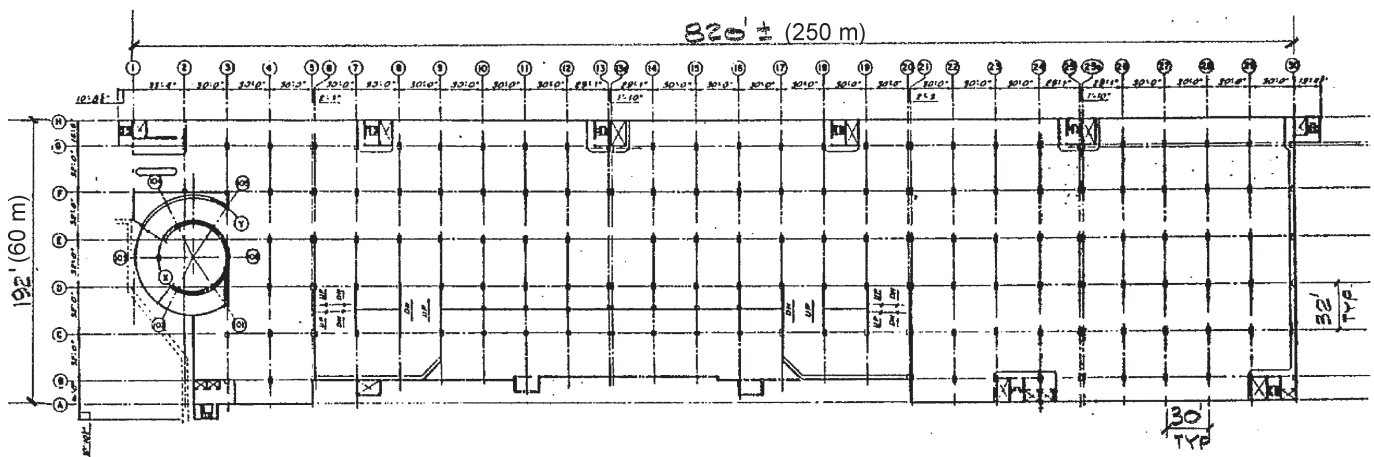
Fig. 2—Plan.

This was a four-story, partially embedded, cast-in-place concrete structure, 820 ft (250 m) long in the east-west direction, 192 ft (60 m) wide, with concrete walls on all sides (Fig. 2).
