VDOT EXPERIENCE WITH GROUTS AND GROUTED POST-TENSIONED TENDONS

MICHAEL M. SPRINKEL

Authorized reprint from: August 2015 issue of the PTI Journal

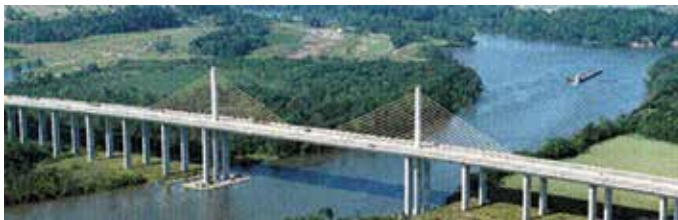
Fig. 1—Varina Enon Bridge.

Varina-Enon Bridge—The tendons in the Varina-Enon Bridge were first inspected in 2001 after failures were noted in similar bridges in Florida. A number of 1 in. (25 mm) diameter inspection holes were found in the plastic ducts. The strands were corroded slightly in the vicinity of the holes and small voids were found in the tops of the ducts. Another problem was a floor drain that was plugged with grout that leaked out while a tendon was being grouted, allowing water from a nearby leaking joint to surround a tendon. The water was acidic from pigeon droppings. The acidic water accelerated corrosion of the strands. A third problem was vent tubes in most draped tendons were found to be open. Borescope inspections made through the open vent tubes revealed voids in the tendons adjacent to the anchor plates (Fig. 3) and traces of grout on the strands and walls of the vent tubes. The traces of grout indicated that the tendon and vent tube had been filled with grout but the grout had bled and segregated, leaving water on the topmost surface of the grout that later evaporated, leaving a void of approximately 4% of the length of the tendon. Longer sections of voids that were found provided an indication that grout had leaked from the tendons prior to setting.

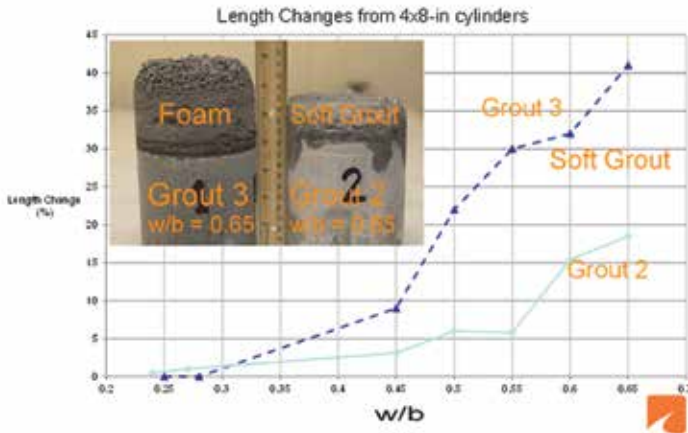
Fig. 13—Length change with w/b for Grouts 2 and 3.

lems with the HPG. Given that Grout 3 performed well in the mockup when batched at the correct water-bag ratio (w/b), grout specimens were cast when batched with extra water to see the effect of increasing the water content. Grouts 1, 2, and 3 were batched at w/b of that specified by the manufacturer as well as 0.45, 0.5, 0.55, 0.6, and 0.65. Results were quite interesting. As the w/b increased, Grout 1 exhibited diminished properties; Grout 2 bled, segregated, and produced soft grout in increasing amounts; and Grout 3 produced a lower-strength foam in increasing amounts. Results are pictured in Fig. 13 and 14. Figure 15 shows that the compressive strength decreases as the w/b
