REPAIR AND REPLACEMENT OF PARTIALLY GROUTED EMBEDDED EXTERNAL TENDONS

Authorized reprint from: August 2015 issue of the PTI Journal

This paper discusses the removal and replacement of two partially grouted embedded external tendons in a two-span 220 ft (67 m) long viaduct. Embedded external tendons were used for cast-in-place viaducts for the Terminal Area Roadways Project (TAR) at Boston Logan Airport in Massachusetts. The project comprised more than 200,000 ft² (18,580 m²) of viaduct. More than 70% of the viaducts were designed using external tendons partially embedded in the bottom slab of the box girder near midspan. The remaining viaducts had internal tendons inside the webs due to their tight curvature. The quality and integrity of grout is of prime importance for the structural integrity and long-term durability of post-tensioned concrete structures. Grout is one of several layers of protection against corrosion. It prevents corrosion of the strands by completely encasing them, it prevents water from collecting and freezing in the ducts by eliminating all voids, and it provides effective bond between prestressing steel and concrete. Improperly grouted tendons do not meet s

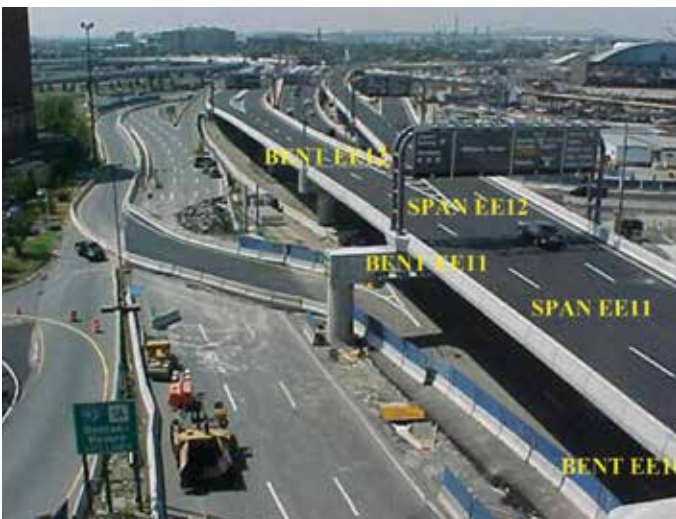
Fig. 15—View of terminal-area roadway viaducts, Spans EE11 and EE12.

Two external tendons partially embedded in the bottom slab were successfully removed and replaced by cutting and detensioning of individual strands. This example demonstrates that it is possible to remove and replace grouted tendons that are partially embedded in concrete if there is access to the tendons, as was the case with the embedded tendons in the bottom slab, to remedy situations such as voids in the tendon grout.
