DISPELLING THE MYTH ABOUT UNBONDED POST-TENSIONED BUILDINGS

CHRISTOPHER FULTON AND STÉPHAN TRÉPANIER

Authorized reprint from: August 2015 issue of the PTI Journal

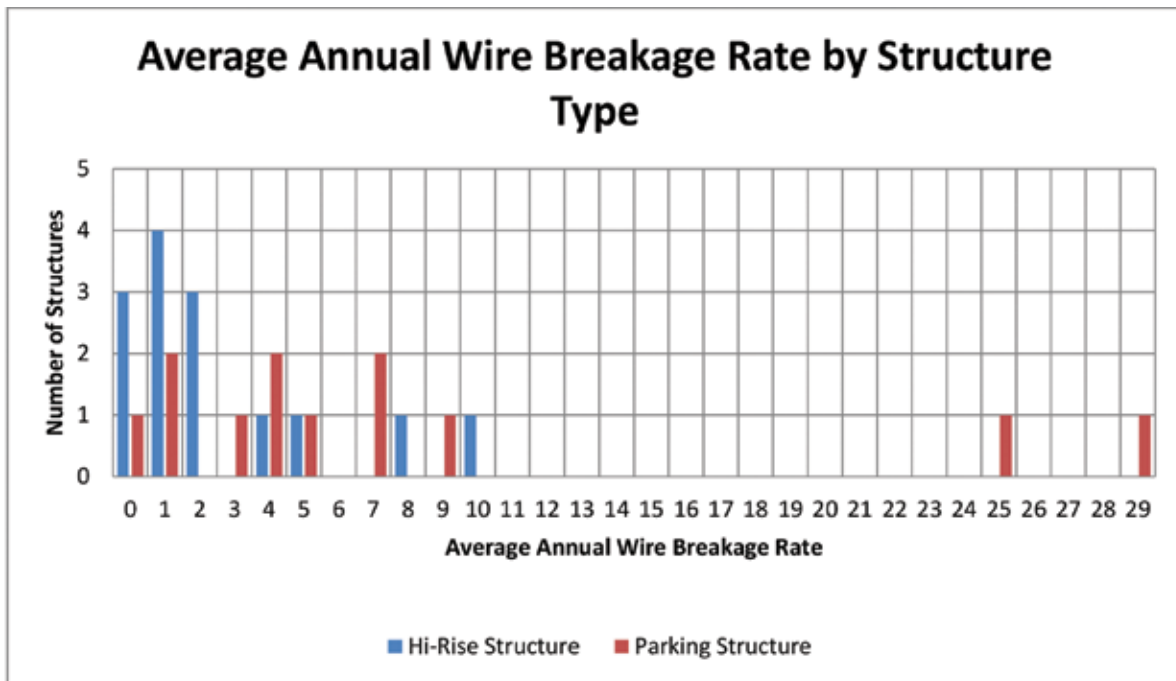
Fig. 1—Average annual wire breakage rate for acoustically monitored structures included in the study of 26 unbonded PT structures.

In Part 1 of the study, analysis of acoustic monitoring records indicated annual average wire breakage rates, based on structure type (it should be noted that acoustic monitoring records the failure of single wires; each tendon is comprised of six wires helically wound around a straight seventh wire) (Fig. 1).

It typically takes more than two individual wire breaks before the stress in the remaining wires exceeds the ultimate strength of the tendon and the tendon ruptures. With the exception of two parking structure anomalies, the remaining 24 structures had an average annual wire breakage rate of 3.6 breaks per year and all the structures averaged 10 or fewer broken wires per year. It is important to note that the wire breaks were reported but have not all been verified by field testing, and that acoustic monitoring systems are typically installed on structures with known durability problems; thus, the breakage rates in Fig. 1 are likely higher than would be expected in the general PT building stock.

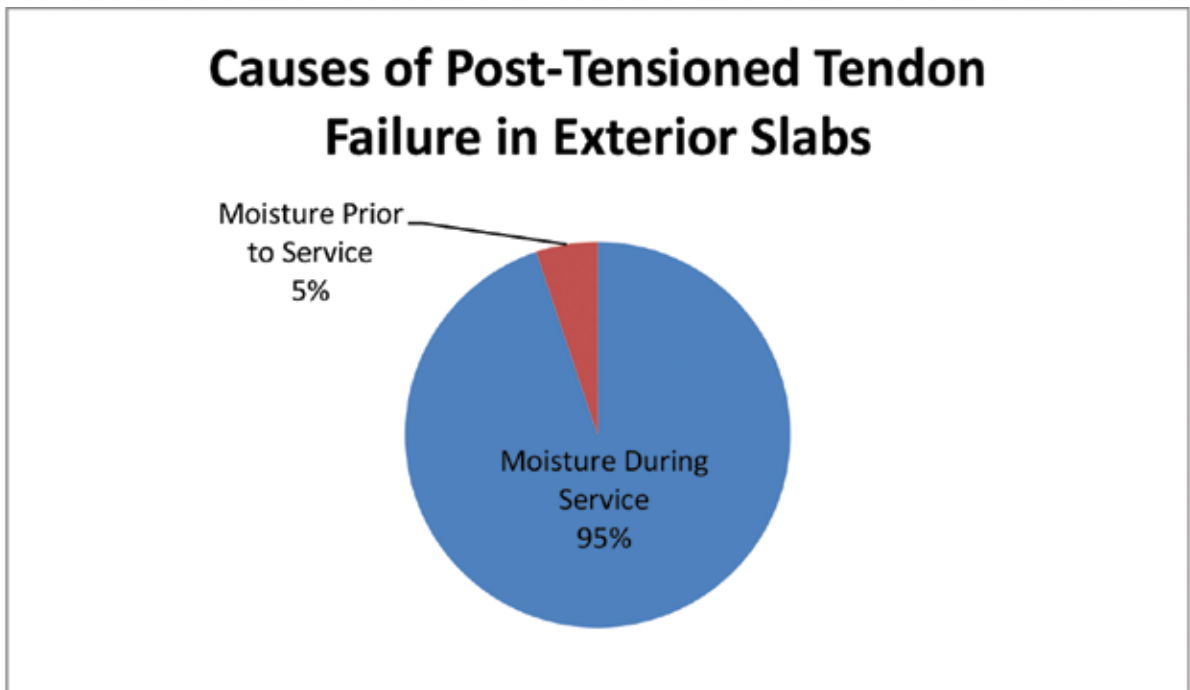
Fig. 4—Causes of tendon failures in exterior spaces (parking garages and building roof slabs), based on evaluation of 174 tendon failures.

Exterior slabs are exposed to more aggressive environments than interior slabs. The direct exposure to heavy precipitation (building and parking garage roof slabs) and salt/water runoff from cars (parking garage slabs) greatly increases the likelihood of PT tendons getting wet during the service life of these structures, as shown in Fig. 4 (95% of tendon failures in exterior slabs are the result of moisture entering the system during the structure's service life). Frequent points of moisture ingress include cracks and construction joints in the concrete slab and at slab edges. To protect the strands from moisture penetration, a proactive approach should be taken. This may be accomplished through slab and expansion joint waterproofing with periodic maintenance.
