PROTECTING UNBONDED PRESTRESSED TENDONS

MYLES A. (TONY) MURRAY, JACK MORROW, AND BRUCE COLLINS

Authorized reprint from: July 2012 issue of the PTI Journal

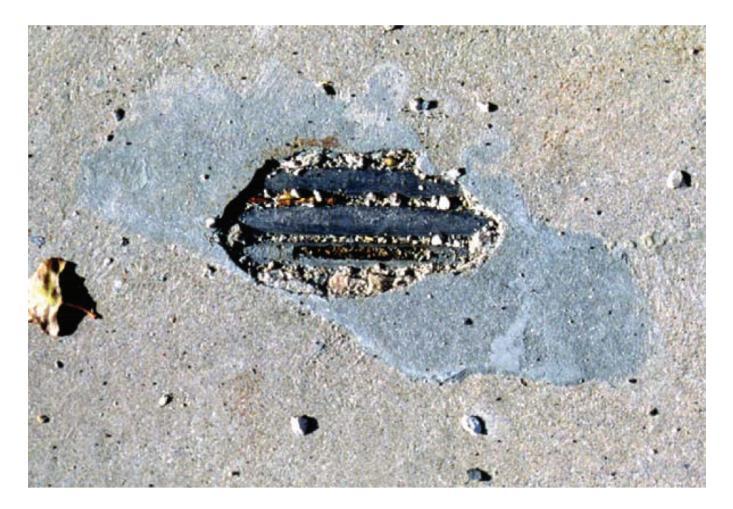
Fig. 1—Corroded strand at surface.

If left unchecked, the corrosion process will cause failure of the prestressed tendons (Fig. 1 and 2). Each tendon is made up of seven wire strands. The corrosion process reduces the cross-sectional area of the strand(s), thereby reducing the load-carrying capability of the tendon. The time to failure will depend on the level of stress that has been induced in the tendon at the time of prestressing and the corrosion rate. Once a tendon has failed, it must be replaced or spliced, then restressed to reestablish the original structural integrity of the beam or slab.

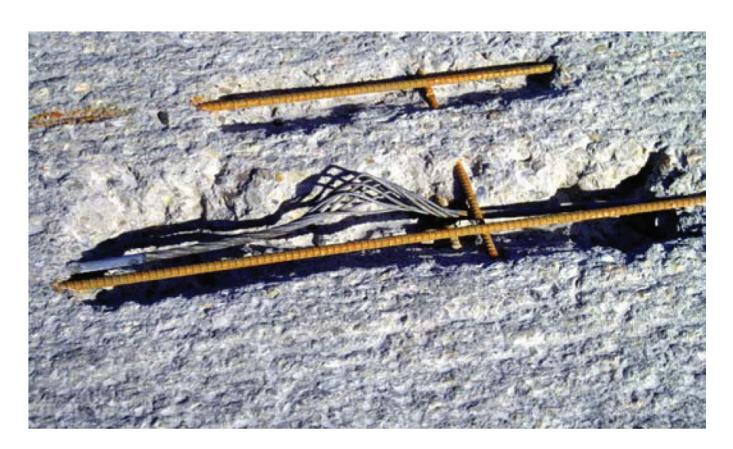
Fig. 2—Result of broken strand.

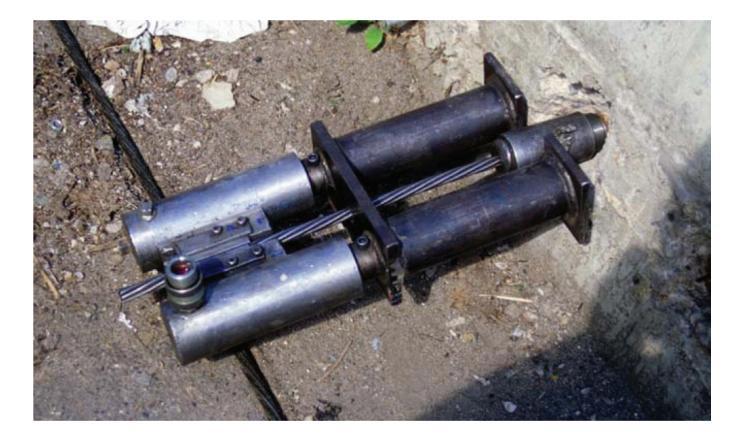
Fig. 3—Modified coupler attached to tendon end with stressing jacks.

Evaluation of the in-place tendon performance capability can be performed by attaching a modified coupler and stressing jack to the exposed tendon end (a minimum exposed length of 5/8 in. is required) and apply a tensile force sufficient to loosen the wedges (Fig. 3). This procedure usually does not exceed the original tensile force required to set the wedges. Occasionally, this procedure will induce a failure of the tendon. The tendon is then normally removed and inspected to determine the extent of damage at the point of the break.

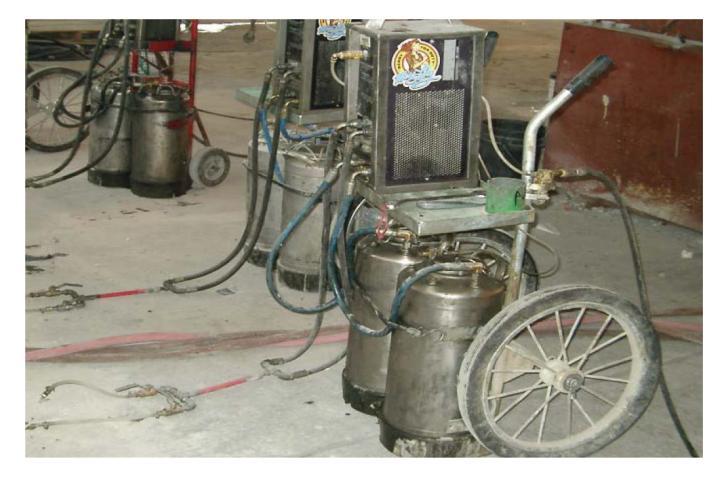
Fig. 4—Pumping urethane into sheathed tendons with multiplecomponent pump.

The polyurethane grout will be injected into the void space around the tendons by a high-pressure multiple component pump (Fig. 4). The pump will push each of the two components through a mixing head that will uniformly mix the components into a homogenous solution. The pump then should have the capability to pump the mixed solution a distance of up to 120 ft. Most applications will require a pumping distance of 60 ft or less.

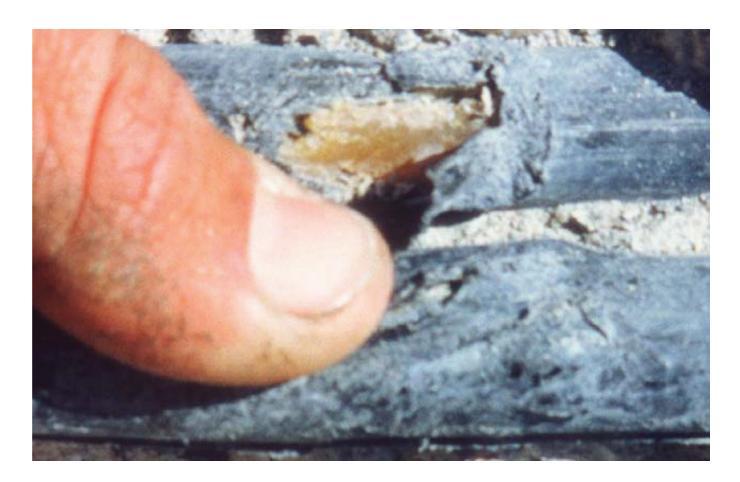
Fig. 5—*Cured polyurethane encapsulating prestressed tendon within sheathing.*
